# **Results of the Investigation into the Allegations about Kashiwazaki-Kariwa Nuclear Power Station Units 6 and 7, and Steps to Be Taken Going Forward**

December 24, 2021

Tokyo Electric Power Company Holdings, Inc.  
Kashiwazaki-Kariwa Nuclear Power Station

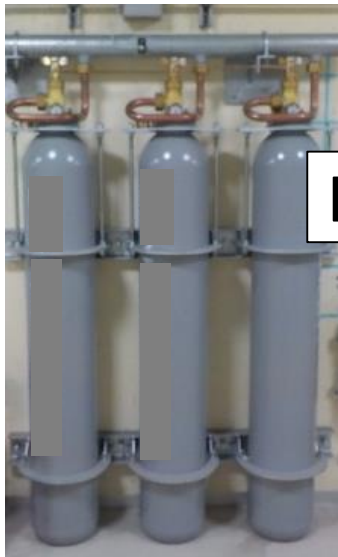
Fire retardant storage tanks  
(Halide tanks)

Main pipes

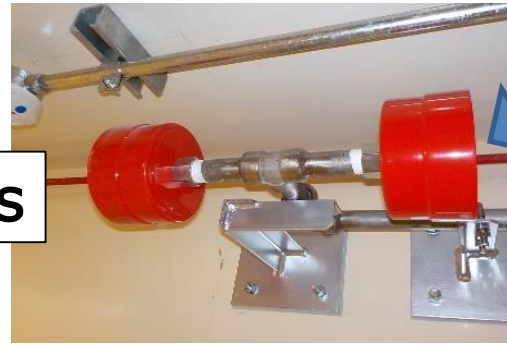
Spray head ※

※ Fire retardant gas travels through the pipes and is sprayed from the spray head

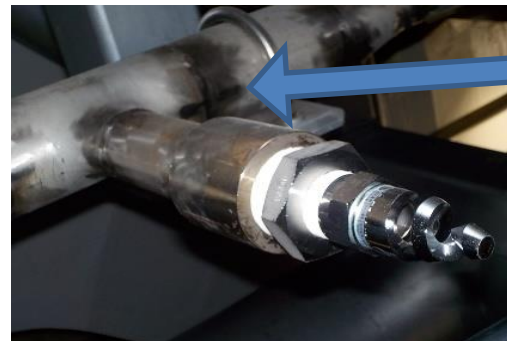
Pipe weld

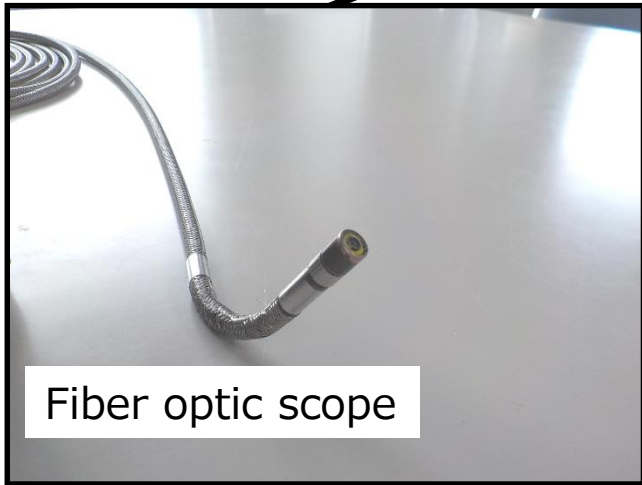
Inner pipe weld inspection: Fiber optic scope is used to inspect the welds on the inside of the pipes since these areas cannot be seen directly.

Fiber optic scope

The flexible probe is 6.5 mm in diameter and attached to a cable approximately 7m in length. The camera head can be pointed in every direction

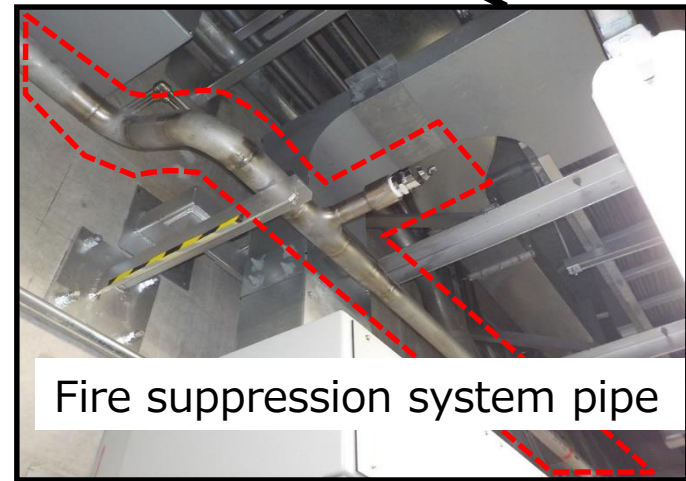
Fire suppression system pipe

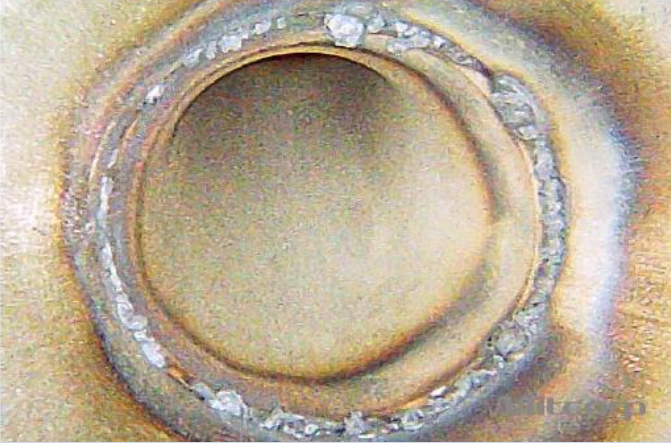
The weld on the inside of the pipe is covered with weld scales from oxidation
Good weld

- Since many of Company A's welders were welding inappropriately without back purging, TEPCO has instructed E&S to **redo all of the 1,220 welds done by Company A after thoroughly implementing recurrence prevention measures.**

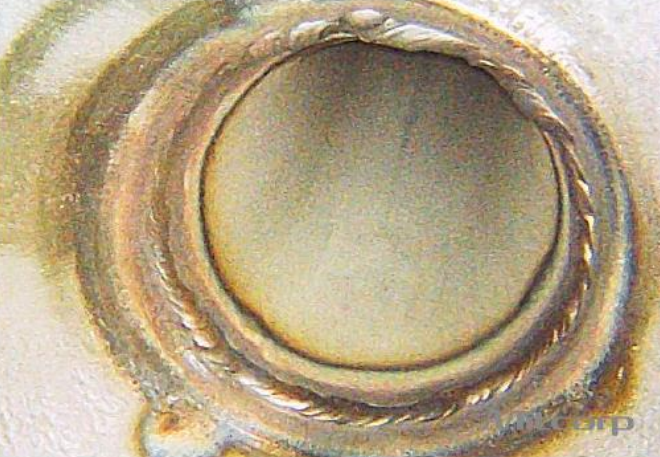
No weld scales on the weld inside the pipe

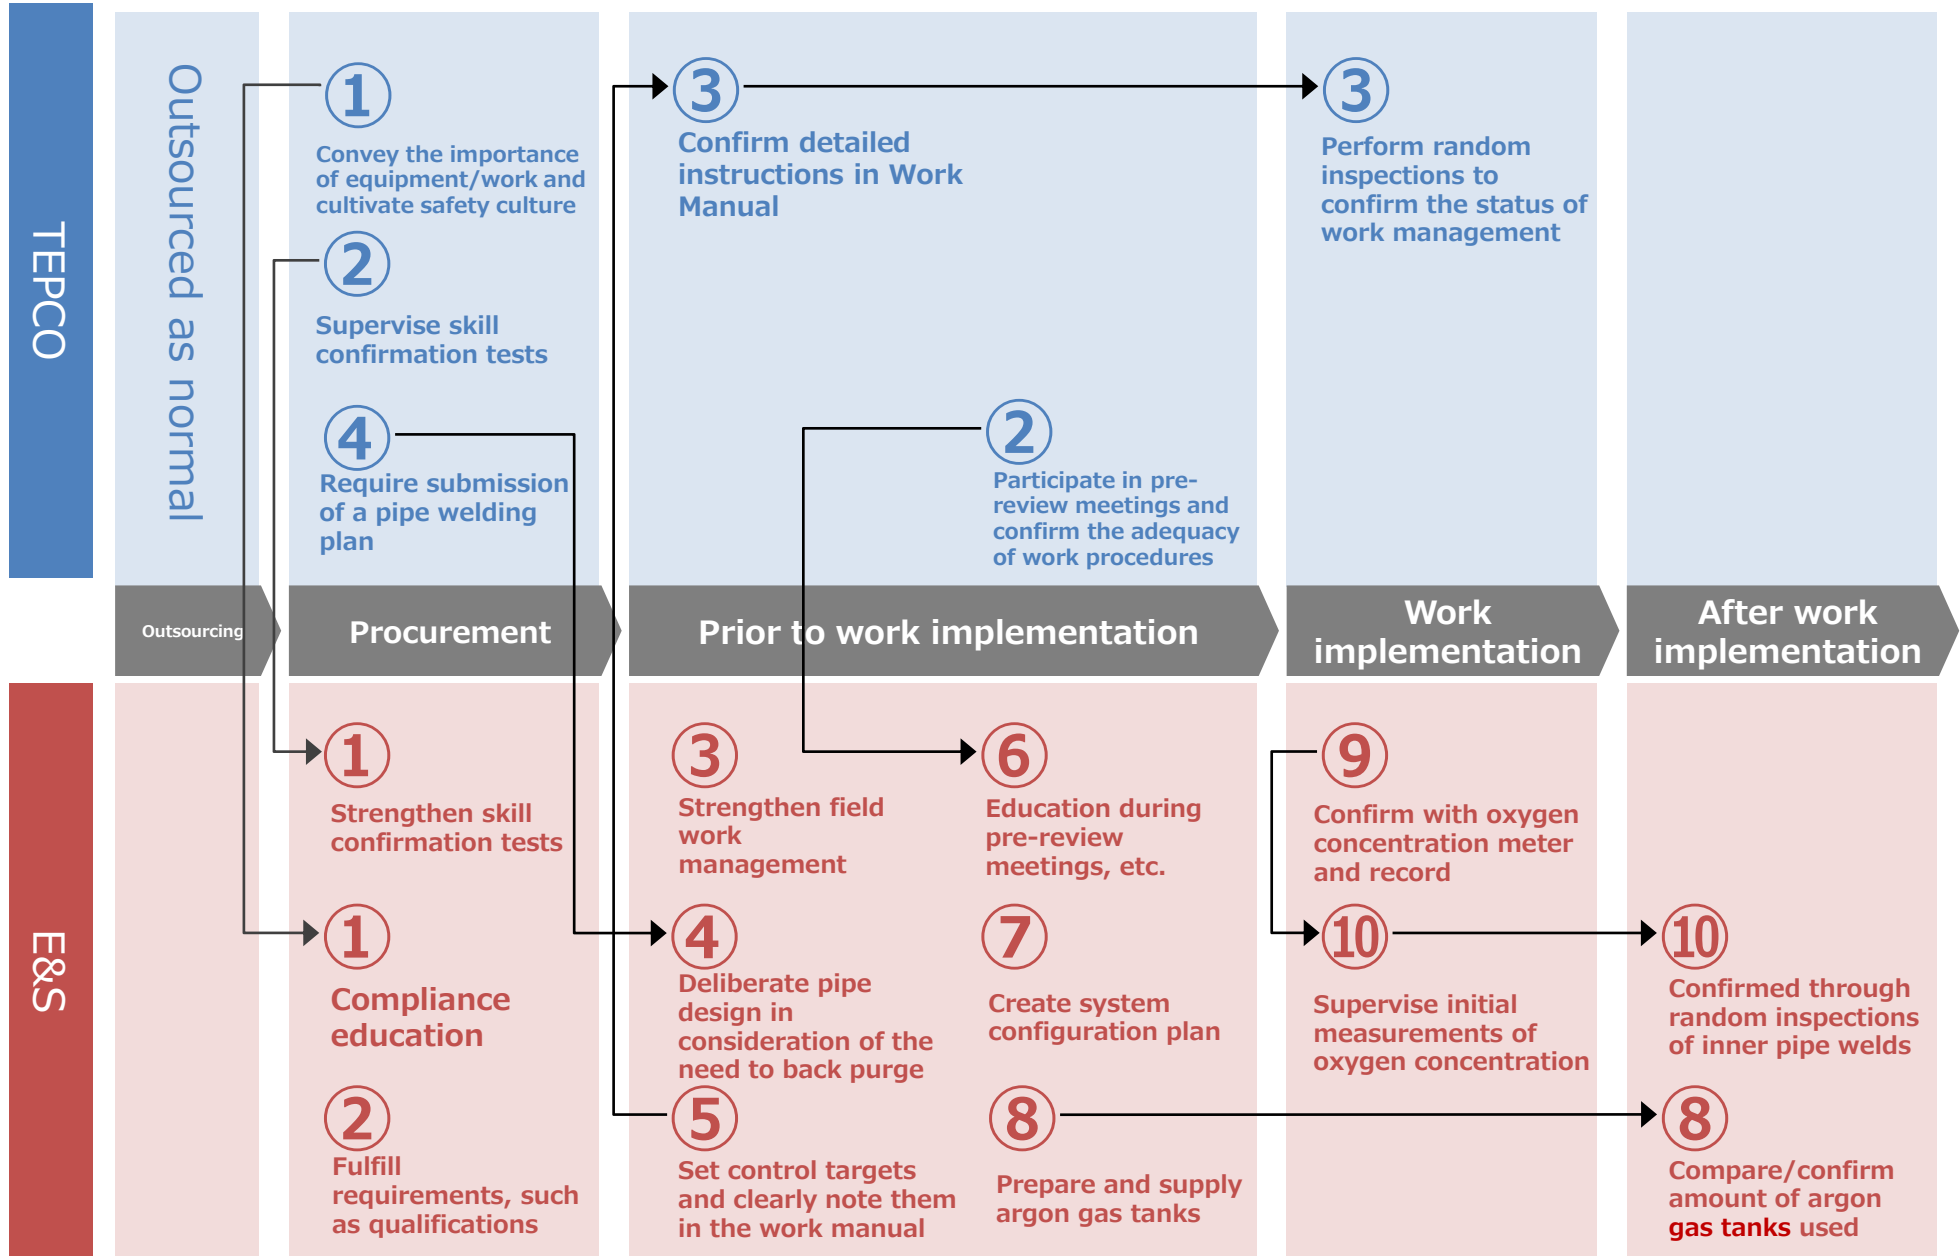
## 8. Weld repair plan (reprinted)

- All welds done by Company A for which back purging was not conducted (1,220 welds) and welds performed by companies B, C and D that are not up to order specifications (317 welds), shall be rewelded (total: 1,537 welds)
- In order to operate/management nuclear power stations safely, strict action shall be taken in regards E&S to prevent a similar incident from happening again, and TEPCO shall implement its own countermeasures to prevent recurrence.
- When rewelding, the effectiveness of recurrence prevention measures by E&S, the general contractor, shall be directly confirmed by TEPCO and a third-party (JAPEIC) while the rewelding work begins in January 2022.
- An inspection of Unit 6 shall be deliberated based upon the progress status of rewelding at Unit 7.
