Detailed Analysis Results in the Port of Fukushima Daiichi NPS, around Discharge Channel and Bank Protection (Sampling Locations of Underground Water Obtained at Bank Protection)

Detailed Analysis Results in the Port of Fukushima Daiichi NPS, around Discharge Channel and Bank Protection (1/4)
Underground Water Obtained at Bank Protection

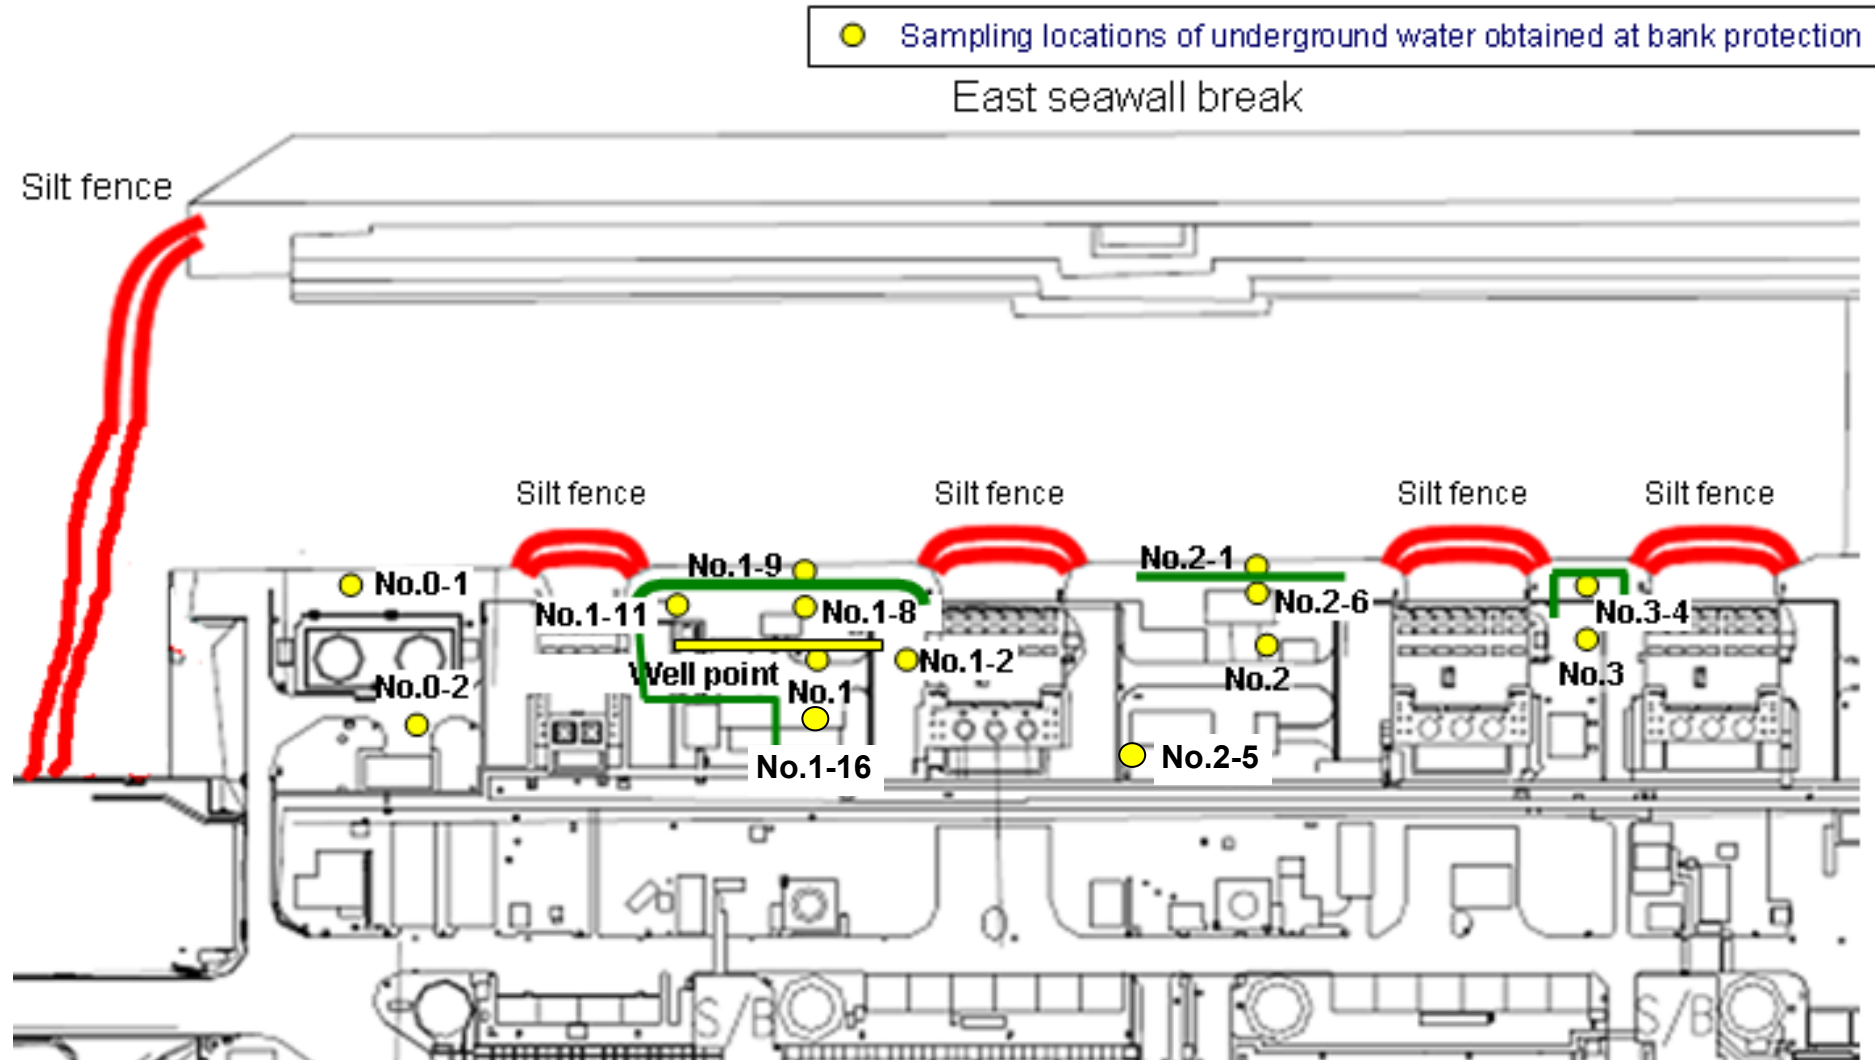
● Sampling locations of underground water obtained at bank protection

— : Location where ground improvement work was completed, or being implemented (as of September 27)

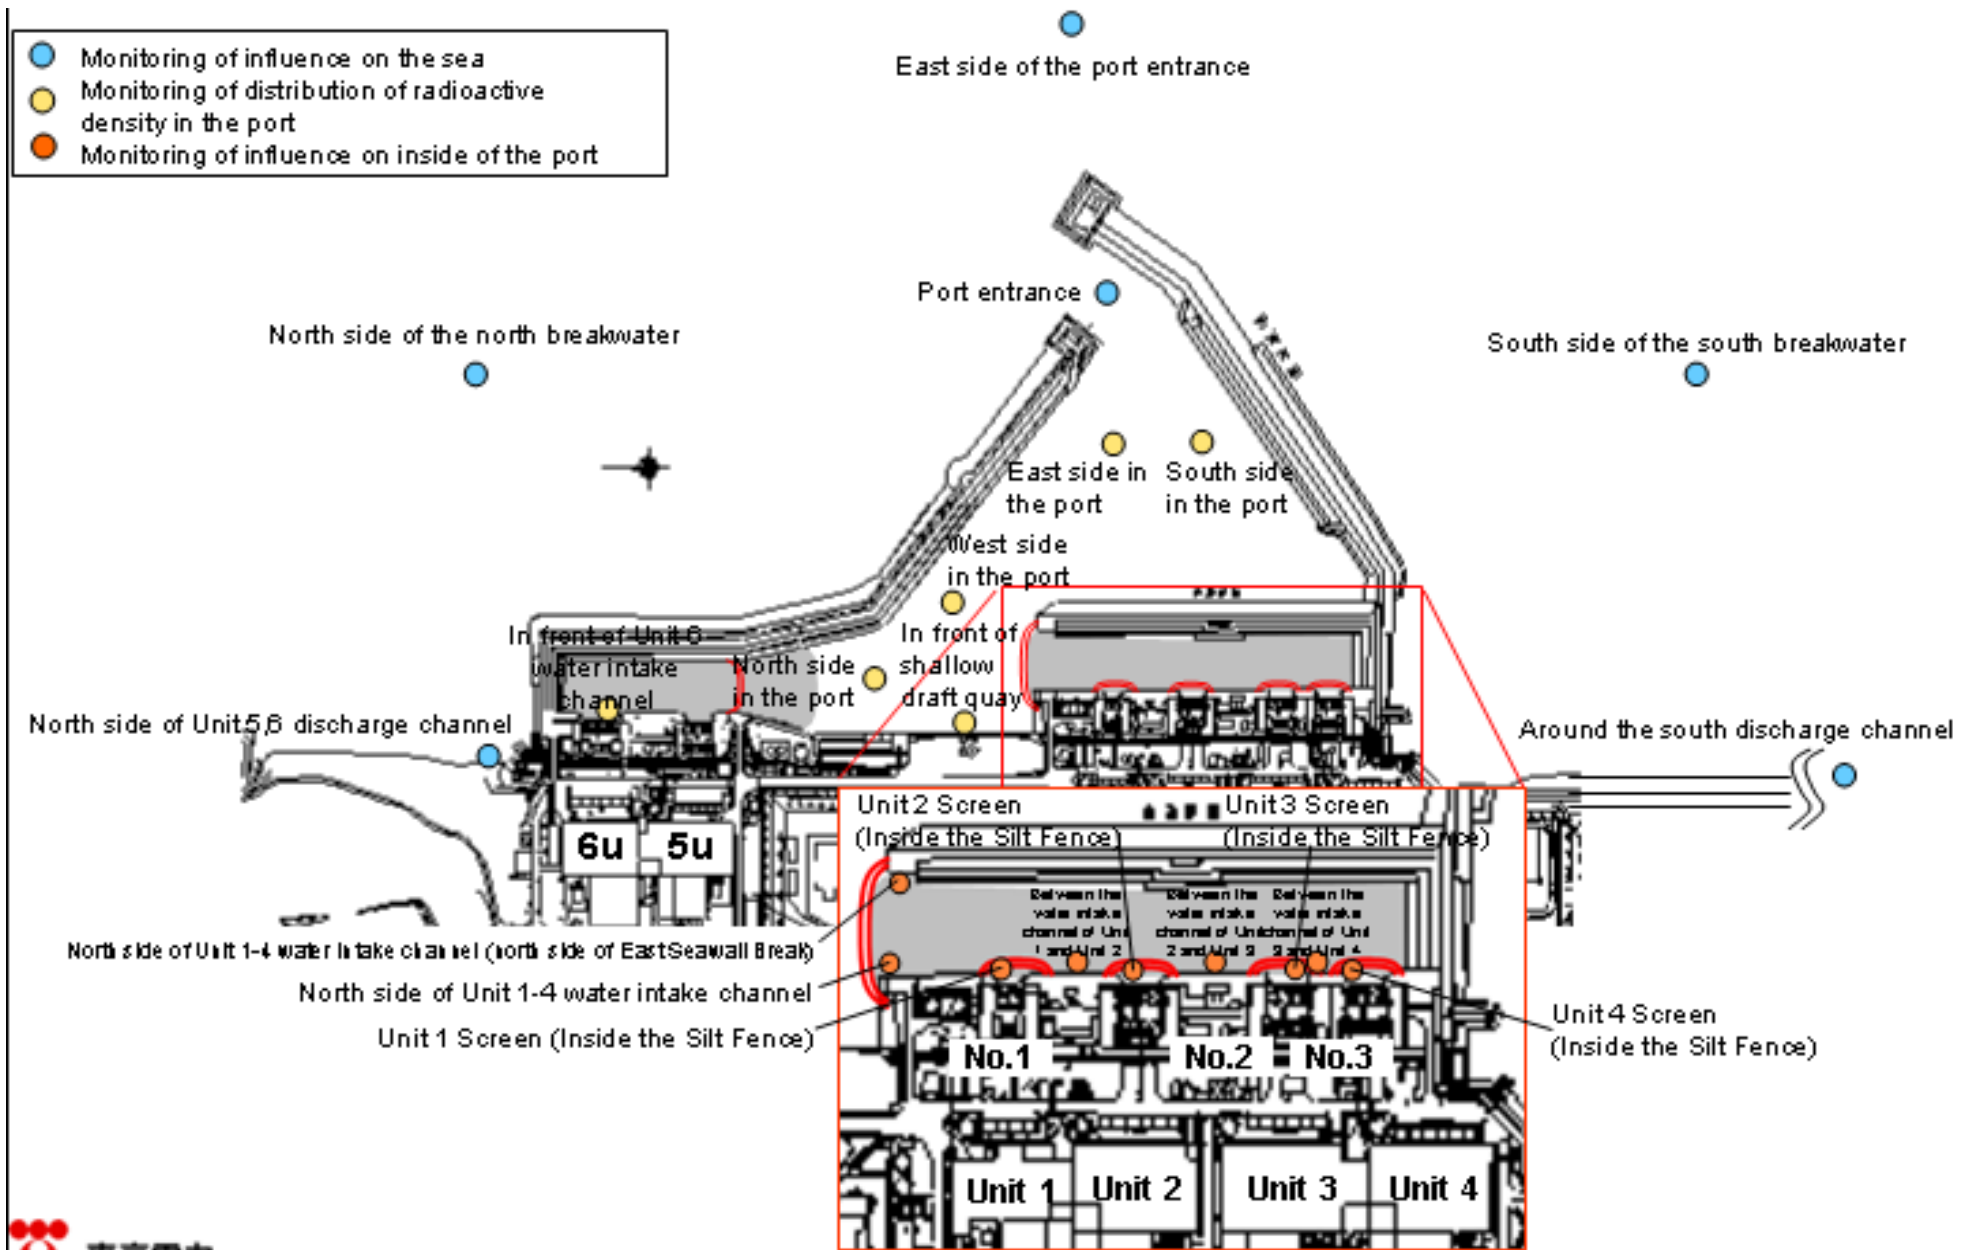
Detailed Analysis Results in the Port of Fukushima Daiichi NPS, around Discharge Channel and Bank Protection (Sampling Locations of Seawater)
