Detailed Analysis Results in the Port of Fukushima Daiichi NPS, around Discharge Channel and Bank Protection (Pumped Water Obtained from Bank Protection) (1/2)

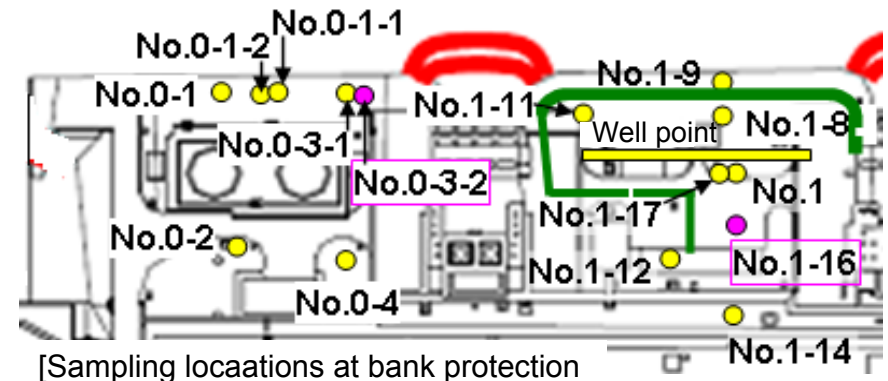
Pumped water from groundwater observation hole No.0-3-2	Pumped water from groundwater observation hole No.1-16
Date of Sampling	Dec 12, 2013	/
Time of sampling	12:00 PM	
Cs-134 (Approx. 2 years)	ND(0.40)	
Cs-137 (Approx.30 years)	0.56	
The other γ		
Gross β	ND(17)	
H-3 (Approx. 12 years)	Under analysis
