Detailed Analysis Results of Grounwater Obtained around Unit 1-4 Building at Fukushima Daiichi Nuclear Power Station

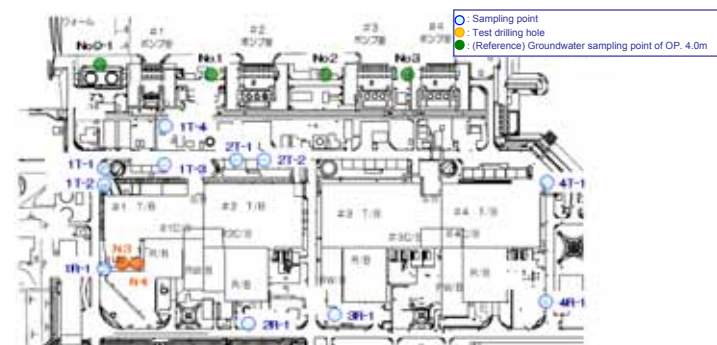
Observation well															
	Sea side of the building								Mountain side of the building							
	Unit 1				Unit 2				Unit 4		Unit 1			Unit 2	Unit 3	Unit 4
	1T-1 ¹	1T-2	1T-3 ¹	1T-4 ¹		2T-1 ¹	2T-2 ¹	4T-1 ¹	Test drilling hole N3 ¹¹	Test drilling hole N4 ¹¹	1R-1 ¹	2R-1 ¹	3R-1	4R-1		
Date of sampling	Sep 5, 2013		Sep 5, 2013	Sep 11, 2013	Sep 13, 2013	Sep 11, 2013	Sep 11, 2013	Sep 9, 2013	Sep 1, 2013	Sep 1, 2013	Sep 5, 2013	Sep 3, 2013		Sep 18, 2013		
Time of sampling	1:00 PM		11:00 AM	11:50 AM	10:00 AM	1:00 PM	11:35 AM	10:30 AM	11:00 AM	11:20 AM	12:50 PM	10:00 AM		9:20 AM		
Cs-134 (Approx. 2 years)	ND(0.37)		ND(0.54)	ND(0.46)	0.64	ND(0.36)	ND(0.47)	ND(0.38)	3.0	4.8	0.64	ND(0.55)		ND(0.46)		
Cs-137 (Approx.30 years)	ND(0.47)		ND(0.52)	0.88	0.90	0.66	ND(0.60)	ND(0.44)	7.2	12	1.3	0.97		ND(0.59)		
The other y	Sb-125 (Approx. 3 years)	ND		ND	ND	ND	ND	ND	ND	32	ND	ND		ND		
All β	ND(21)		ND(21)	9500	7,000	ND(24)	830	ND(17)	ND(21)	62	ND(21)	36		ND(18)
