## Sampling Results Regarding the Water Leak at a Tank in the H4 area in Fukushima Daiichi Nuclear Power Station (South Water Outlet, Drainage Channel)

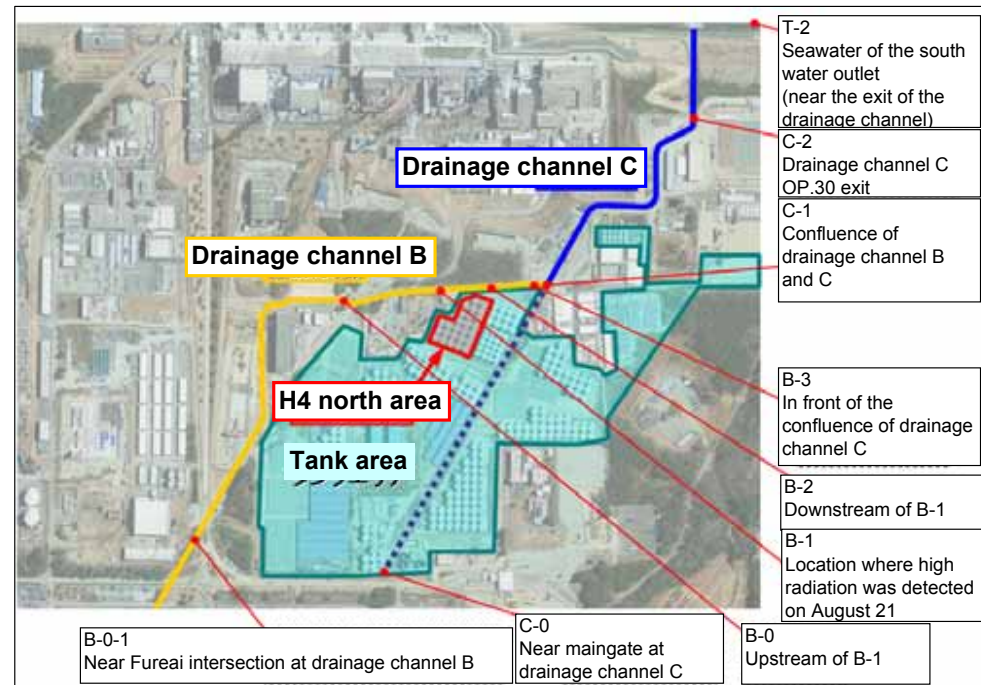
Note 1: Approx. 330m south from Unit 1-4 water outlet (T-2)

Note 2: Same sampling point as side ditch in front of the core warehouse sampled on August 19 (announced on August 20) and August 20 (announced on August 21)

Note 3: Water inflow location of drainage channel to the tank area

Note 4: The drainage channel B is being cleaned since September 7.

Note 5: We have corrected the name of the sampling point which had been mentioned as "Drainage channel C OP.30 exit" until September 12. (No change on the sampling location)
