Sampling Results Regarding the Water Leak at a Tank in the H4 area in Fukushima Daiichi Nuclear Power Station (South Water Outlet, Drainage Channel)

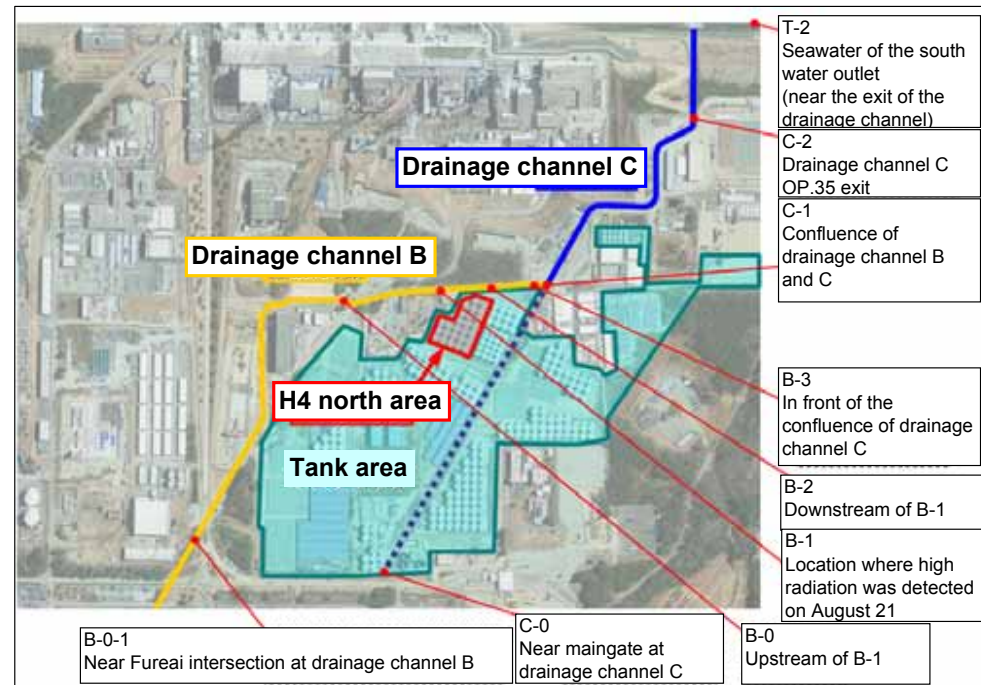
Note 1: Approx. 330m south from Unit 1-4 water outlet (T-2)

Note 2: Same sampling point as side ditch in front of the core warehouse sampled on August 19 (announced on August 20) and August 20 (announced on August 21)

Note 3: Water inflow location of drainage channel to the tank area

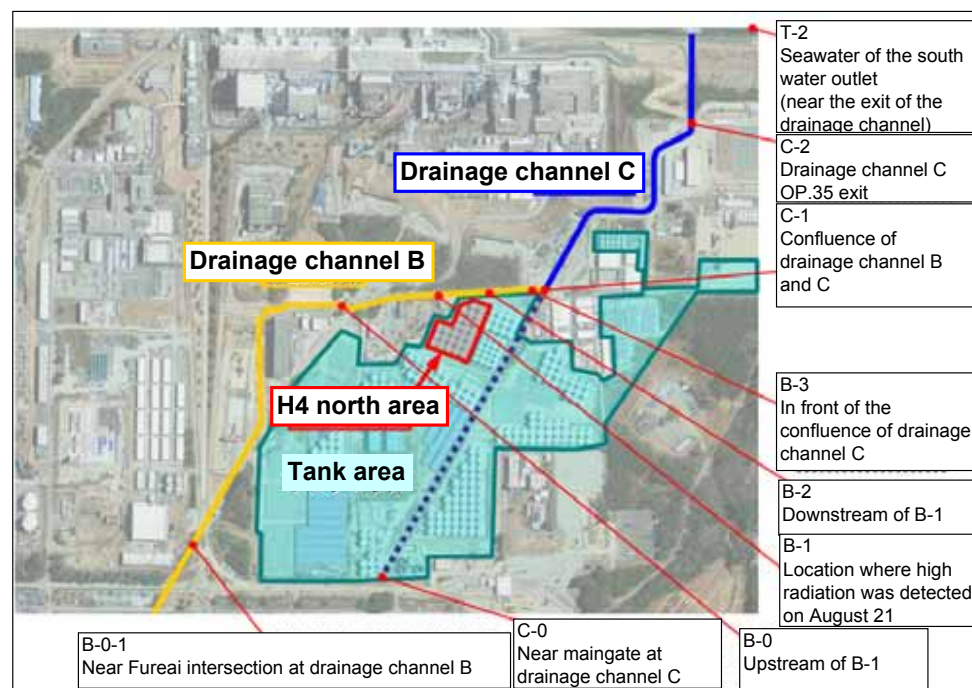
Note 1: Approx. 330m south from Unit 1-4 water outlet (T-2)

Note 2: Same sampling point as side ditch in front of the core warehouse sampled on August 19 (announced on August 20) and August 20 (announced on August 21)

Note 3: Water inflow location of drainage channel to the tank area
