Sampling Results Regarding the Water Leak at the Tanks in the H4 area and the B area in Fukushima Daiichi Nuclear Power Station (South Water Outlet, Drainage Channel)

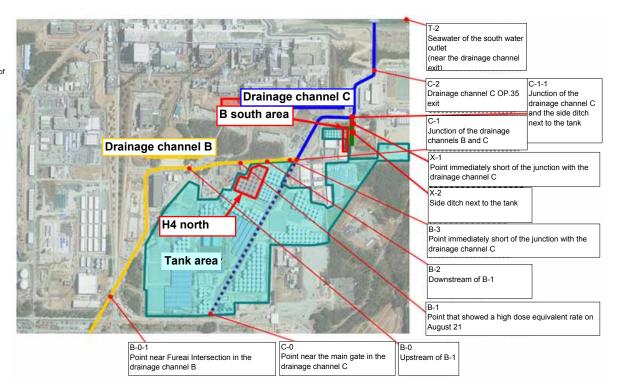
Note 1: Approx. 330m south from Unit 1-4 water outlet (T-2)

Note 3: Water inflow location of drainage channel to the tank area
