Sampling Results Regarding the Water Leak at the Tanks in the H4 area and the B area in Fukushima Daiichi Nuclear Power Station (South Water Outlet, Drainage Channel)

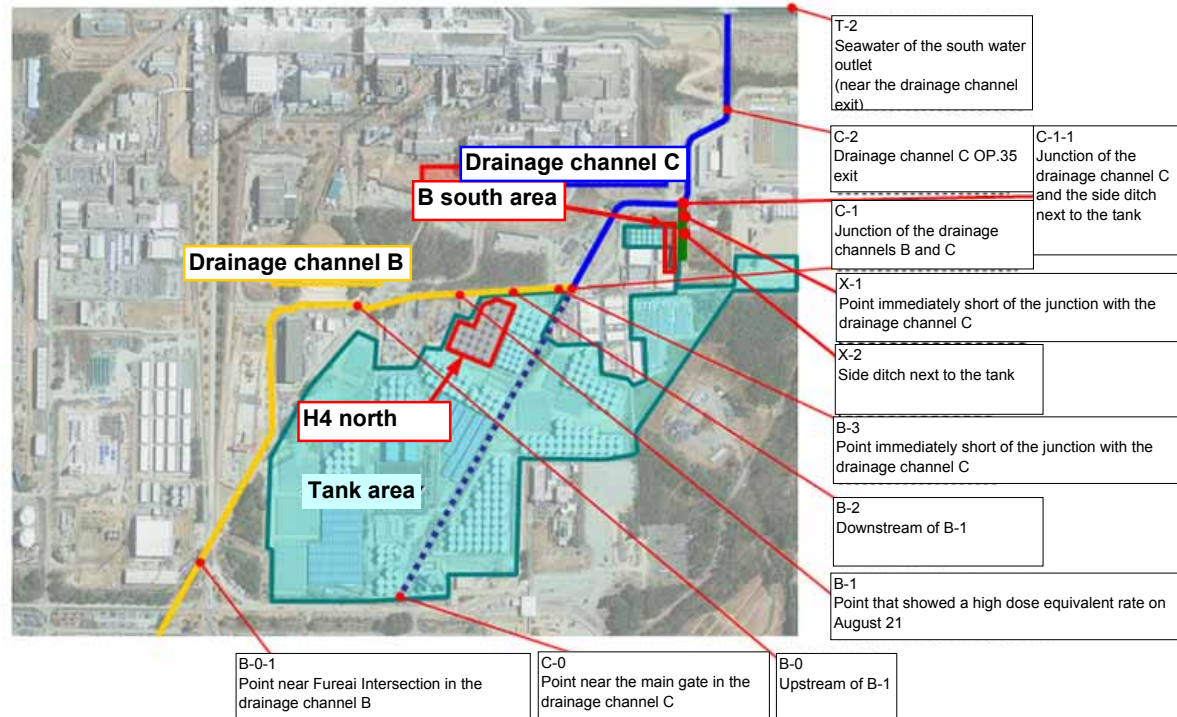
Note 1: Approx. 330m south from Unit 1-4 water outlet (T-2)

Note 2: Same sampling point as side ditch in front of the core warehouse sampled on August 19 (announced on August 20) and August 20 (announced on August 21)

Note 3: Water inflow location of drainage channel to the tank area
