Sampling Results Regarding the Water Leak at the Tanks in the H4 area in
Fukushima Daiichi Nuclear Power Station (South Water Outlet, Drainage Channel)

<Reference>
January 14, 2014
Tokyo Electric Power Company

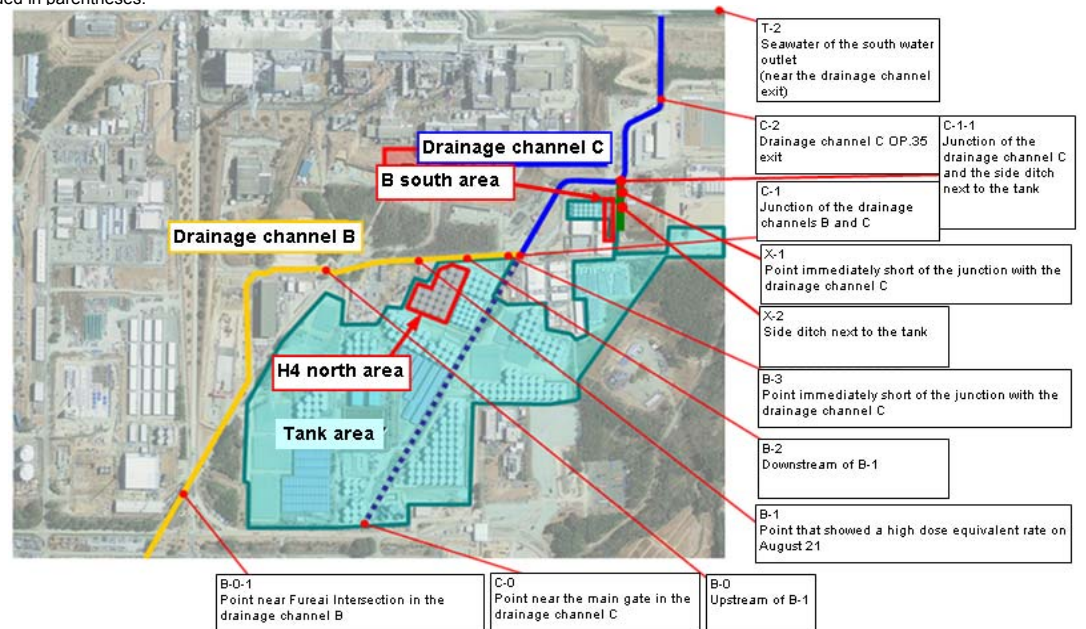
Note 1: Approx. 330m south from Unit 1-4 water outlet (T-2)

Note 2: Same sampling point as side ditch in front of the core warehouse sampled on August 19 (announced on August 20) and August 20 (announced on August 21)

Note 3: Water inflow location of drainage channel to the tank area
