# Sampling Results Regarding the Water Leak at the Tanks in the H4 area in Fukushima Daiichi Nuclear Power Station (South Water Outlet, Drainage Channel)

<Reference>  
April 26, 2014  
Tokyo Electric Power Company

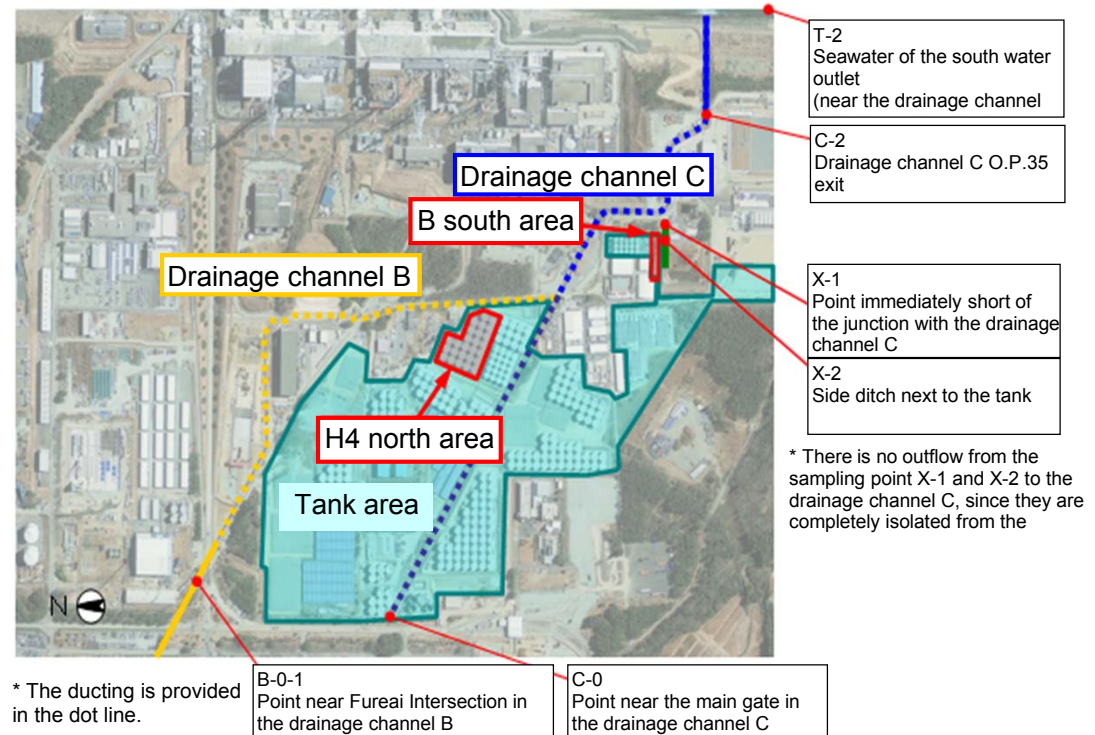
\* The ducting is provided in the dot line.

B-0-1 Point near Fureai Intersection in the drainage channel B

C-0 Point near the main gate in the drainage channel C
