Debris Removal from the Upper part of Unit 3 Reactor Building at Fukushima Daiichi Nuclear Power Station: Removal of Steel Truss Debris

< Reference >
February 6, 2013
Tokyo Electric Power Company

The steel truss debris in the upper part of the spent fuel pool has been removed.

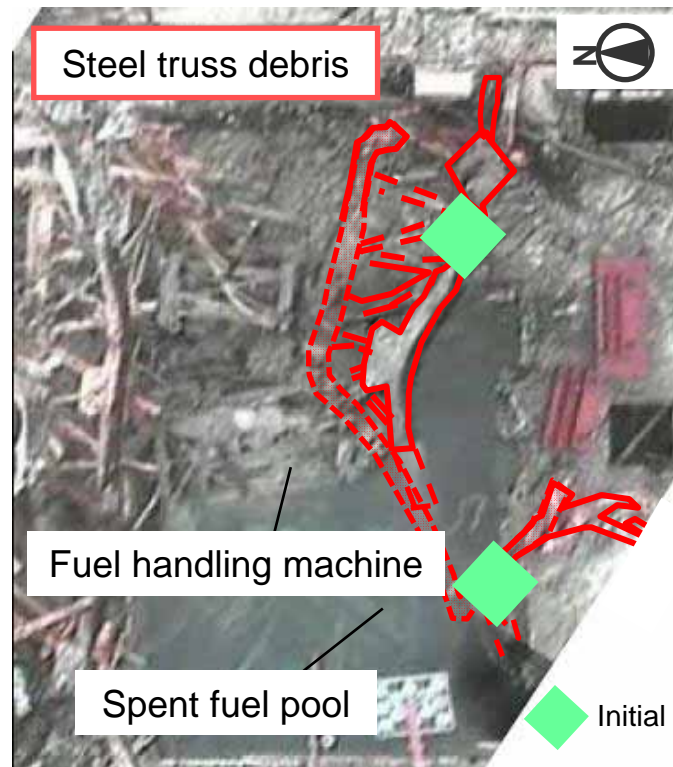
Spent fuel pool (Before steel truss removal)

At around 10:37 AM: Started the steel truss debris removal.

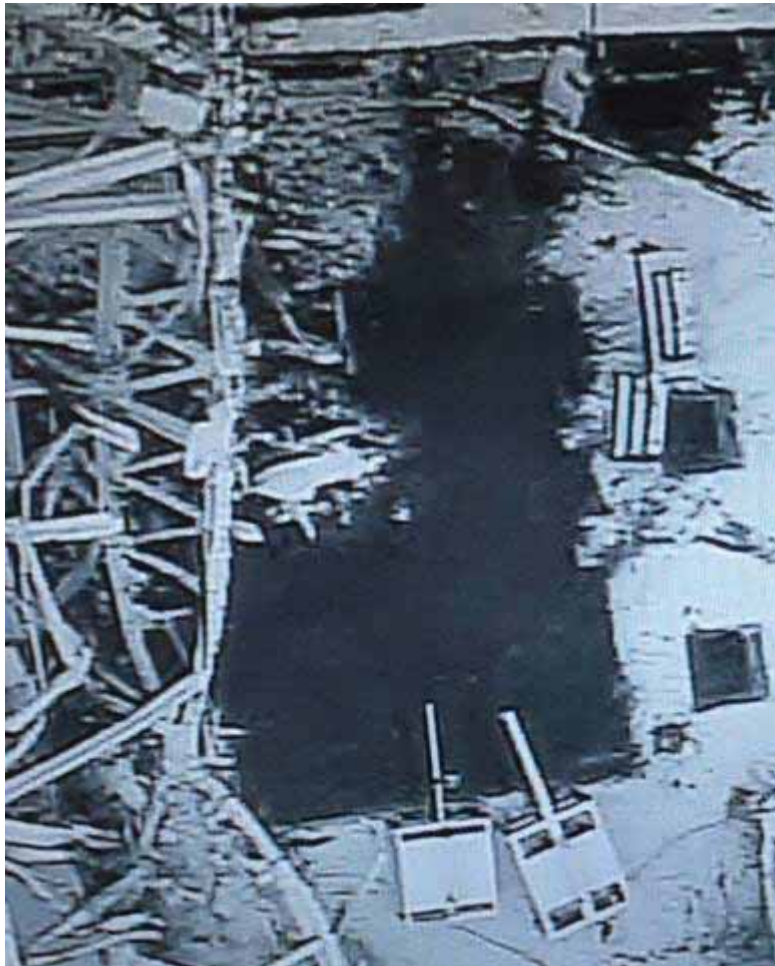
Spent fuel pool (after steel truss removal)

As a result of monitoring the debris utilizing an underwater camera and a camera, the debris was confirmed to have no impact on the fuel rack and the pool liner.

The atmosphere doses in the upper part of the spent fuel pool before and after the debris removal work were 25.6mSv/h and 21.3mSv/h. No significant change was found with the spent fuel pool water level.

At around 2:06 PM: The steel truss debris removal was completed.

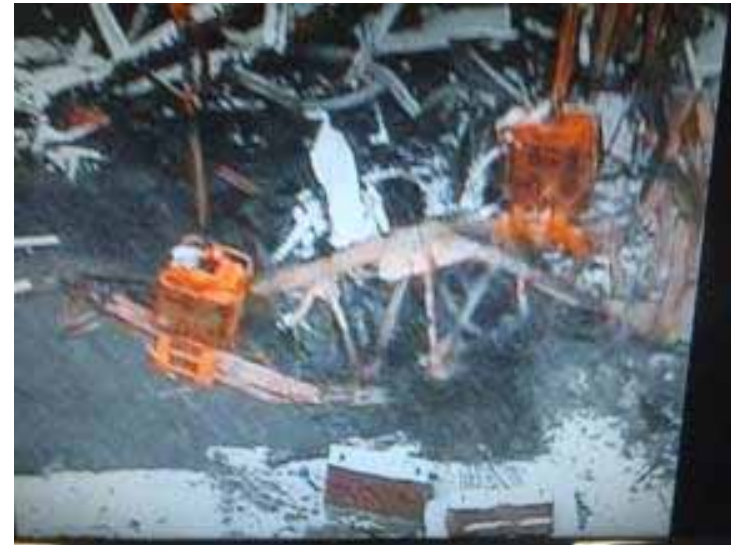
Steel truss debris (being lifted up)

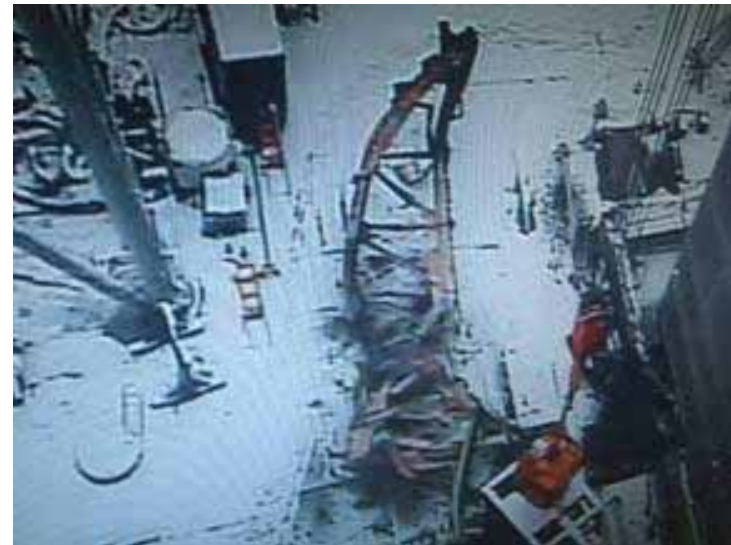
Steel truss debris (after removed)
