# Puddle found in Unit 2 Turbine Building of Fukushima Daiichi Nuclear Power Station

February 27, 2013  
Tokyo Electric Power Company

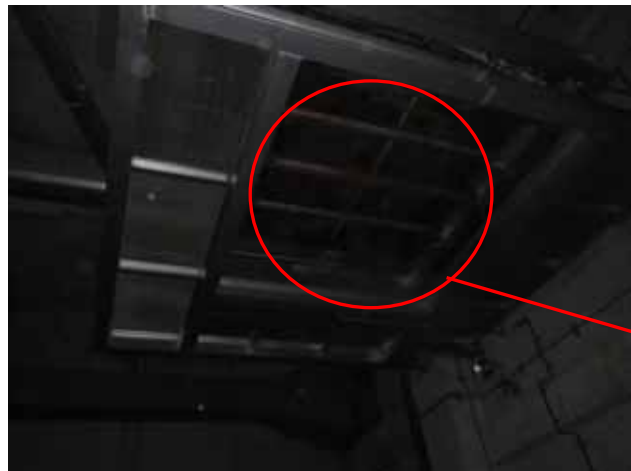
Ceiling on the second floor (Photo taken on February 25 by TEPCO)

Location where water was found to be dripping

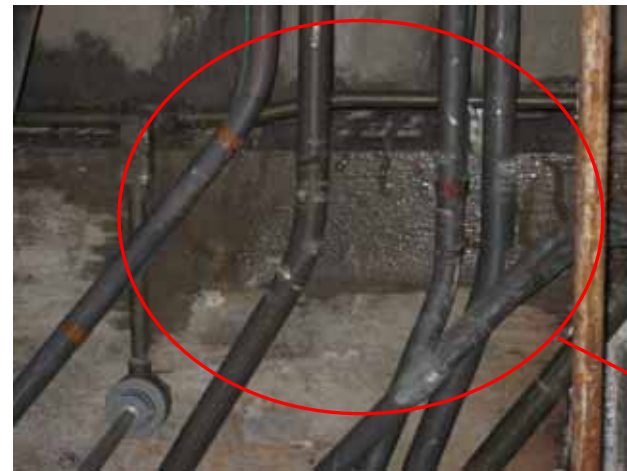
Ceiling on the first floor (Photo taken on February 23 by TEPCO)

Location where water was found to be dripping

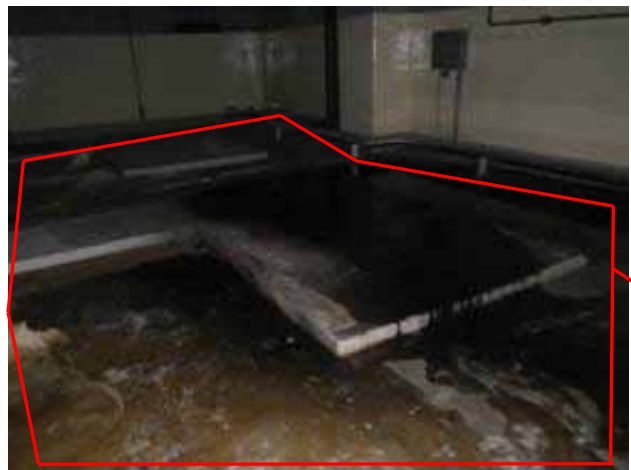
Radioactivity density analysis results of the water dripping from the ceiling of the Turbine Exhaust Filter Room on the second floor:

Cs-134:  $1.1 \times 10^0 \text{Bq/cm}^3$ , Cs-137:  $1.9 \times 10^0 \text{Bq/cm}^3$

Based on these results, the water dripping from the ceiling of the Turbine Exhaust Filter Room on the second floor is considered to be rainwater.

Puddle on the second floor (Photo taken on February 25 by TEPCO)

Puddle

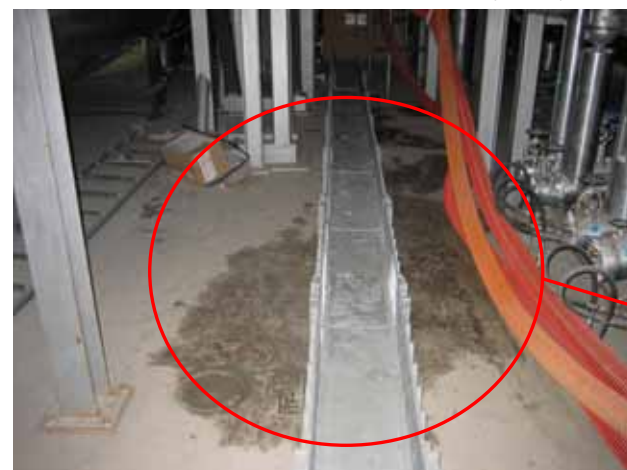
<Reference> Radioactivity density analysis results of the puddle on the floor on the Heater Room on the first floor

Cs-134:  $1.3 \times 10^2 \text{Bq/cm}^3$ , Cs-137:  $2.5 \times 10^2 \text{Bq/cm}^3$

Puddle on the first floor (Photo taken on February 23 by TEPCO)

Puddle
