Current Approach toward the Stabilization Decommissioning of Fukushima Daiichi Nuclear Power Units 1-4

In December 2011, we confirmed the accomplishment of the target "release of radioactive materials is under control and radiation doses are being significantly held down". As for the next step, we have compiled the "Mid-to-long-Term Roadmap toward the Decommissioning of Fukushima Daiichi Nuclear Power Units 1-4" in government and TEPCO Mid-to-Long-Term countermeasure conference. Currently, we are working toward "Phase 1: Period to the start of fuel removal from the spent fuel pool (Target: Accomplish within 2 years after completion of Step 2)".

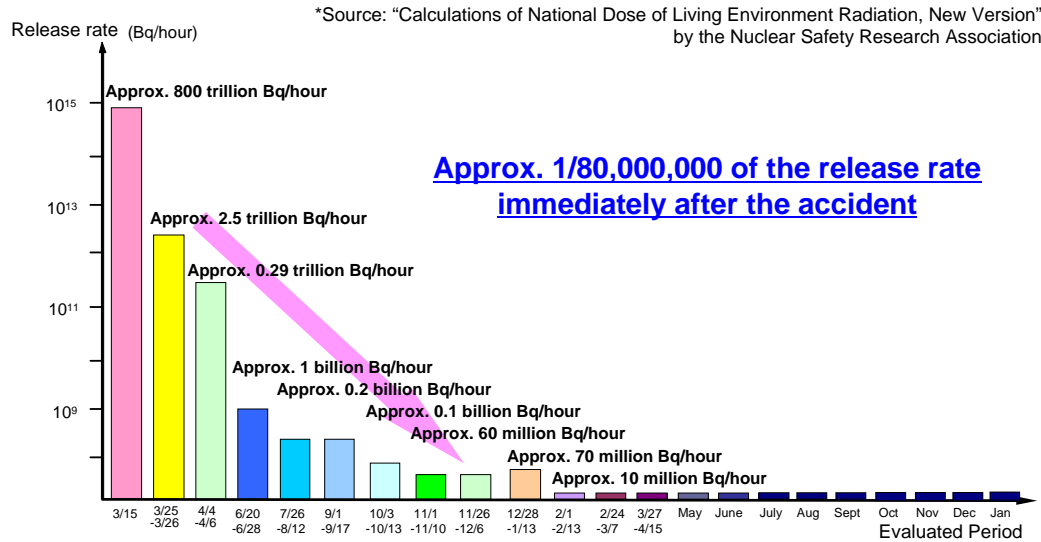
<Release Rates of Radioactive Materials (Cesium) Per Hour from the PCVs of Units 1 to 3>

- Taking into account variable factors and other contributing elements, total emissions from Units 1-3 have been assessed to be a maximum of approximately 10 million becquerel/hour.
- This is approximately 80 millionth of the release rate right after the accident. Since February, a level has been maintained below this count.
- Based on this, the radiation exposure at the site boundary is assessed to be 0.03mSv/year. This is approximately 1/70 of the annual exposure from natural radiation (average of approx. 2.09mSv/year in Japan *) (excluding the effect of radioactive materials already released until now).

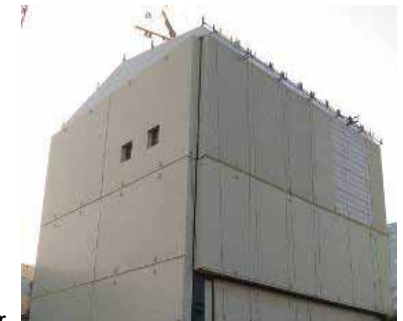
Installation of Unit 1 reactor building cover

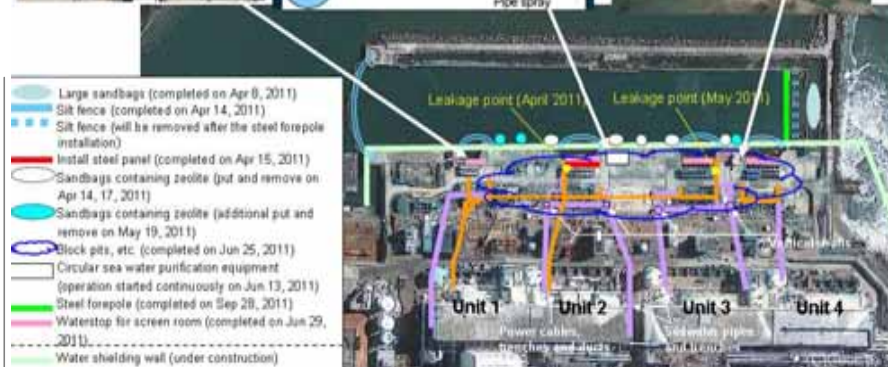
- Covering work has been completed using solidified soil to prevent the dispersion of marine soil that contains highly concentrated contaminant in the area in front of the intake channels for Units 1-4 and Units 5 & 6.
- Purification utilizing fiber cesium adsorbent is planned in order to reduce contaminant concentration in the water intake open conduit at Unit 1-4.

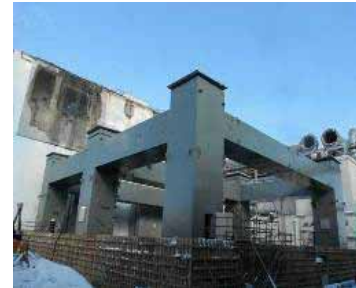
The first layer of steel framing completed (January 14)

- Steel framing construction for the cover to be installed for fuel removal at Unit 4 has been started. (Since January 8)
- Fuel removal from Unit 4 spent fuel pool is targeted to be started in November 2013.
- Soundness inspection of the Reactor Building is conducted 4 times a year on a regular basis.

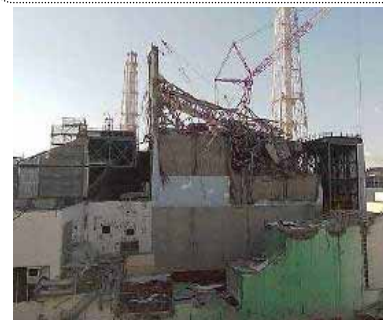
- Platform installation and debris removal from the upper part of the Reactor Building are ongoing towards the installation of cover for fuel removal at Unit 3.

Unit 3 Reactor Building (January 29)

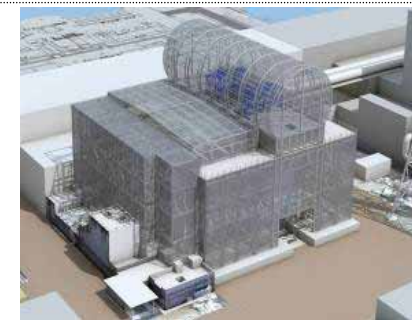
Simulated image of the cover to be installed for fuel removal

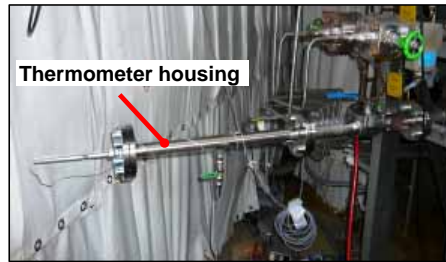
- Inspection was conducted inside the PCV by inserting an image scope through a penetration hole. (Jan 19, Mar 26, 27, 2012)
- RPV thermometer to replace the existing broken thermometer was installed as a monitoring instrument. (November 6, 2012)
- For the purpose of improving the reliability of PCV ambient temperature thermometer, a new PCV thermometer was installed as a monitoring instrument. (November 6, 2012)

RPV Thermometer Installation Condition (October 3, 2012)

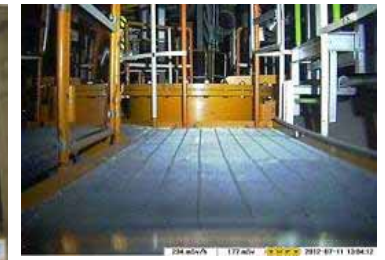
- Investigation of the contamination condition inside the Reactor Building was conducted by using robots (June 11-15, 2012), and decontamination sample was sampled in order to select the best decontamination method (June 29-July 3, 2012).
- In order to review how to inspect and repair the PCV leakage points, the accumulated water level inside the torus room was measured (June 6, 2012), and investigation of the torus room was conducted by using robots (July 11, 2012).

Investigation of the torus room by using robots (July 11, 2012)
