Completion of Water Stop Work at the Location Where Water Inflow into Unit 3 Radioactive Waste Underground Storage Facility Building was Found at Fukushima Daiichi Nuclear Power Station

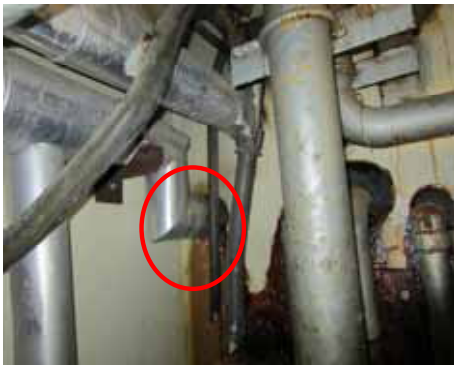
Pipe penetration area where water inflow was found

(Photo taken on May 29, 2012 by TEPCO)

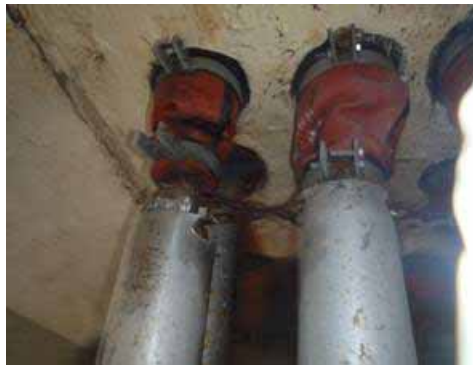
Pipe penetration area before water stop work (duct side)

(Photo taken on July 2, 2012 by TEPCO)

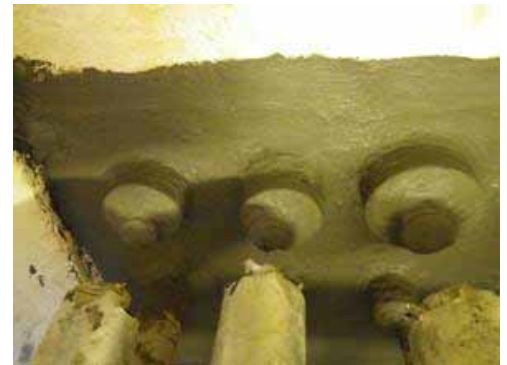
Pipe penetration area after water stop work implementation (duct side)

(Photo taken on December 19, 2012 by a cooperative company)

- Some of the pipes have been cut.
- Water stop work has been implemented near the piping (application of waterproof material).
