# Cable Discoloration and a Burn on the Terminal Block of the Standby Liquid Control System Tank Heater at Fukushima Daiichi NPS

April 5, 2013

Tokyo Electric Power Company

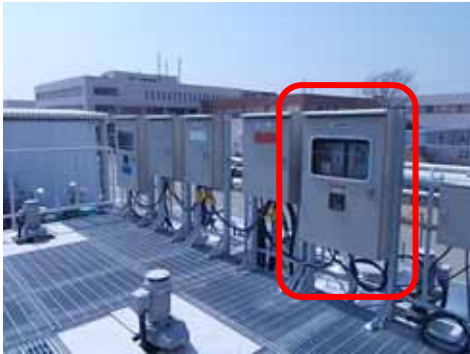
The control panel of heater A1

The control panel of heater A2

2 heaters are installed for each tank.

The control panel of the Standby Liquid Control System Tank Heater A (Upper part of the Standby Liquid Control System Tank A)

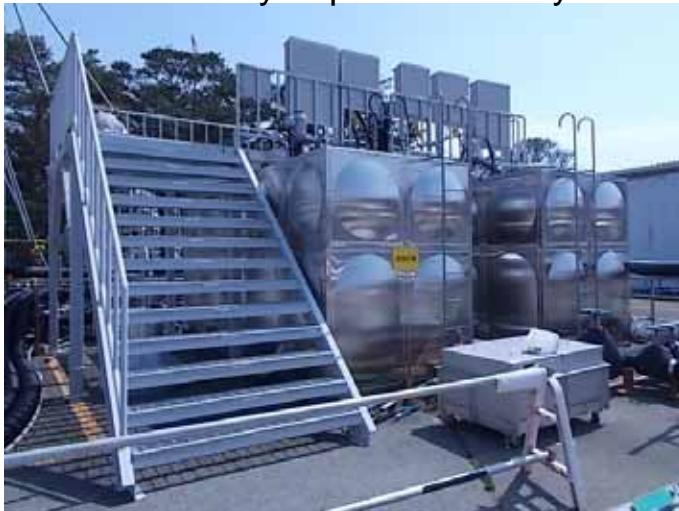
Appearance of the Standby Liquid Control System Tank (From left, Standby Liquid Control System Tank A and B)

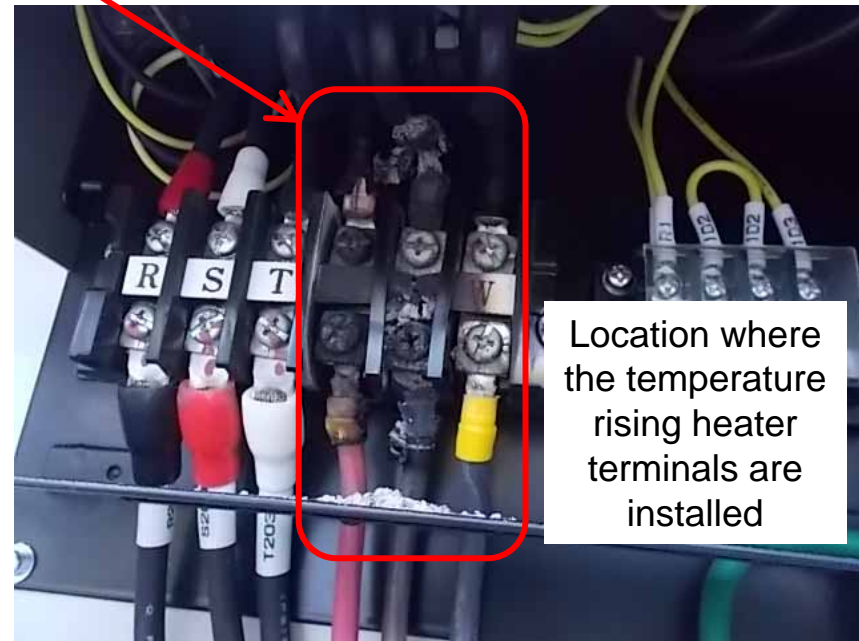
Location where the temperature rising heater terminals are installed

The terminals of the heater control panel A2 (After removing the terminal cover)

- 12:55 PM A burn on the terminal block was found in the control panel of the SLC Tank Heater A2.  
(No smoke was found when the burn was found.)
- 1:05 PM The incident was reported to the fire department.
- 1:45 PM After replacement of the Standby Liquid Control System Tank Heater A1, the operation of No.1 heater was started and the temperature control of the boric acid solution in the Standby Liquid Control System Tank A was restarted. The heater A1 was found to be functioning properly (the temperature of the SLC Tank: 17 ).
- 3:30 PM The fire department has judged that the incident was not a fire.
