Water Leakage from the Pipe Flange When the Water Transfer from the Underground Reservoir No.3 to No.6 was Started

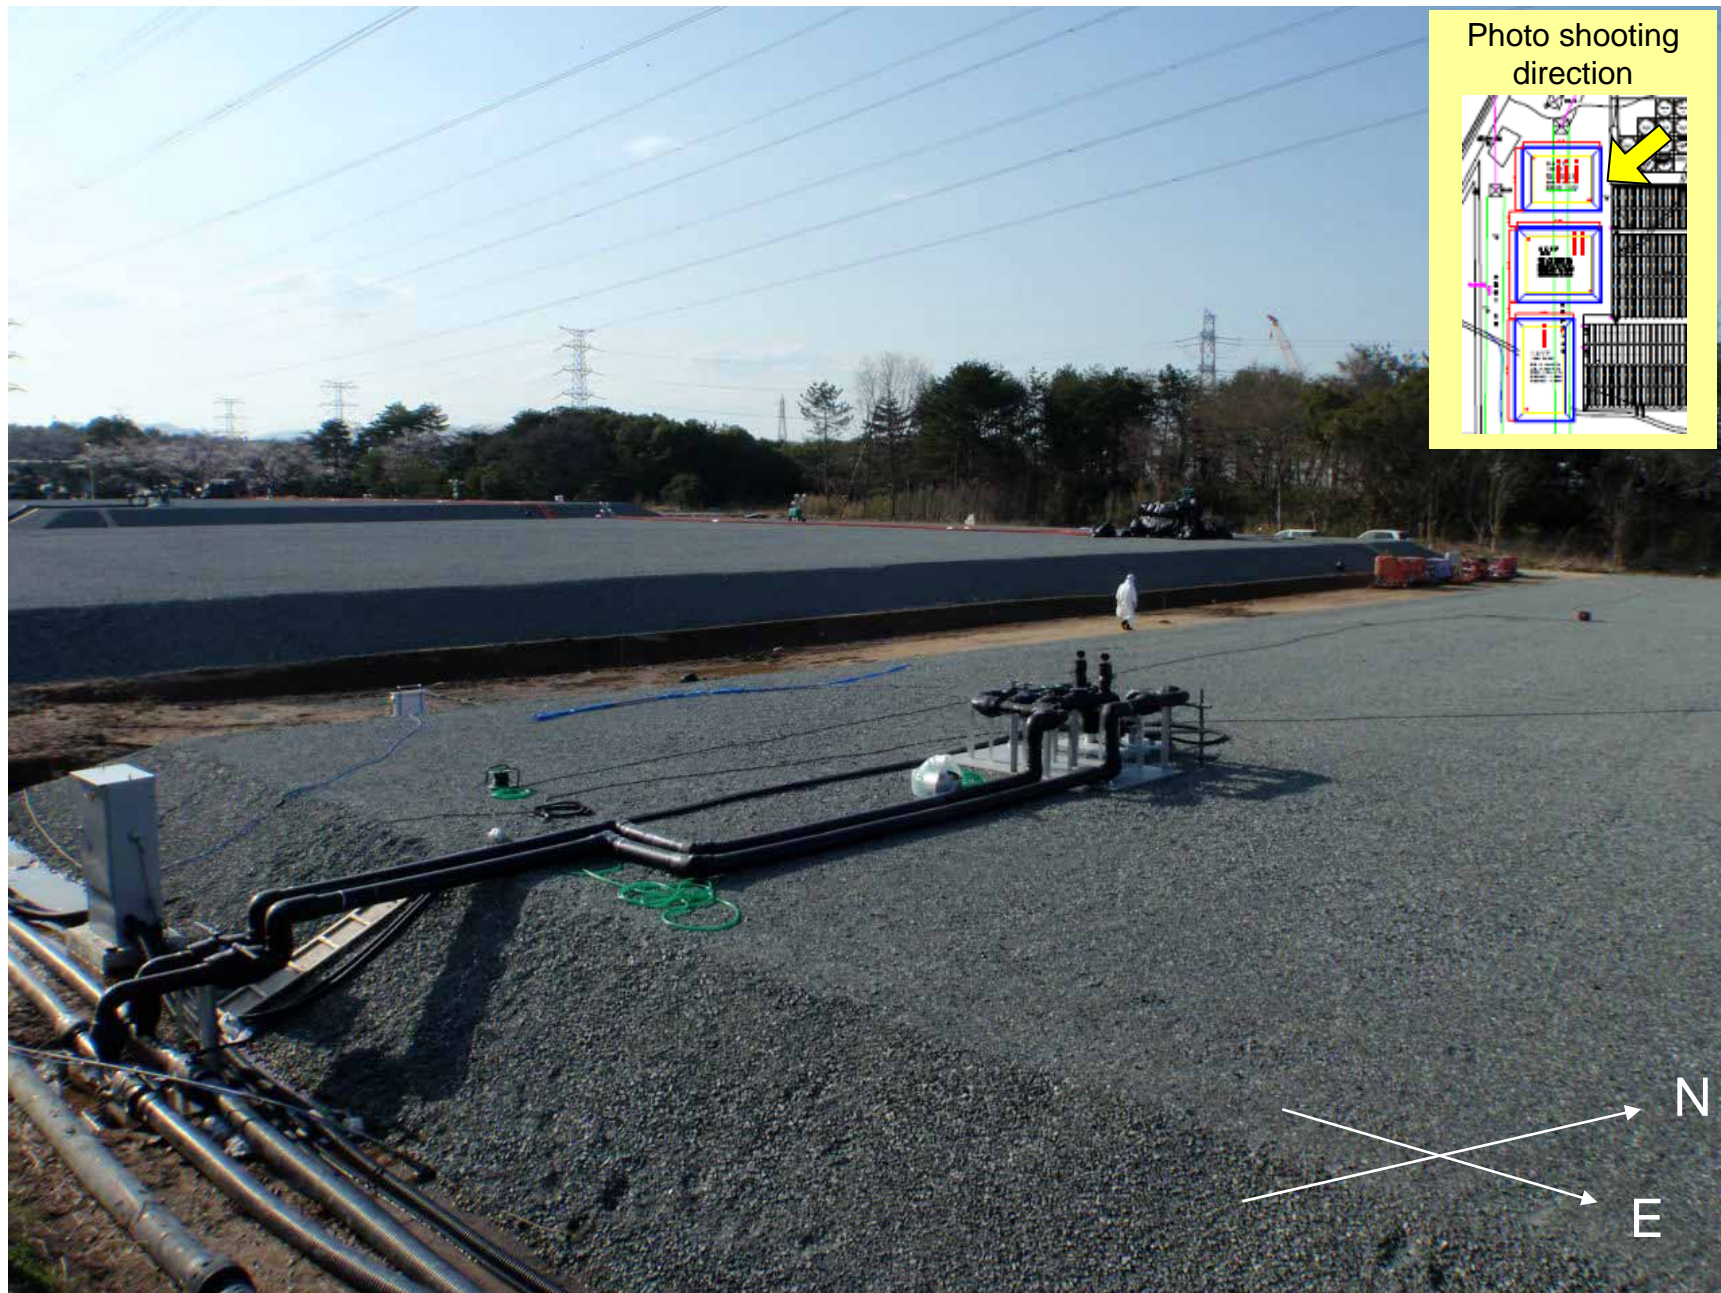
Manhole on the southwest side of the underground reservoir No.3

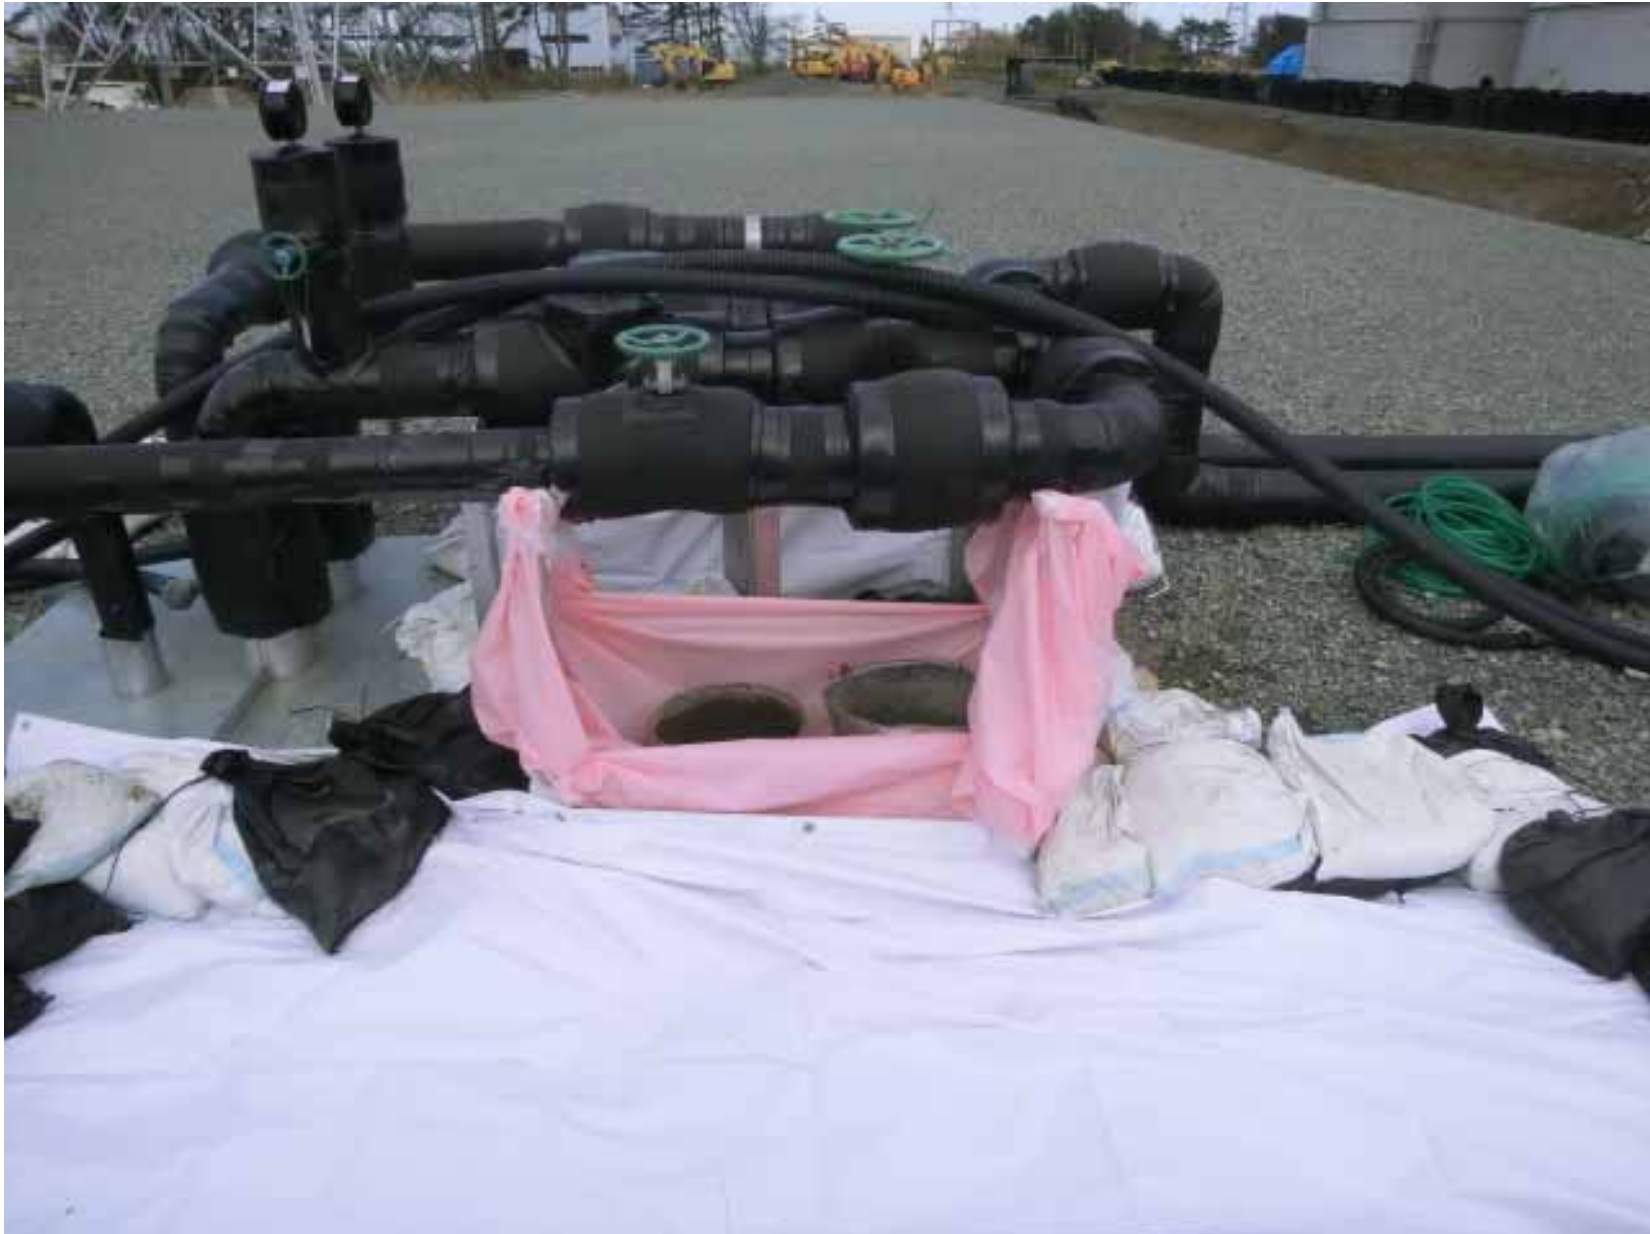
**Manhole on the southwest side of the underground reservoir No.3
(After the soil cover is protected)**

- The pipe flange will be disassembled for cause investigation.
- The removal of the soil covering the upper part of the underground reservoir (embankment) where the leaked water is considered to have been absorbed will be started.

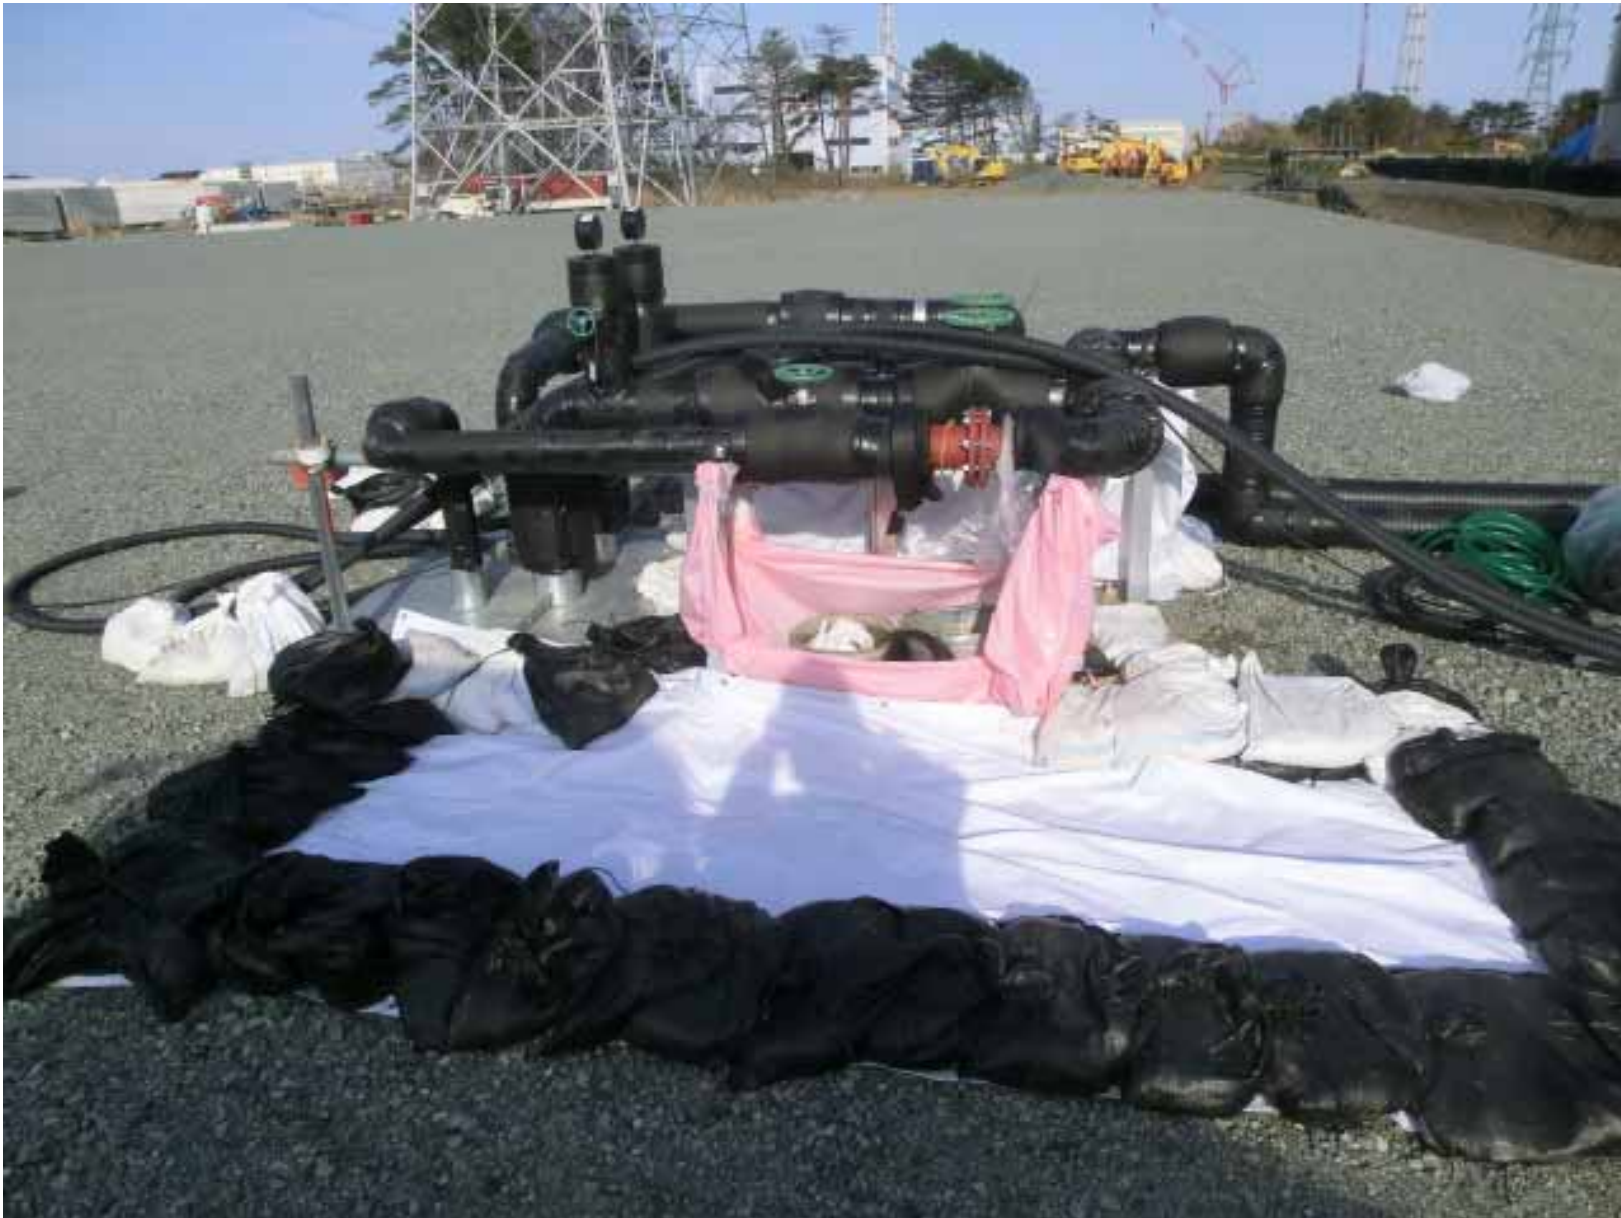
- Though the water transfer from the underground reservoir No.3 to No.6 was started at 2:00 PM on April 11, the transfer pump was stopped at 2:03 PM on the same day since water leakage from the connection part (flange) of the transfer pump outlet pipe.

- The leakage stopped after stopping the transfer pump. The leaked water has been absorbed into the covering soil.
- The area affected by the water leakage is 2m x 3m on the soil covering the upper part of the reservoir (embankment) near the reservoir No.3 tank manhole. Since the leaked water has been absorbed into the covering soil, there is no possibility of the leaked water flowing out of the site boundary. The amount of leakage is estimated to be approx. 22L (calculation value).

Transfer pump at the manhole on the southwest side of the underground reservoir No.3: Full view of the leakage location (flange)

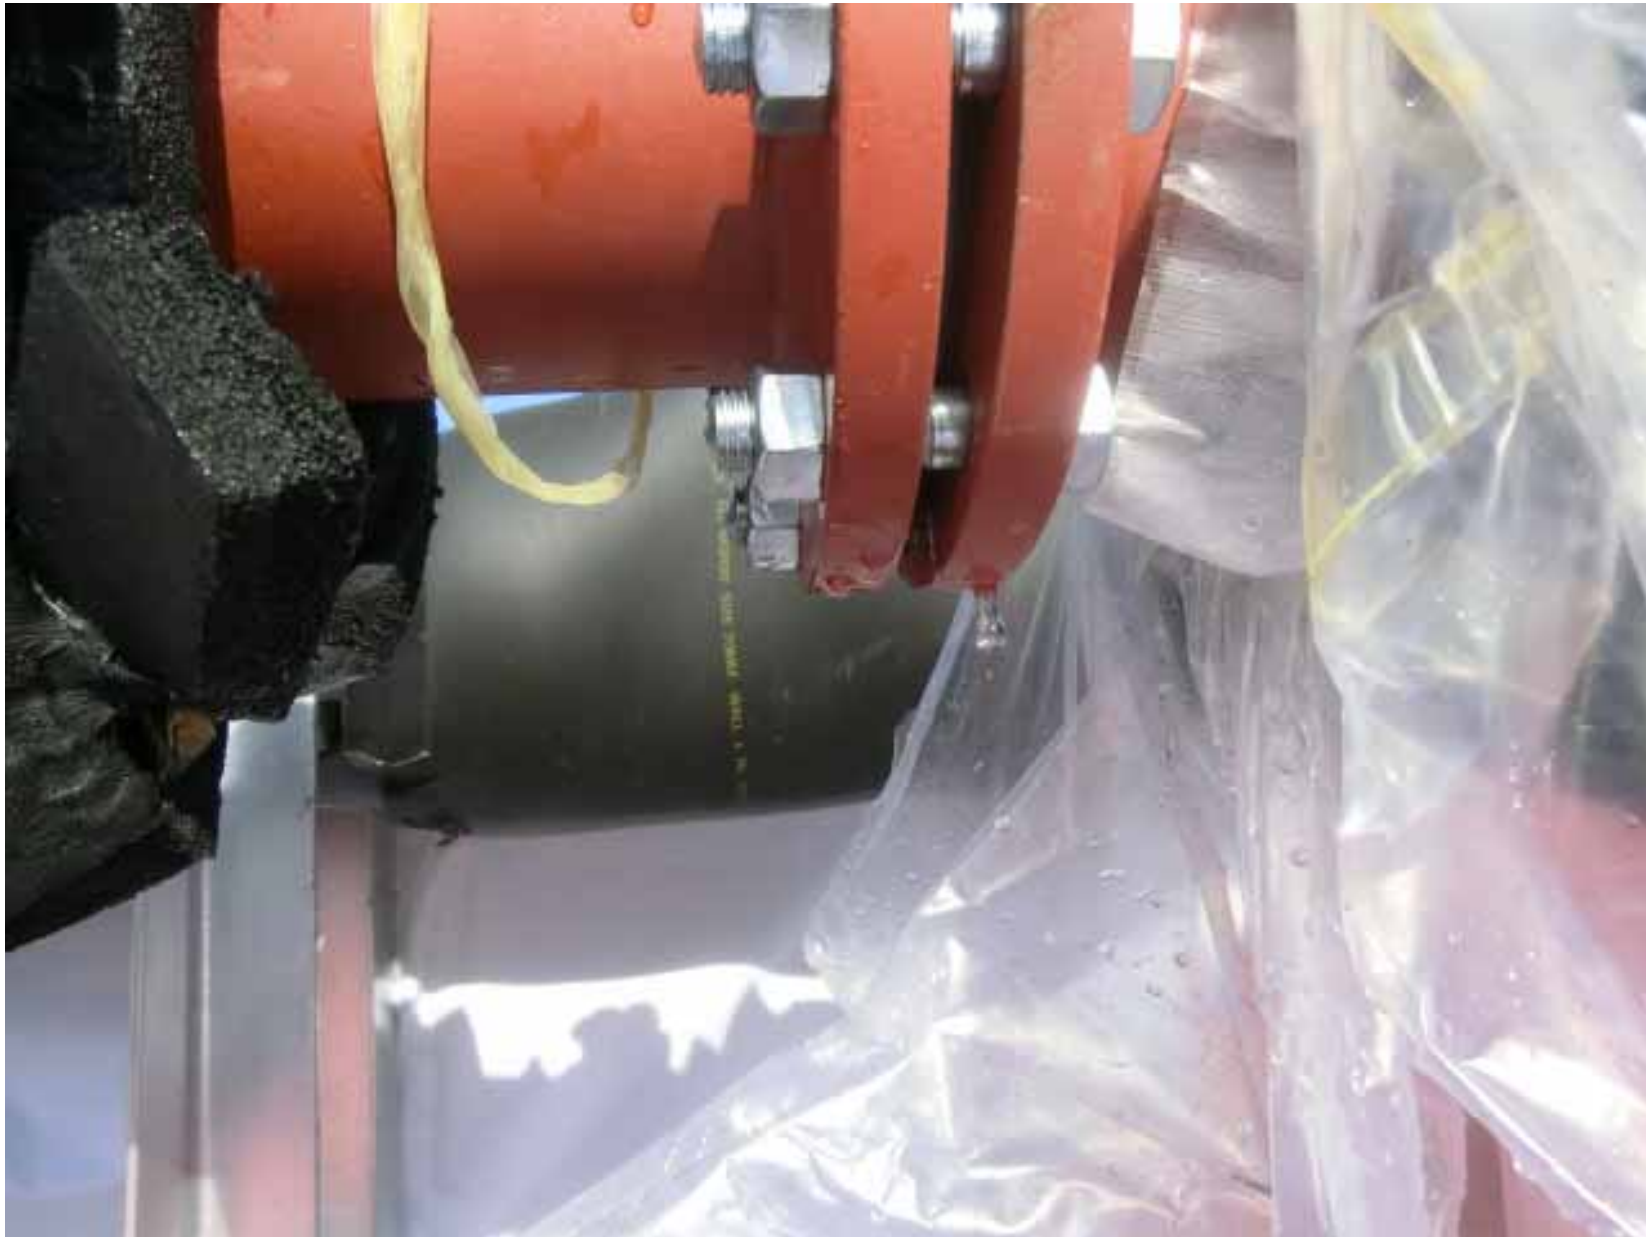
**Transfer pump at the manhole on the southwest side of the underground reservoir No.3:
Leakage location (flange) after the insulation material was removed**
