Investigation of Unit 2 Torus Room at Fukushima Daiichi Nuclear Power Station

April 12, 2013
Tokyo Electric Power Company

1. Investigation Method (Temperature, Dose, Camera, Sampling of Accumulated Water and Sediments)

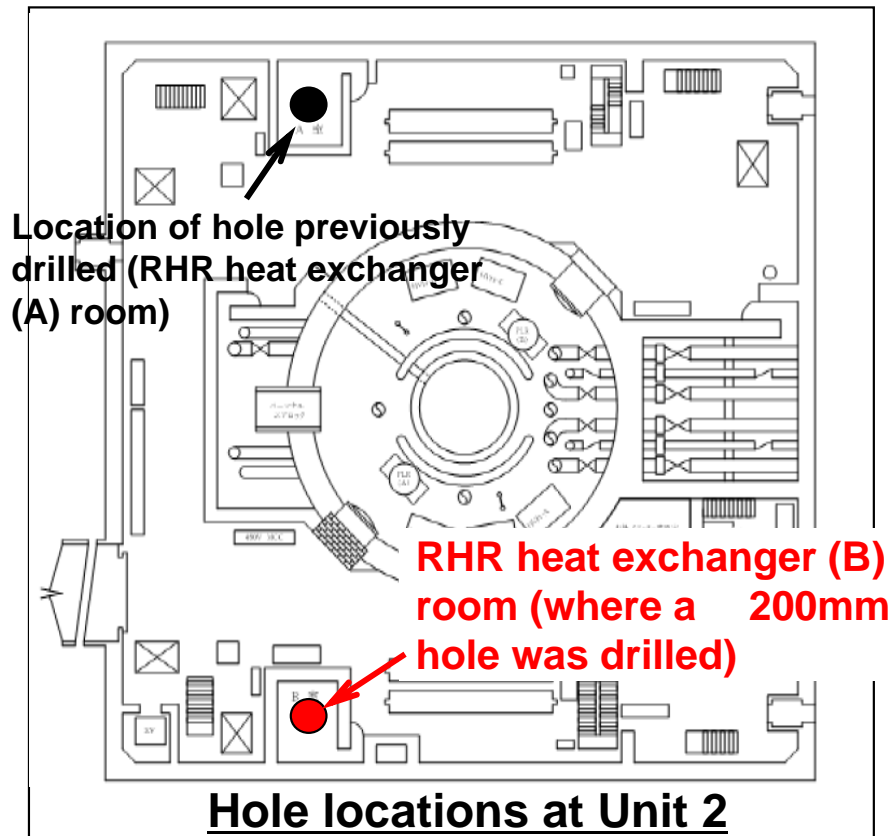
Investigation of the inside of the Torus Room was performed by inserting a thermometer, a dosimeter and a camera from a hole of a diameter of 200mm drilled on the floor of the RHR heat exchanger (B) room in the south side of the first floor of the Reactor Building (on April 11). A hose for sampling accumulated water and a sediment sampler were inserted from the same hole to collect accumulated water and sediments (on April 12).

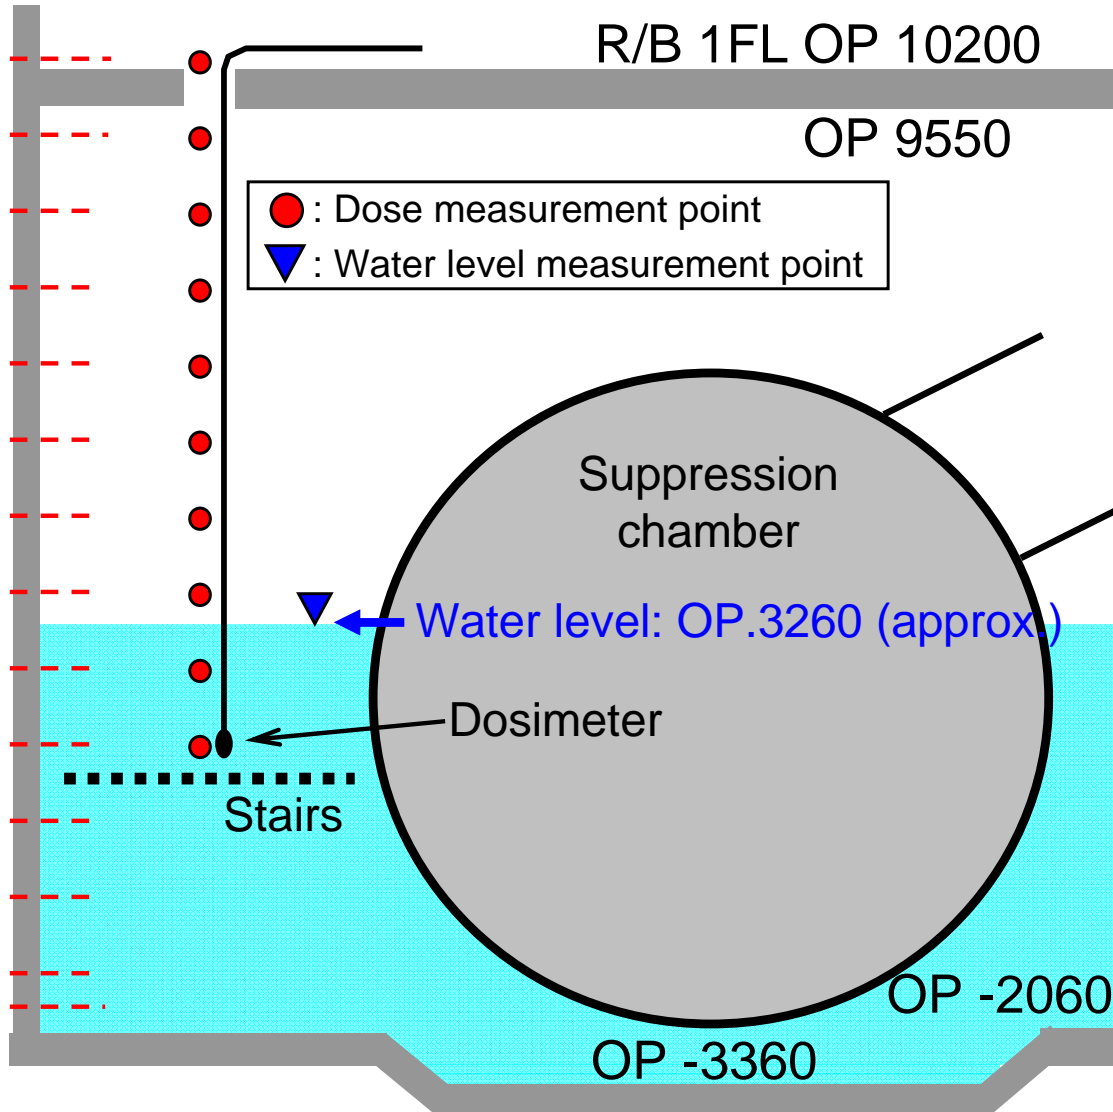
2. Measurement Results (Dose)

Location (Reference value)		Dose [mSv/h]
	OP.10500	4.3
	OP.9500	6.2
	OP.8500	10.3
	OP.7500	15.3
	OP.6500	20.5
	OP.5500	32.8
	OP.4500	74.0
	OP.3500	134.0 (Max.)
-	OP.3260 (Water level)	-
	OP.2500	18.7
	OP.2000	23.7
	OP.500	-
	OP.-500	-
	OP.-1500	-
	OP.-1760	-

- Dose was measured in the interval of approx. 1m.
- The maximum dose was approx. 134mSv/h measured near the water surface.

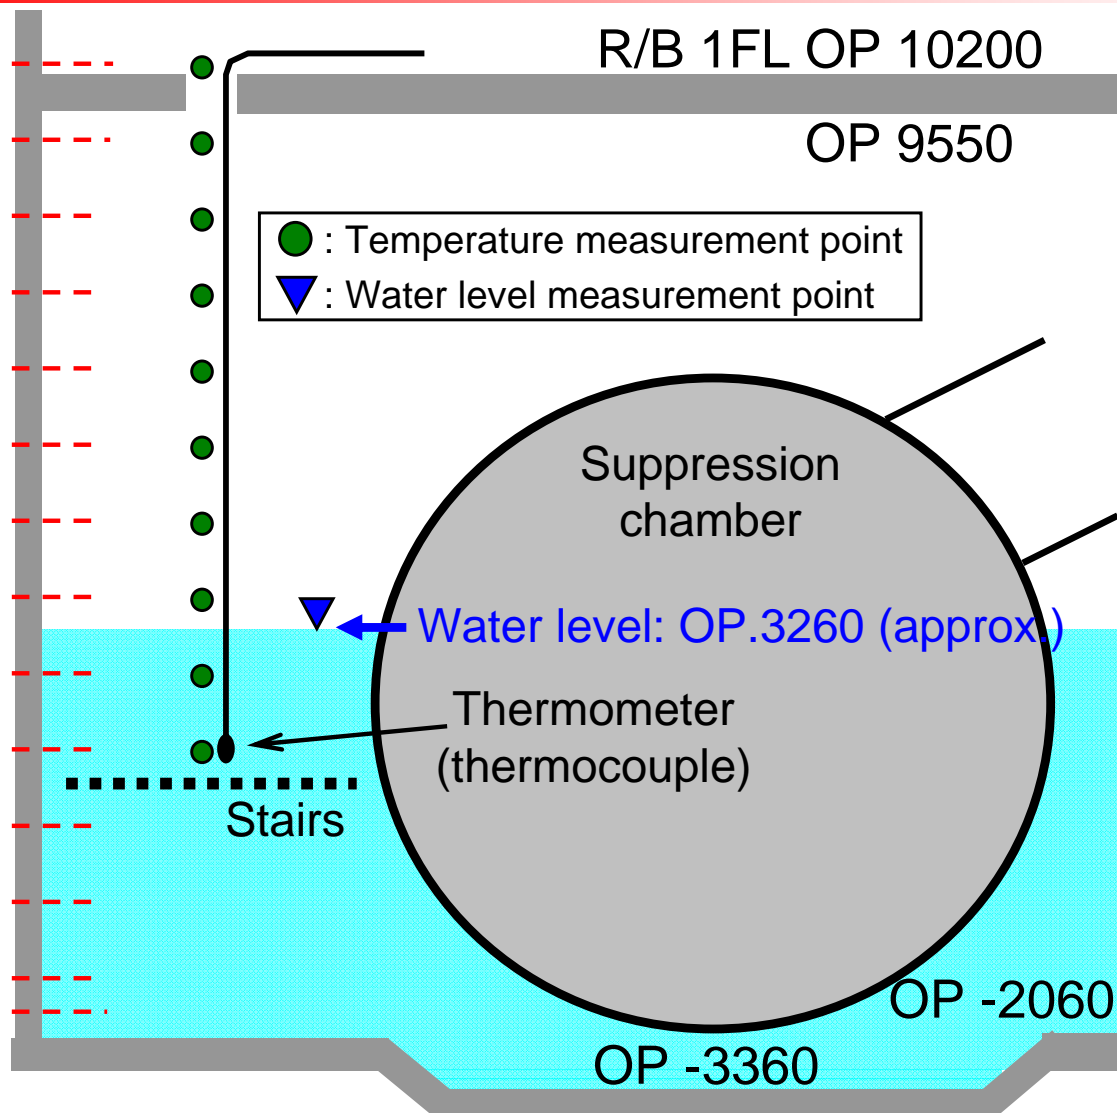
3. Measurement Results (Temperature)

Location (Reference value)		Temp. [°C]
	OP.10500	16.3
	OP.9500	18.1
	OP.8500	19.6
	OP.7500	20.4
	OP.6500	20.4
	OP.5500	20.7
	OP.4500	20.6
	OP.3500	20.1
-	OP.3260 (Water level)	-
	OP.2500	25.2
	OP.2000	25.2
	OP.500	-
	OP.-500	-
	OP.-1500	-
	OP.-1760	-

- Temperature was measured in the interval of approx. 1m.
- The air temperature was approx. 20 °C and the water temperature was approx. 25 °C.

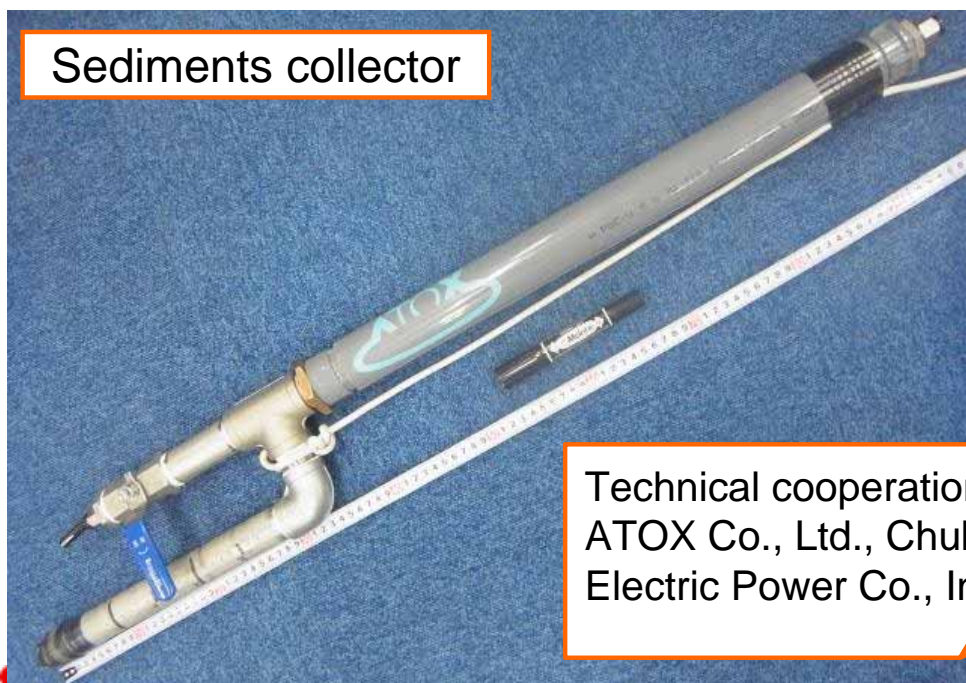
Sediments collector

Sampling location	Sampling amount	Surface dose of the container	Analysis item
Actual	Upper surface of the stair landing of the Torus Room (Approx.OP.1700)	Approx. 5cc	Approx. 0.1mSv/h	density

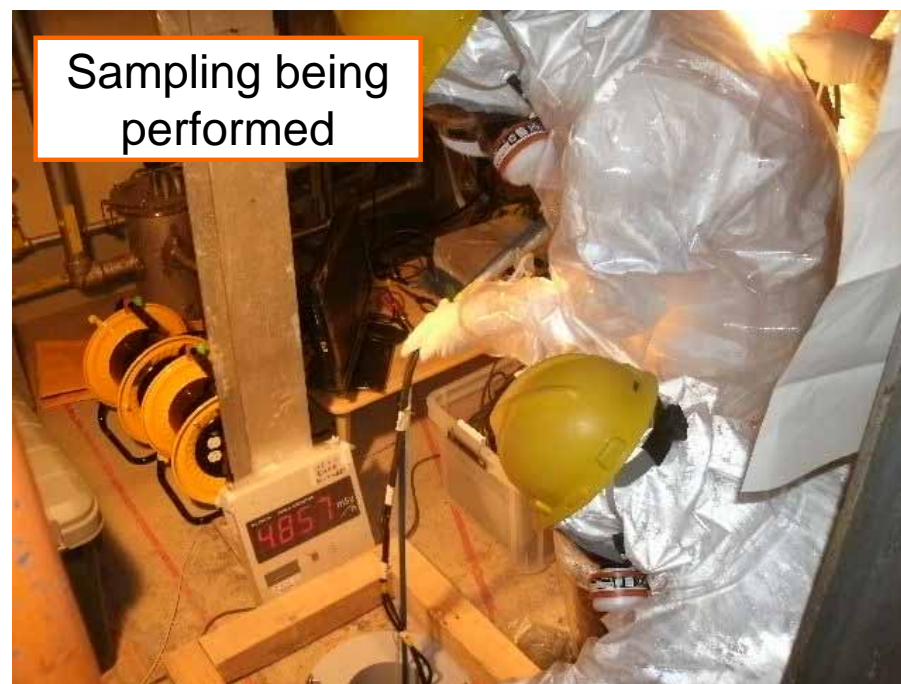
Sampling being performed

The sampling location was changed due to the interference with the stairs in the Torus Room.
