[Construction area of ground improvement]

- The ground improvement work (chemical injection work) was started with maximum 8 teams since July 8.
- The chemical injection work is performed at 2 rows starting with first row.

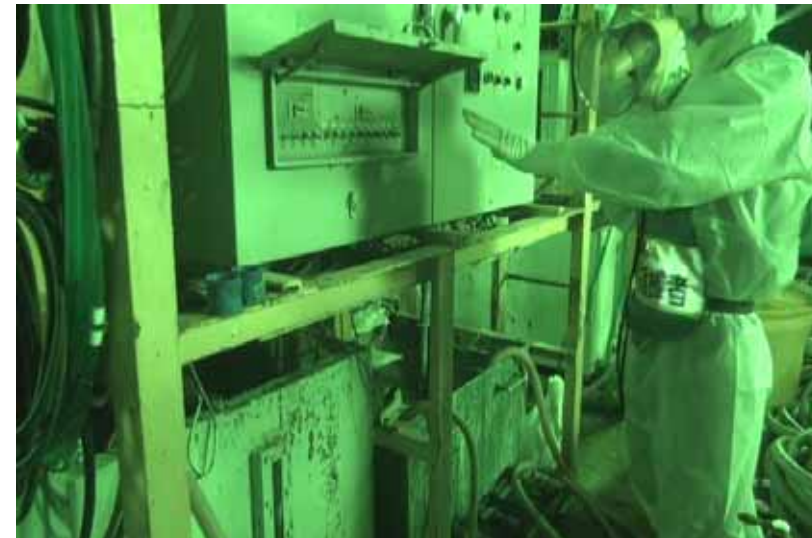
<Chemical plant>

[Construction equipment of ground improvement (2)]

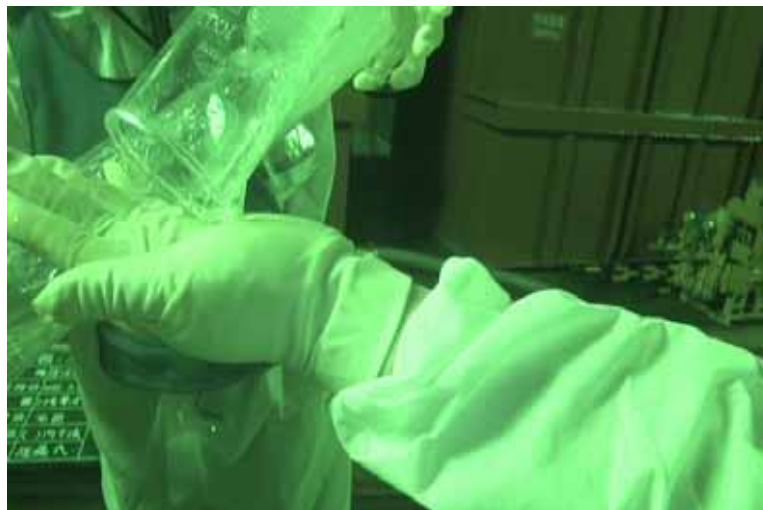
Solidified chemical

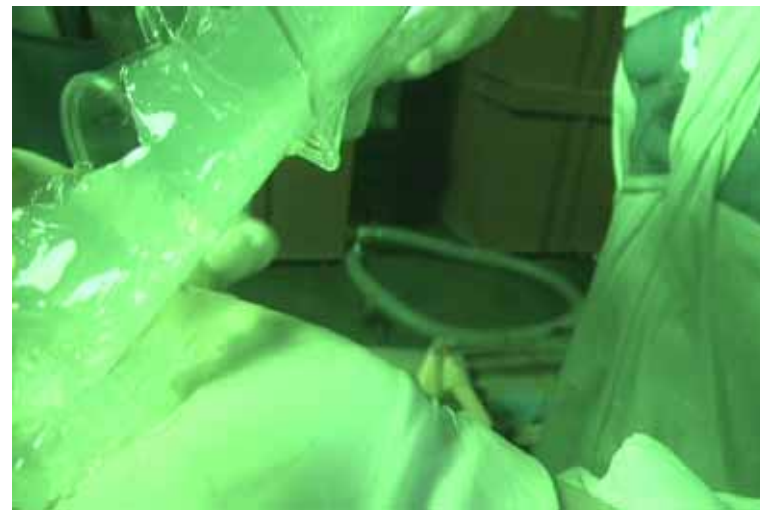
Solidified chemical (enlarged image)

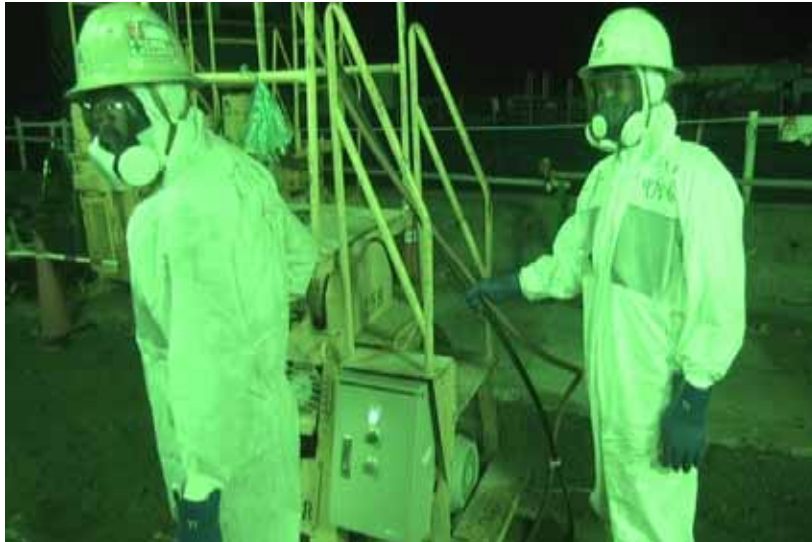
<Before the work>

[Chemical injection work]
