**Findings Regarding the Exit of a
Contaminated Vehicle from the Fukushima
Daiichi NPS**

July 19, 2013

Tokyo Electric Power Company

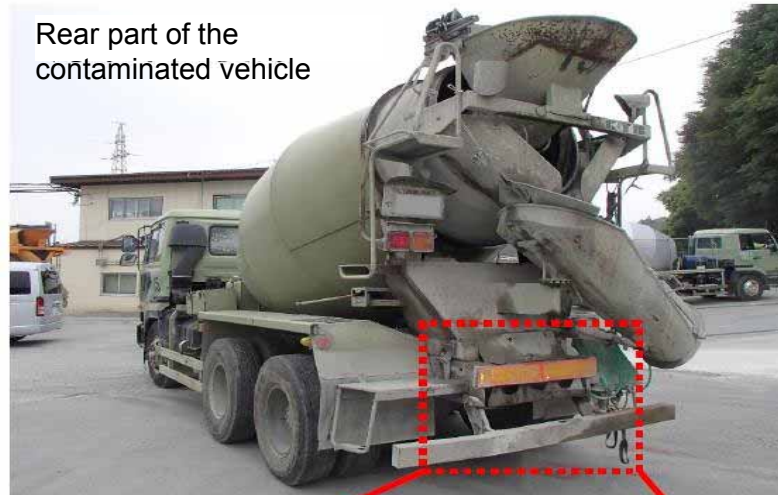
Concrete with contamination attached was found adhered on the upper part of the rear bumper of the concrete truck.

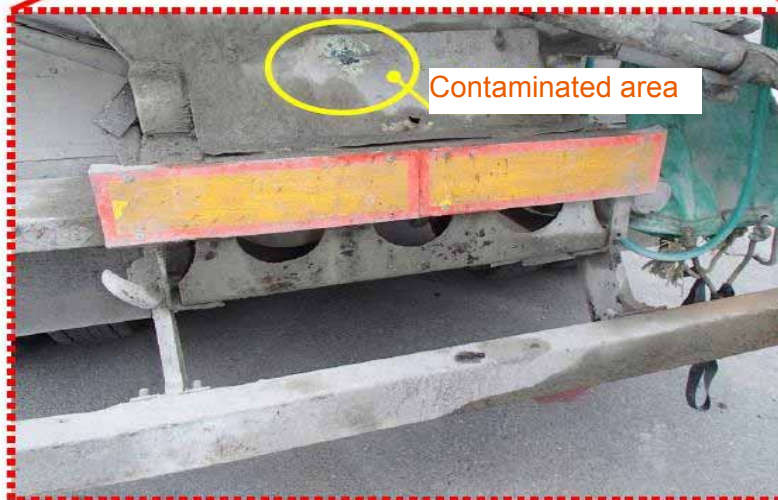
Enlarged view of the contaminated area

The range of contamination was approximately 10cm × approximately 10cm
