Inside Investigation of Unit 2 PCV at Fukushima Daiichi Nuclear Power Station

August 2, 2013
Tokyo Electric Power Company

1. Overview of the Investigation of the Inside of the PCV

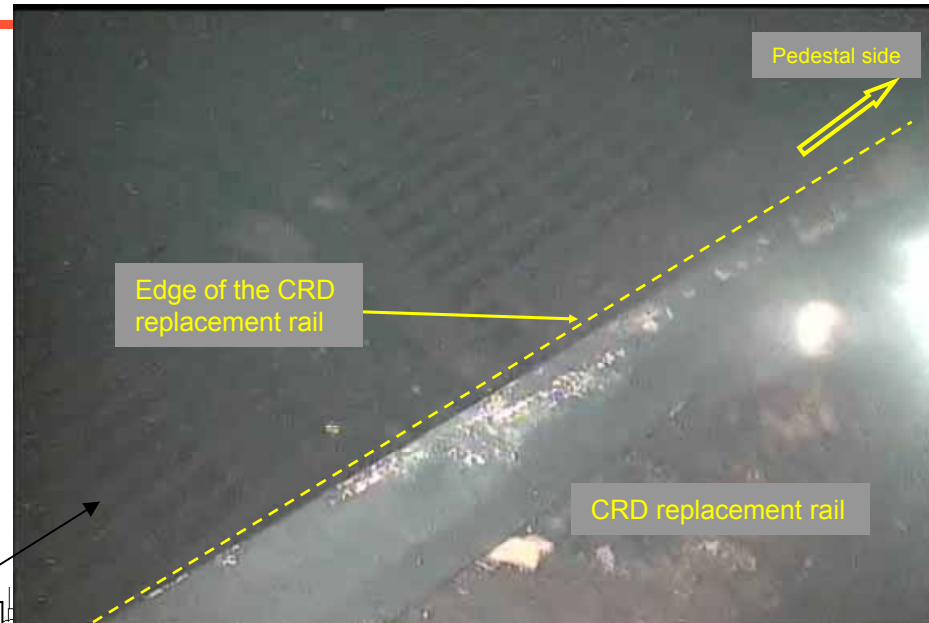
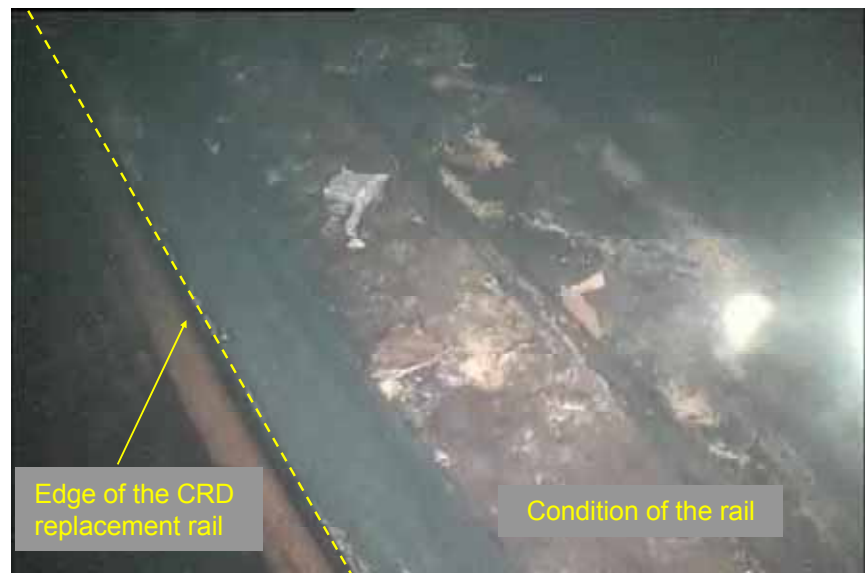
2. Photo Inside the PCV

- Although we were able to guide the investigation equipment onto the CRD replacement rail, operation avoiding obstacles took more time than expected. Therefore, the investigation equipment was collected, and investigation was stopped.
- After reviewing investigation procedures based on the investigation results obtained today, reinvestigation will be performed on August 6.
- Sampling of accumulated water in the PCV will be performed on August 5 before the reinvestigation.
