# Water Leak at a Tank in the H4 Area in Fukushima Daiichi Nuclear Power Station

<Reference>  
August 19, 2013  
Tokyo Electric Power Company

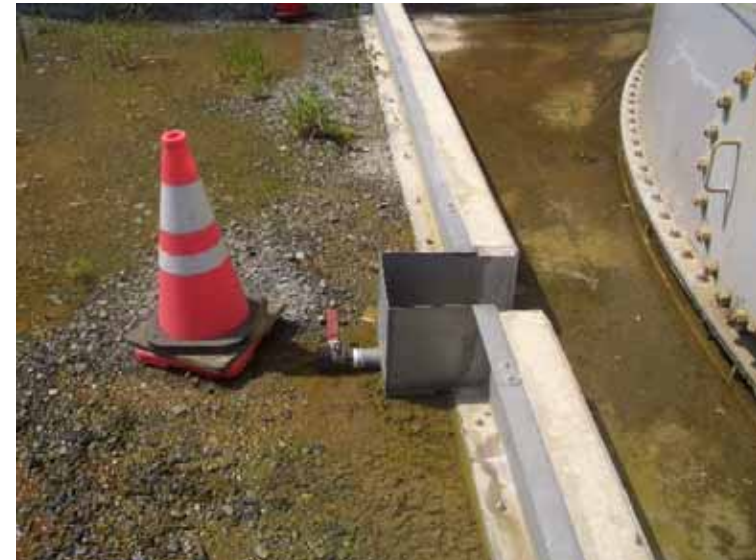
Puddle (1)

- As a result of confirmation on the site conditions, a puddle of approximately 1-2cm was found inside the dike, and 2 puddles of (1) approximately 3m × 3m × 1cm and (2) approximately 0.5m × 6m × 1m was found outside of the drain valve of the dike. There is no trace of water having flowed into a public drainage ditch, etc. from the puddle found outside of the drain valve of the dike. Therefore, we consider that the water has not flowed out into the sea.

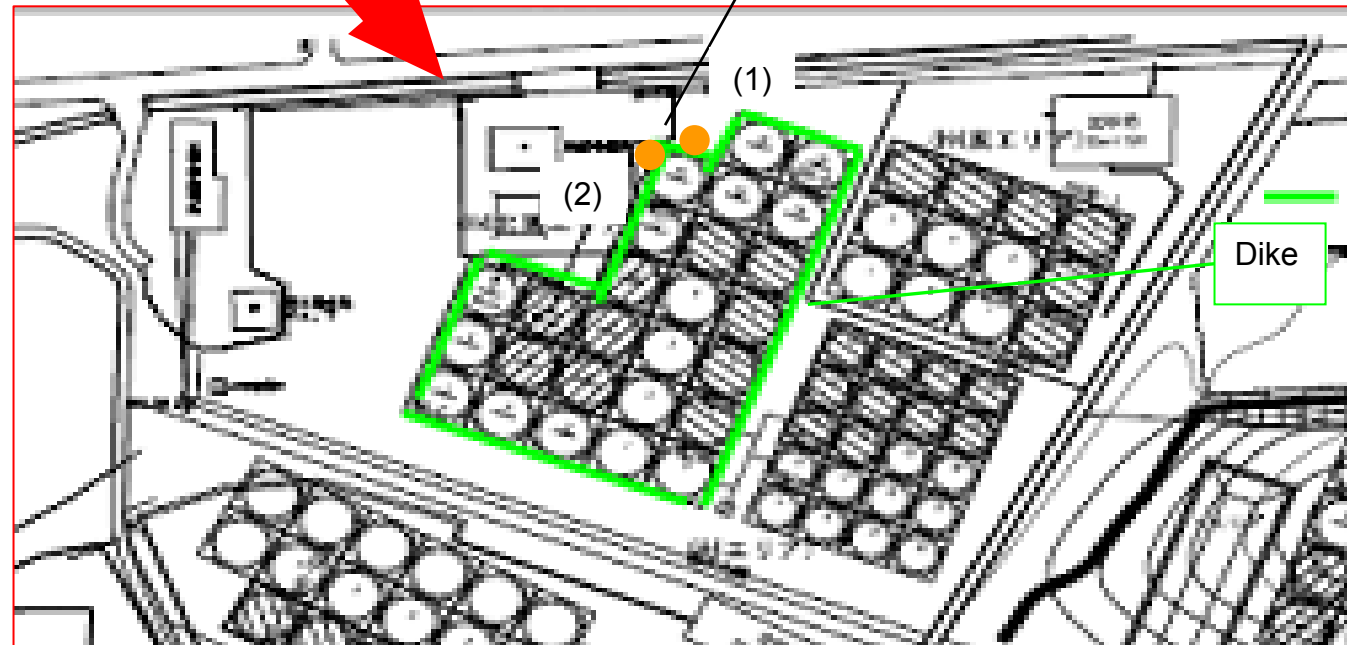
# Location of Tanks at H4 Area

The place where the puddles were observed
