Results of Dust Sampling Performed during Debris Removal Work in Unit 3 Reactor Building at Fukushima Daiichi Nuclear Power

<Reference>
August 30, 2013
Tokyo Electric Power Company

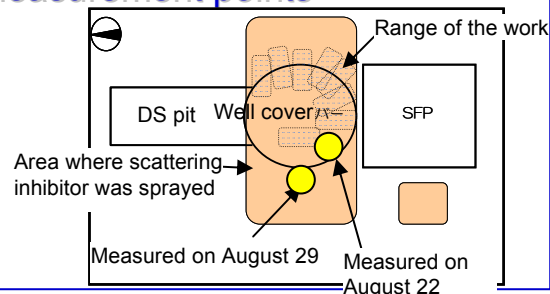
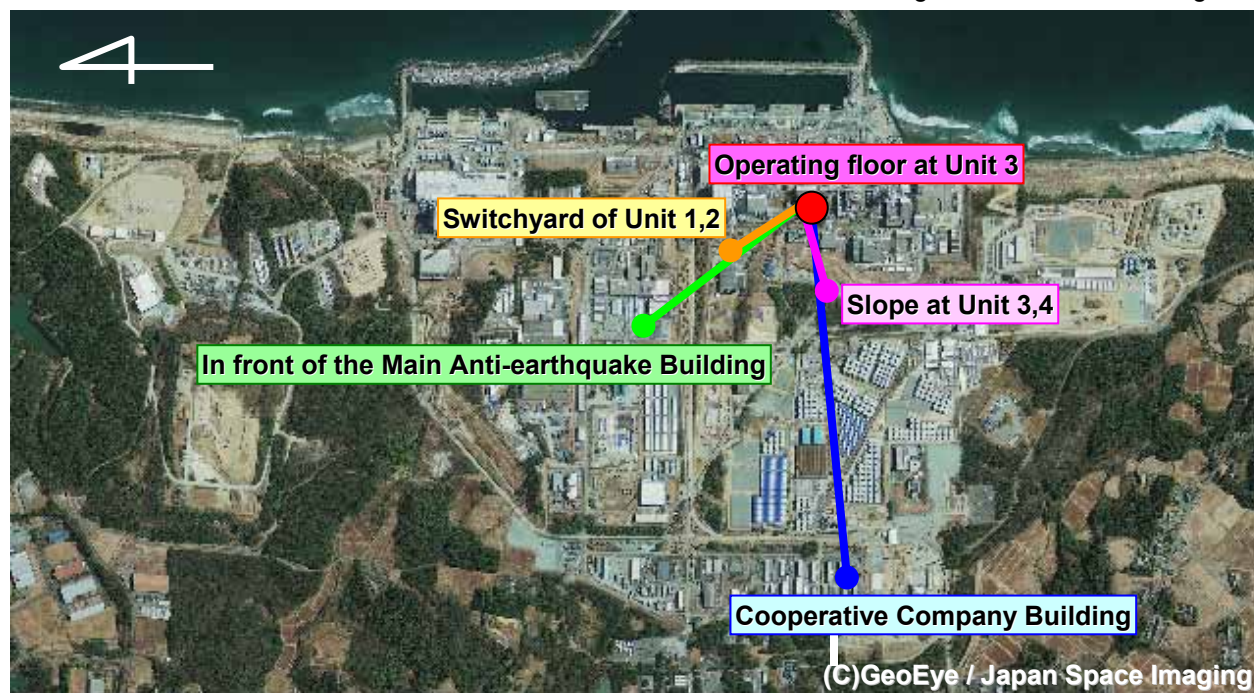
Debris removal work at Unit 3

- Period of work: 1:15 PM – 2:03 PM
- Range of the work and positions of the measurement points
