Condition of the Bank Protection Area at Fukushima Daiichi Nuclear Power Station

<Reference>
September 4, 2013
Tokyo Electric Power Company

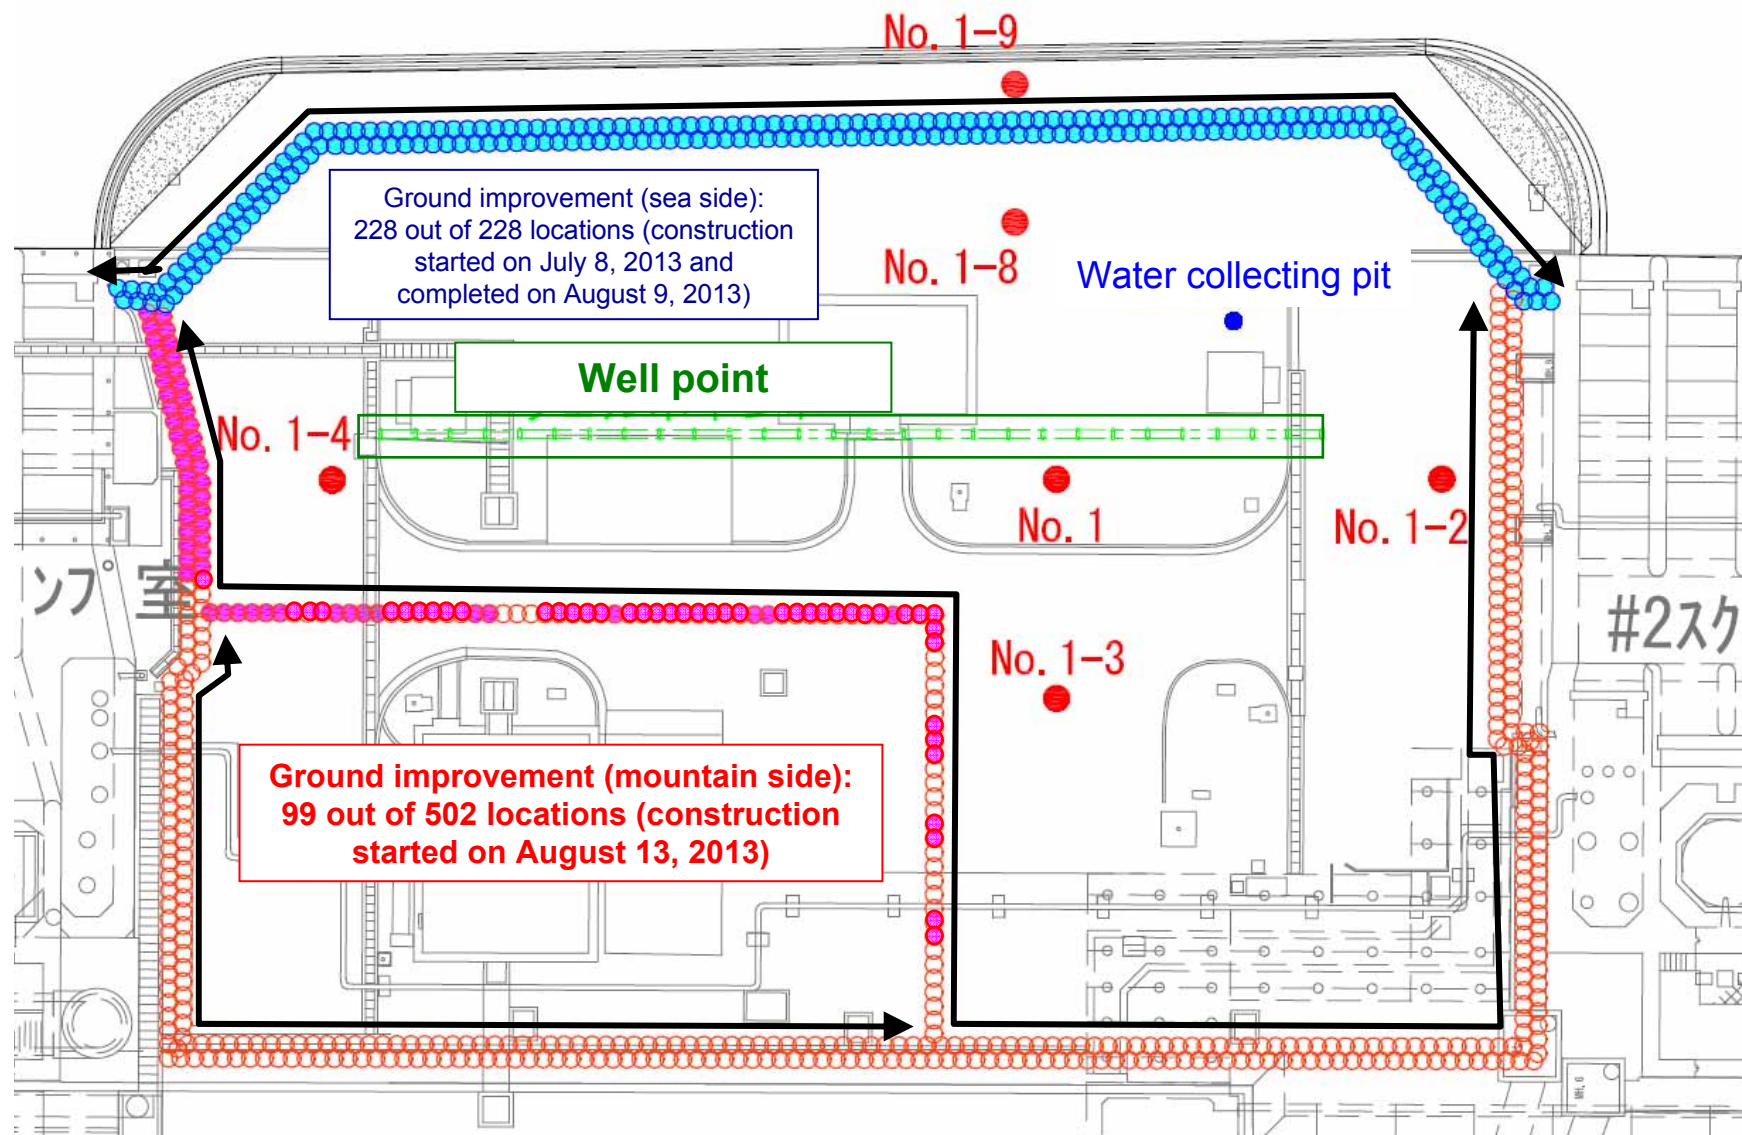
■Progress Status of Ground Improvement Construction between Unit 1 and 2 (as of the morning on September 4)

* The range of the construction is subject to change depends on the site status.

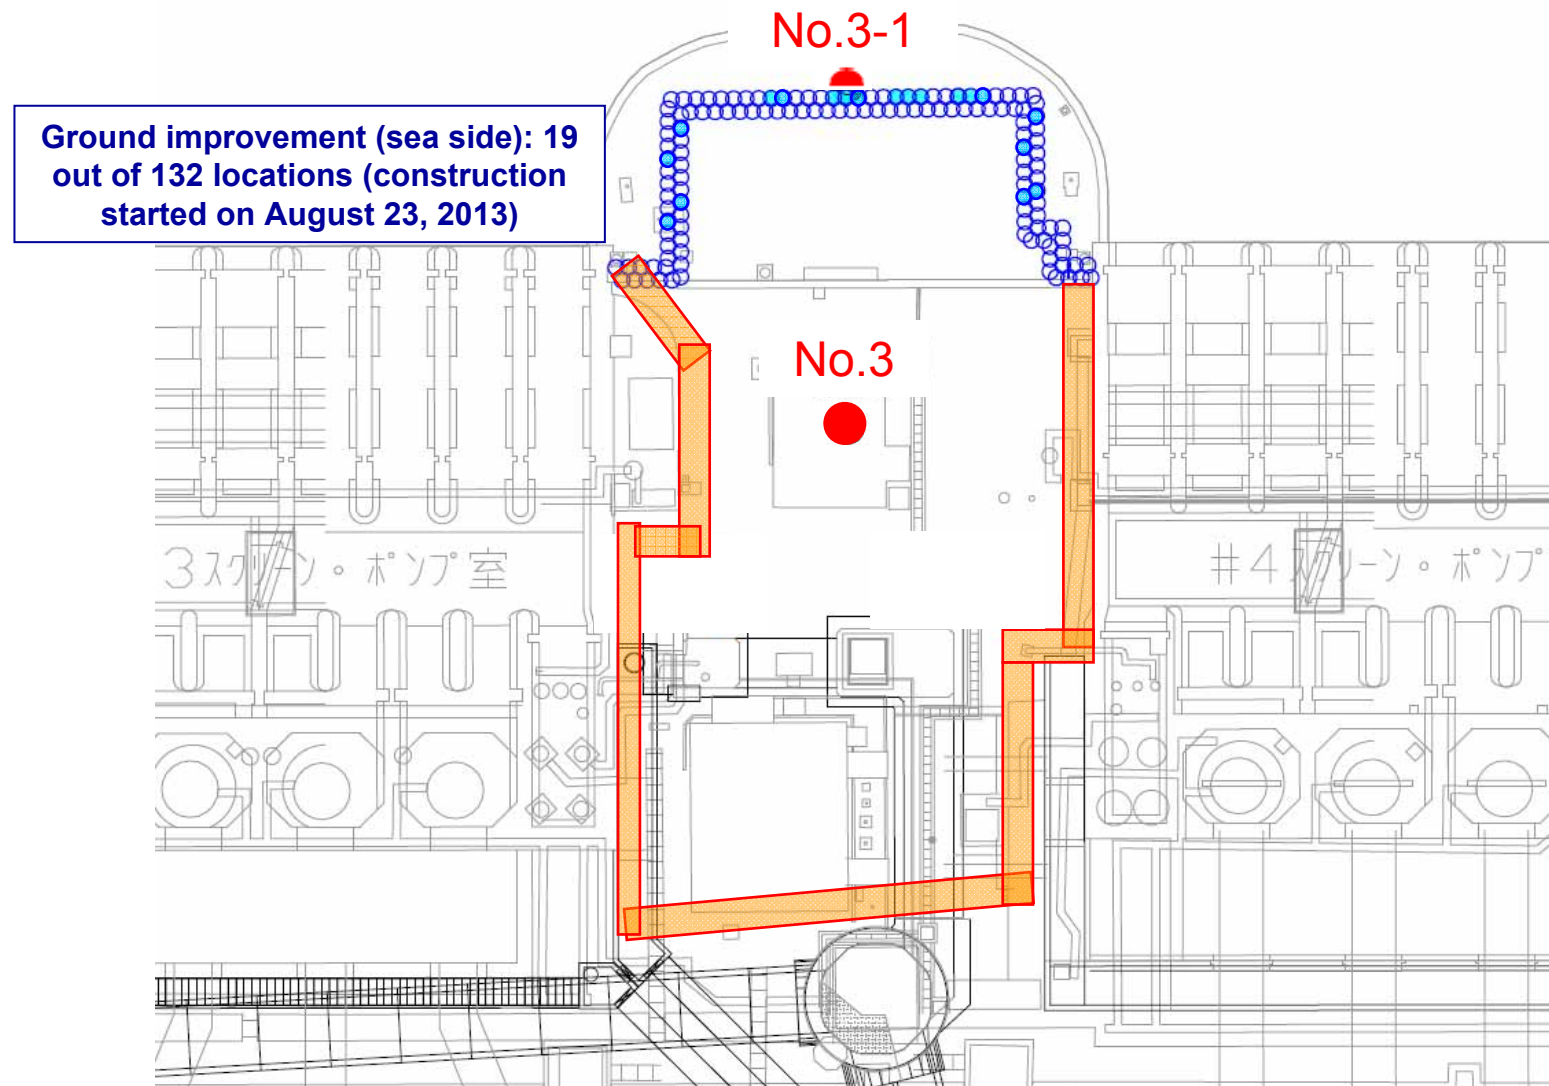
■Progress Status of Ground Improvement Construction between Unit 3 and 4 (as of the morning on September 4)

*1 The range of the construction is subject to change depends on the site status.

*2 Groundwater observation hole No.3-1 will be not in use due to the ground improvement construction.
