# Accumulated Water Inside the Dike in Each Tank Area at Fukushima Daiichi Nuclear Power Station

<Reference>  
September 17, 2013  
Tokyo Electric Power Company

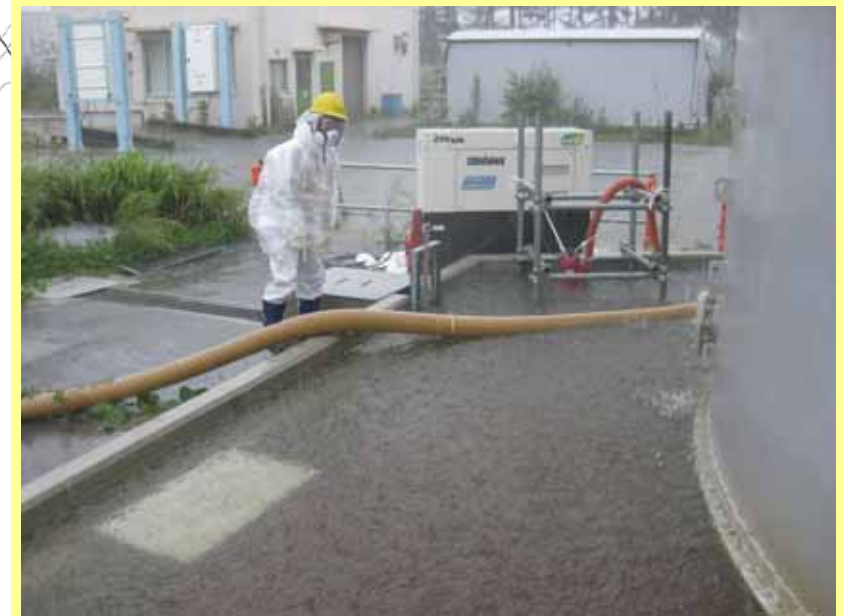
<Condition at the B area (South)>

- : Area where pumping up of the water inside the dike was performed
- : Area where closing of the drain valve was performed
- : B area (South) where overflow of the water was observed

(Photo taken by TEPCO on September 15, 2013)

B (North)	23	Pump-up	2:20 PM - 8:31 PM	-	Approx. 20cm → Approx. 5cm
B (South)	37	Pump-up	12:07 PM - 8:28 PM	-	Approx. 25cm → Approx. 6cm
C (East)	24	Discharge	1:50 PM - 3:26 PM	Approx. 70 t	Approx. 25cm → Approx. 9cm
C (West)	8	Discharge	12:42 PM - 3:51 PM	Approx. 160 t	Approx. 25cm → Approx. 2cm
E	6	Discharge	1:30 PM - 4:14 PM	Approx. 460 t	Approx. 16cm → Approx. 6cm
G4 (South)	3	Discharge	2:20 PM - 4:33 PM	Approx. 90t	Approx. 20cm → Approx. 14cm
G6 (North)	8	Discharge	1:20 PM - 4:26 PM	Approx. 210t	Approx. 20cm → Approx. 3cm
G6 (South)	34	Pump-up	12:18 PM - 8:24 PM	-	Approx. 20cm → Approx. 5cm
