<Reference>
September 25, 2013
Tokyo Electric Power Company

Cause and Preventive Actions Following Leakage from a Batch Treatment Tank of Multi-nuclide Removal Equipment

Locations of Leakage and Corrosion

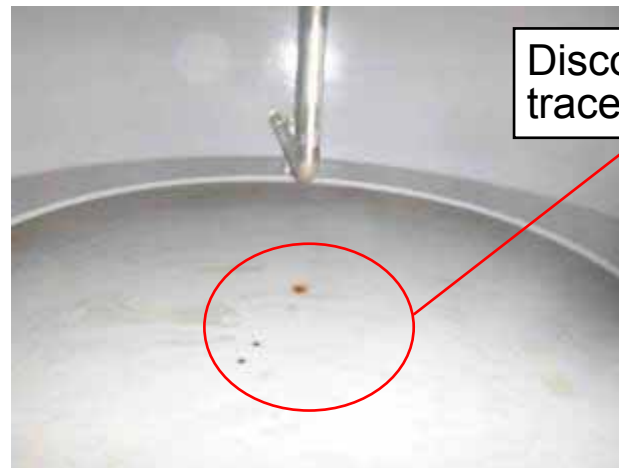
② Leaked-water receiving pan

Not being large-scale leakage, this was found during a patrol as small-scale leakage (a few water drop traces) on the floor of a receiving pan placed under the tank.

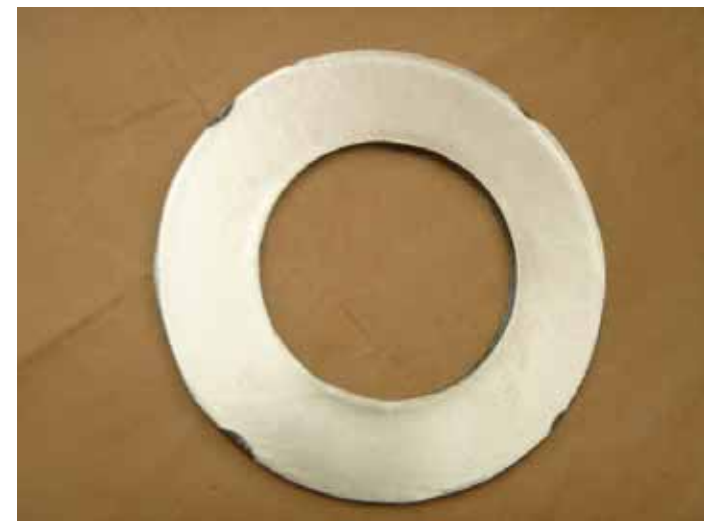
Gasket-type sacrificial positive electrode

Gasket-type sacrificial positive electrodes, etc., were provided to flanges that have the risk of suffering crevice corrosion. Additionally, for higher reliability, we are considering future **replacement with lining pipes**.
