Condition of the Bank Protection Area at Fukushima Daiichi Nuclear Power Station

<Reference>
September 30, 2013
Tokyo Electric Power Company

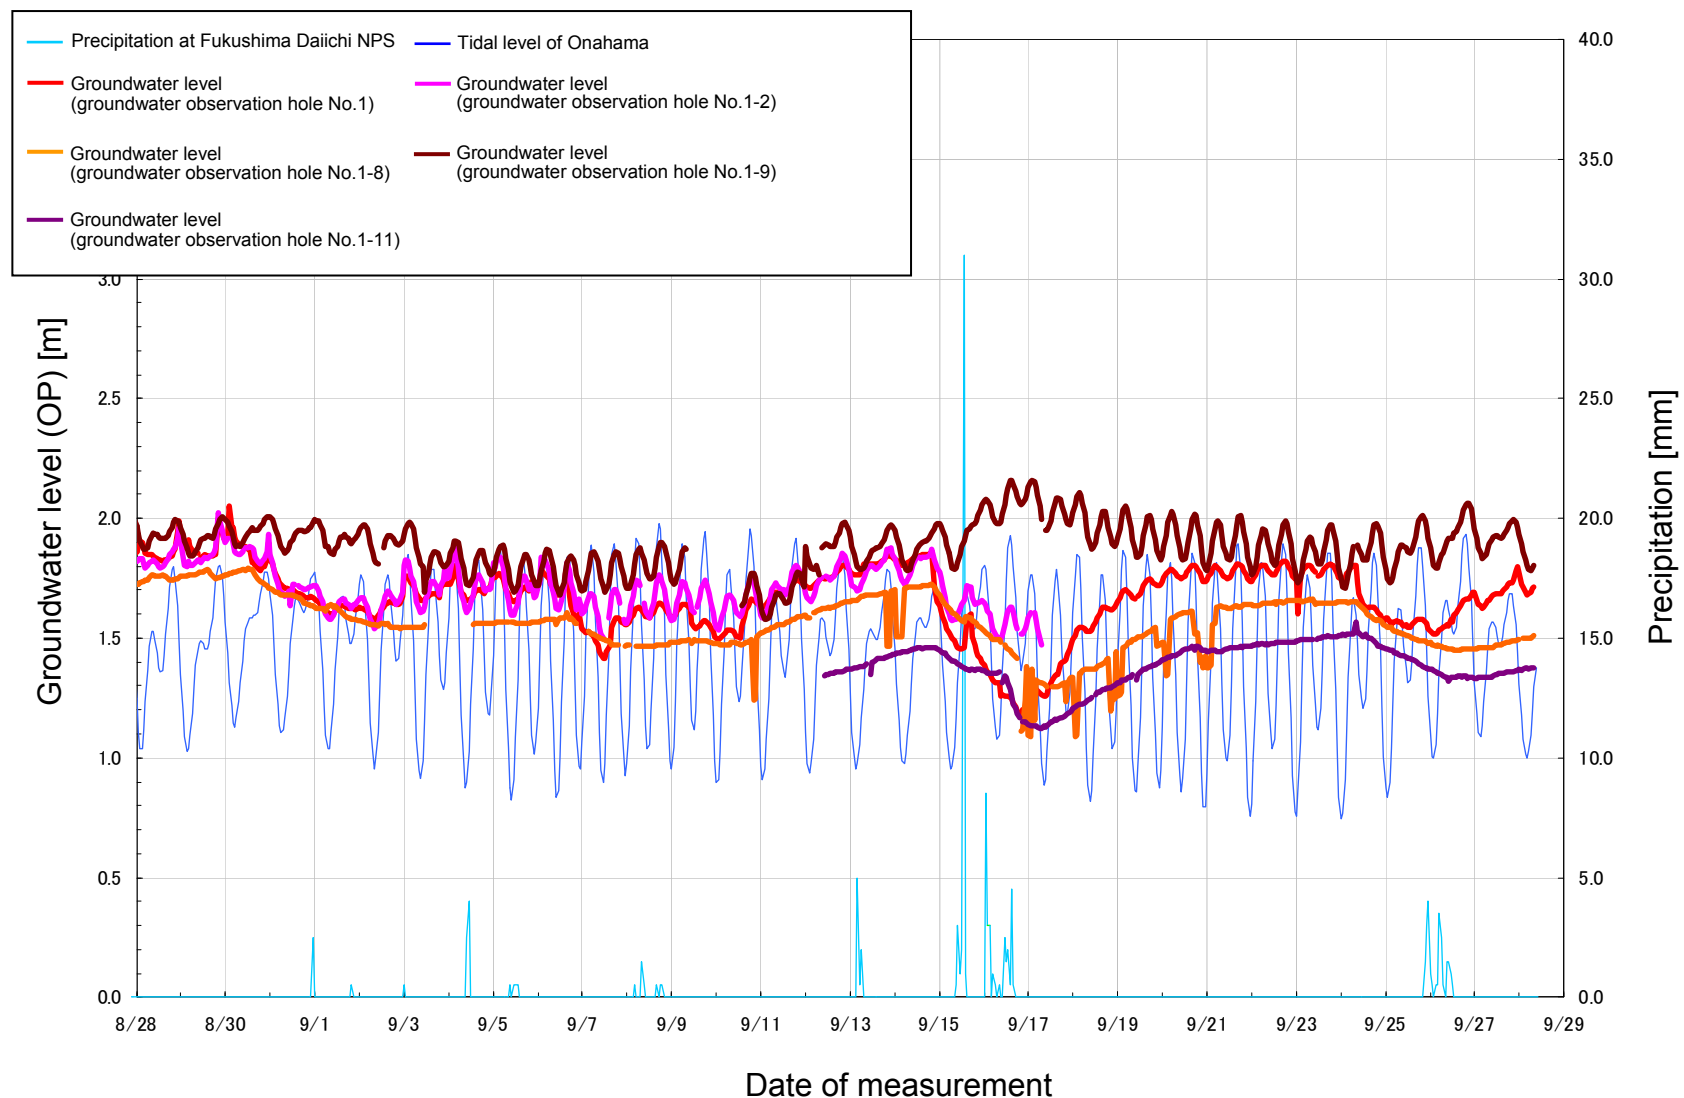
■ Transition of the groundwater level between Unit 1 and 2 (August 28 - September 28)

* Automatic measurement data measured by water gauge

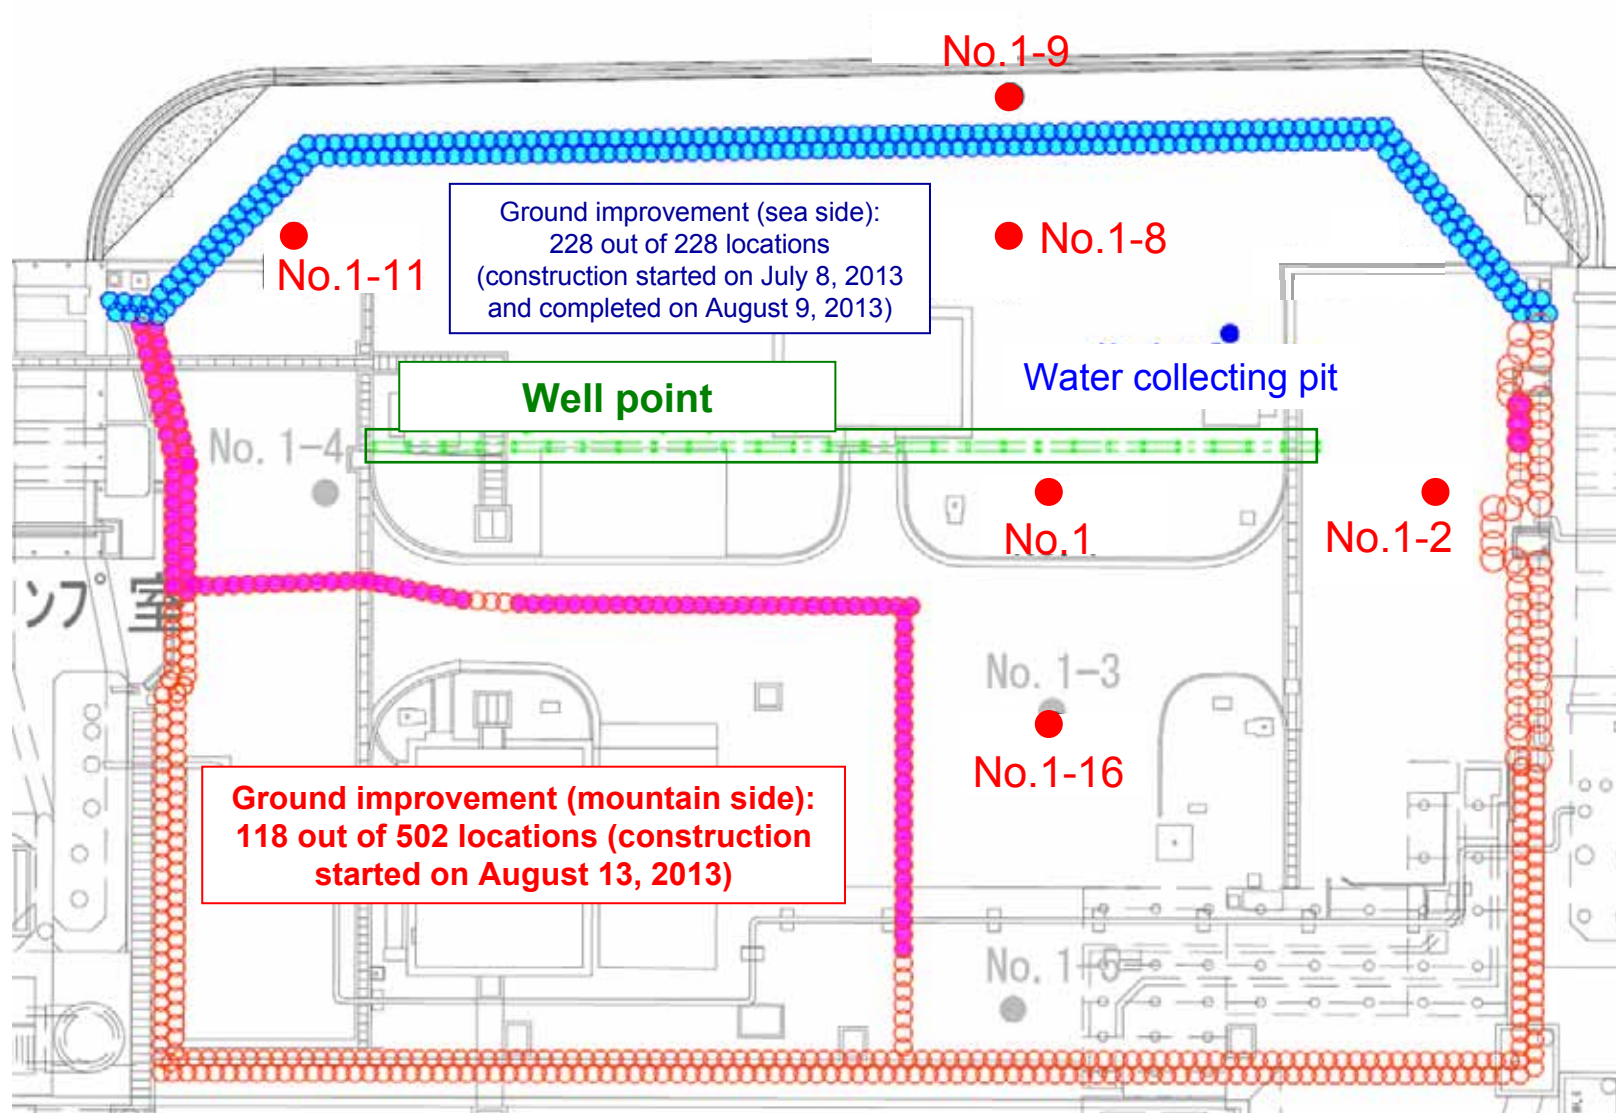
■ Progress Status of Ground Improvement Construction between Unit 1 and 2 (As of the Morning on September 30)

* The range of the construction is subject to change depends on the site status.

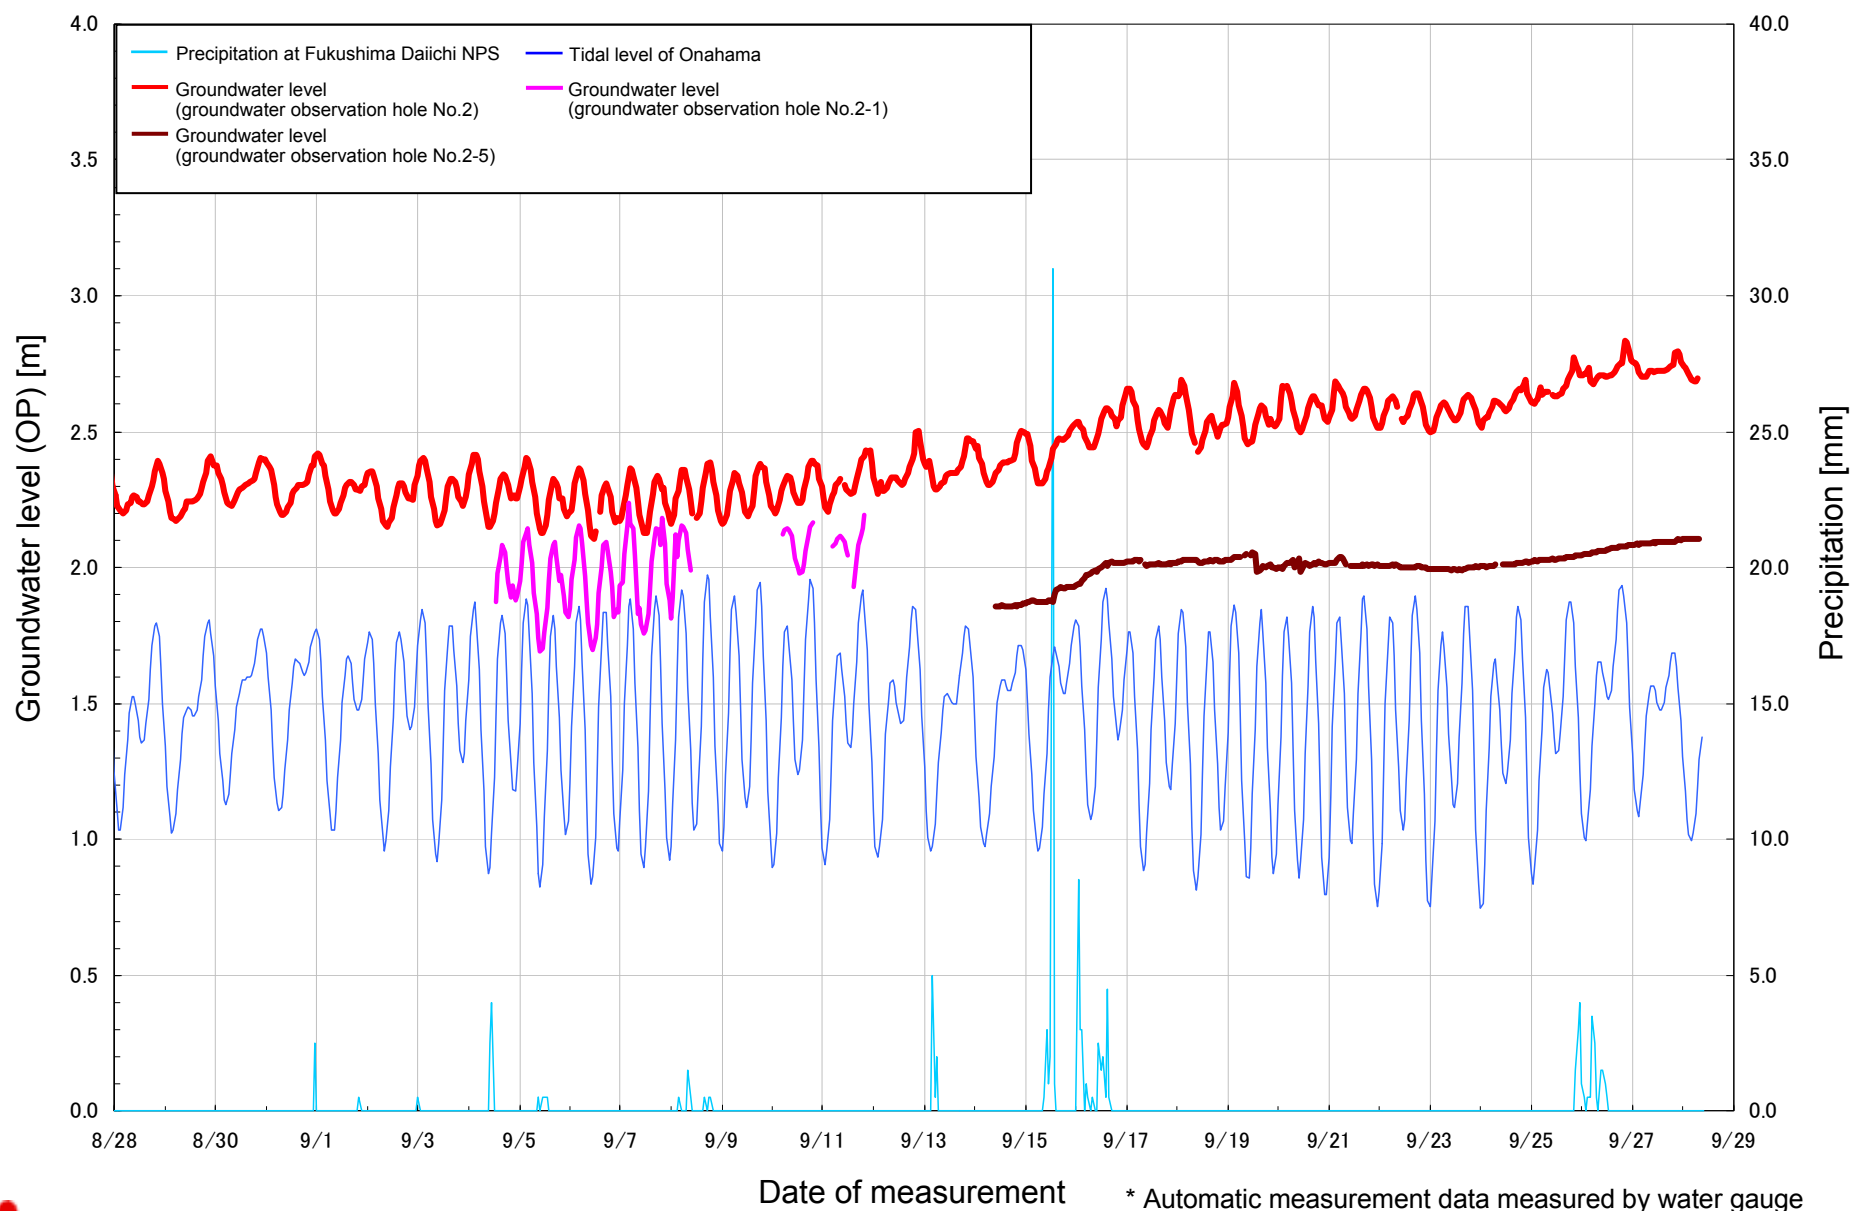
■ Transition of the groundwater level between Unit 2 and 3 (August 28 - September 28)

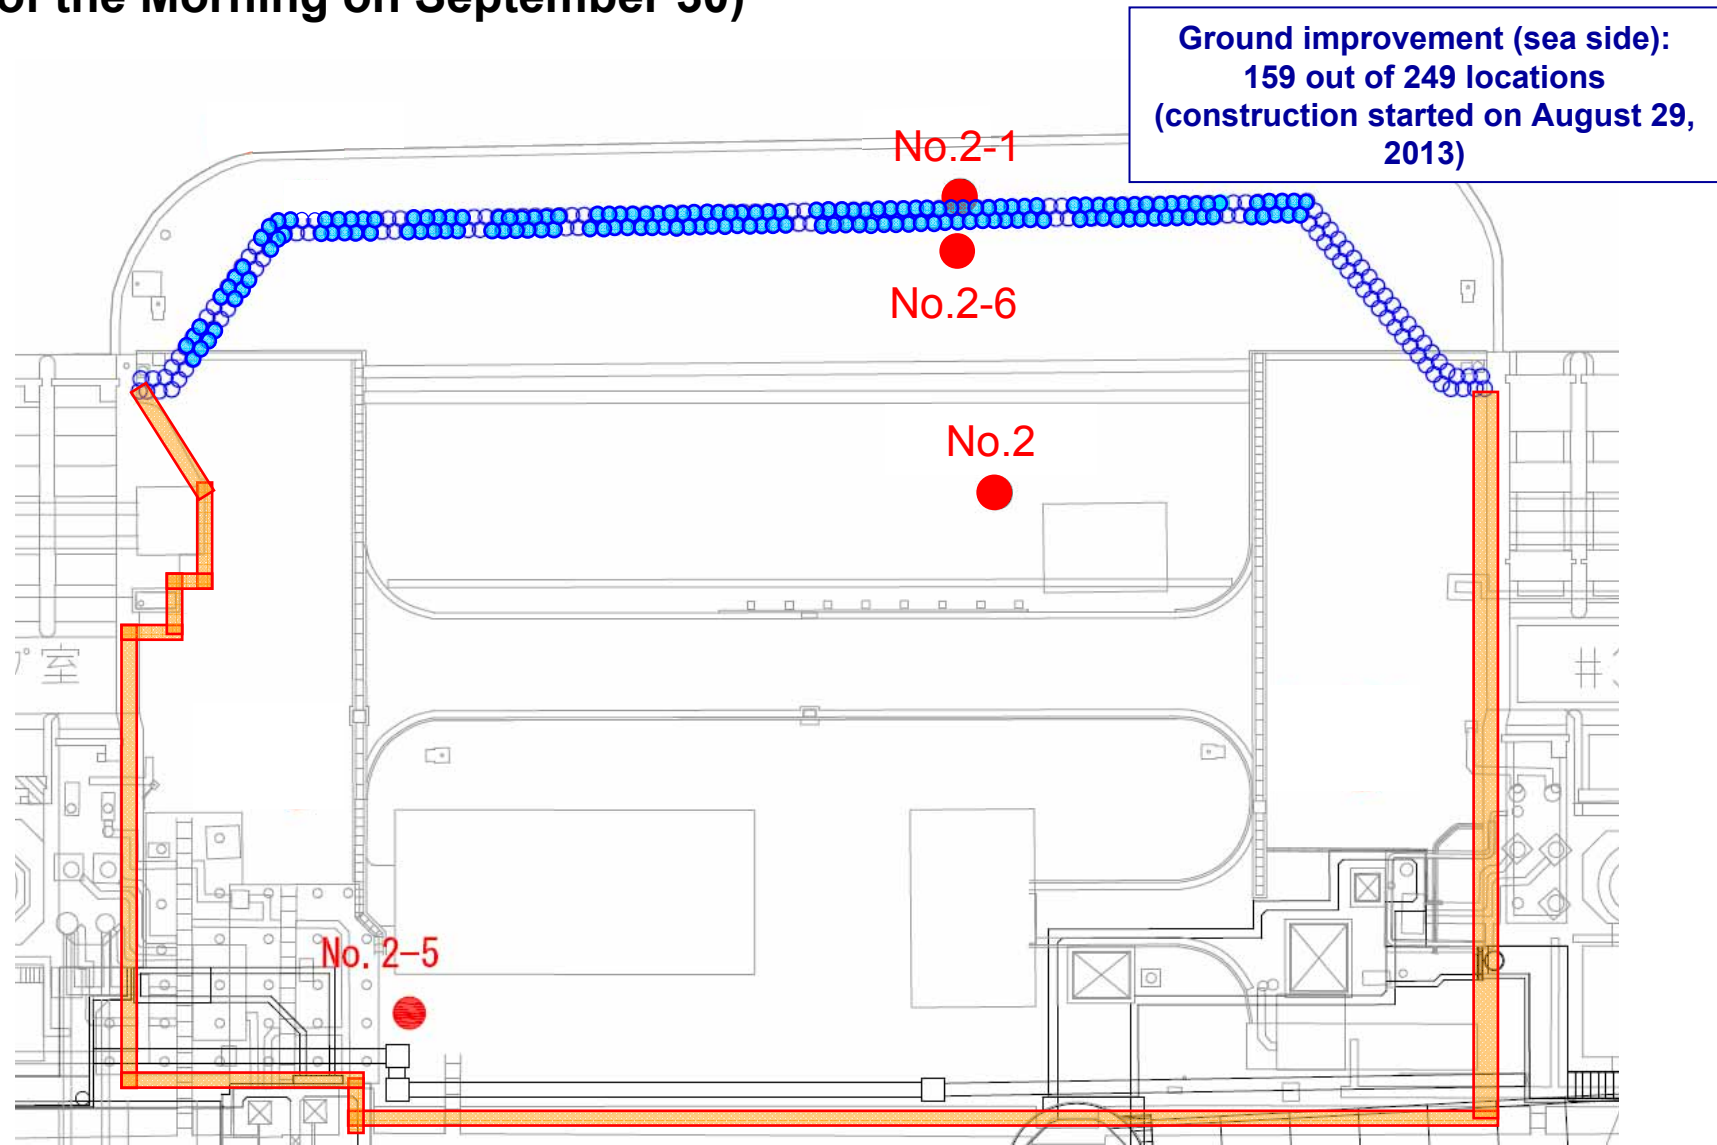
■ Progress Status of Ground Improvement Construction between Unit 2 and 3 (As of the Morning on September 30)

* The range of the construction is subject to change depends on the site status.

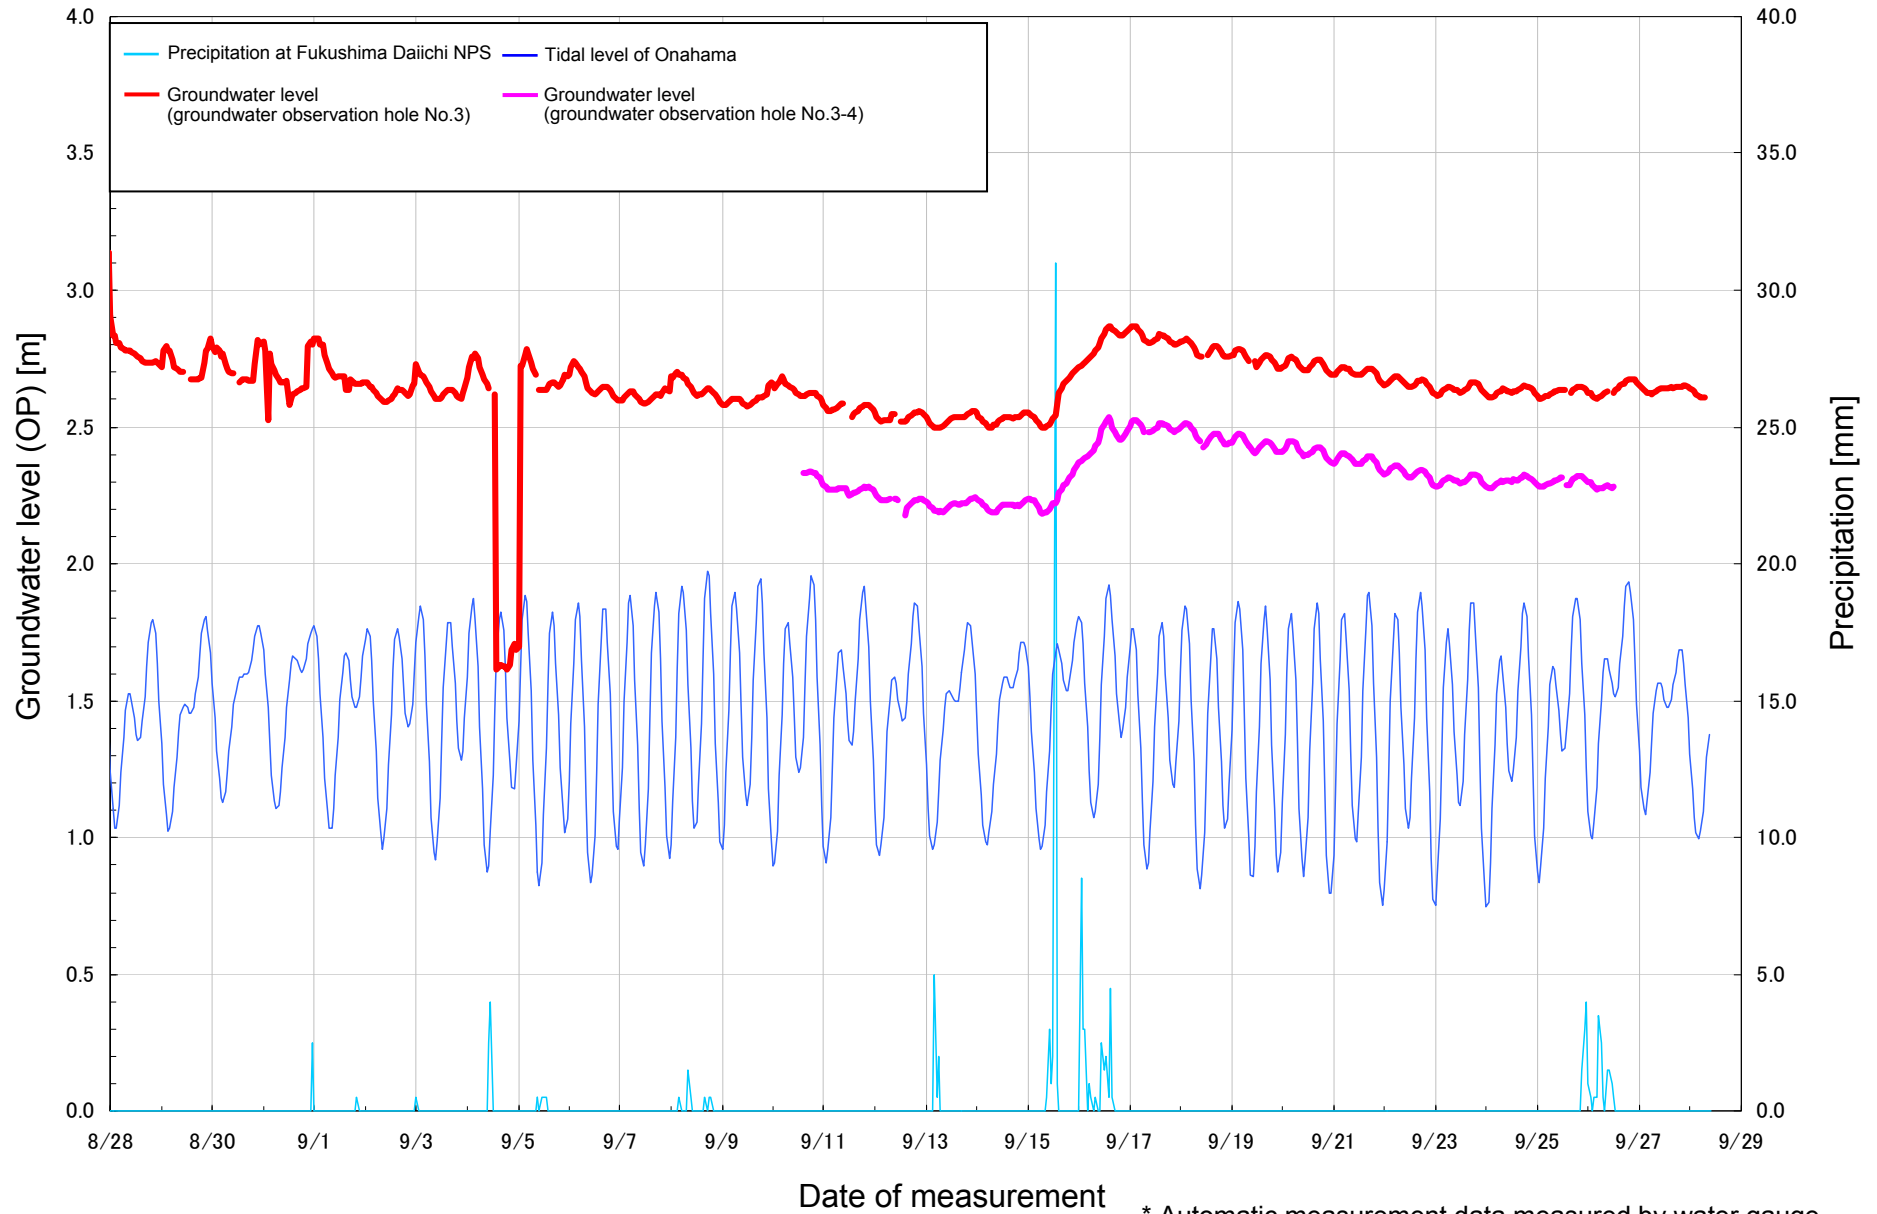
■ Transition of the groundwater level between Unit 3 and 4 (August 28 - September 28)

* Automatic measurement data measured by water gauge
