The Suspension of the Common On-Site Power Supply (3B) Facilities at Fukushima Daiichi NPS

October 7, 2013

Tokyo Electric Power Company

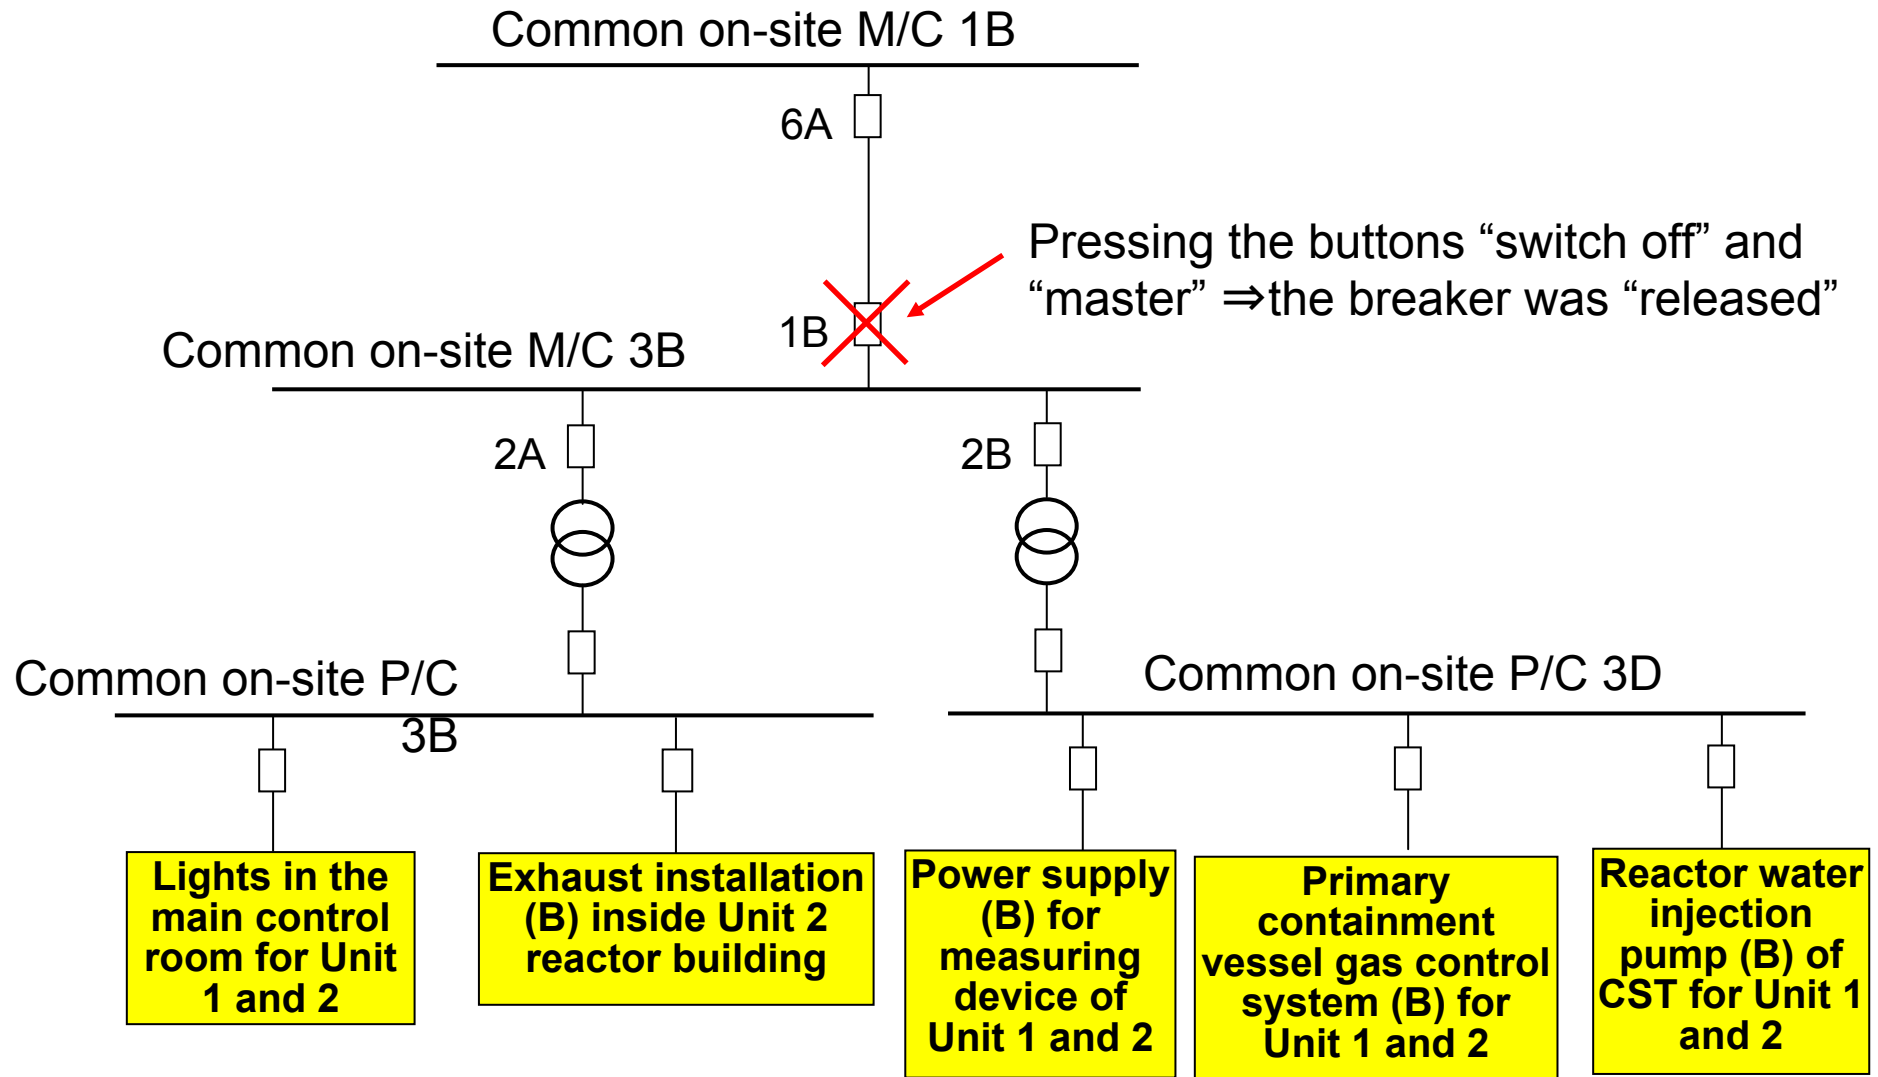
4. One-line diagram

- At around 9:47 AM on October 7, we found that “the bus voltage low alarm” was activated, and that the common on-site power supply facility (M/C: Metal clad 3B) was suspended.

- Then, the operator pressed a button activating the breaker activation by mistake, and the M/C initial power receiving breaker went “released”. It caused the suspension of the bus line.

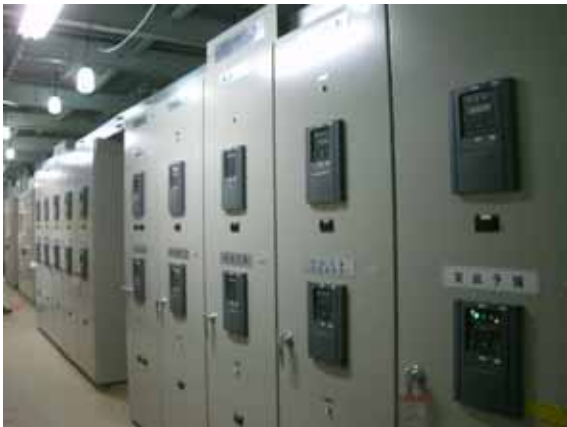
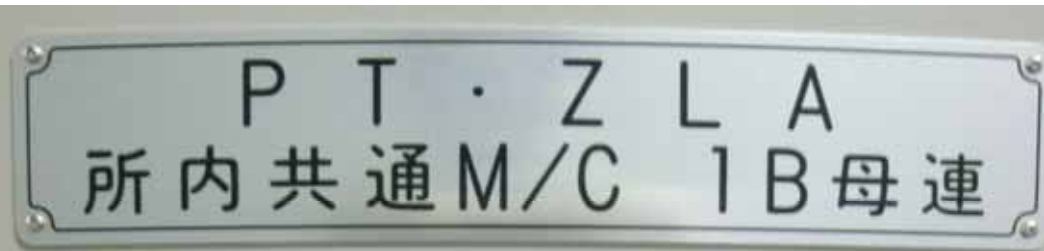
The control panel of the initial power receiving breaker

- A TEPCO employee **pressed the button activating a breaker by mistake**, when checking the data of the M/C.
- An operator is originally supposed to press only the button “measuring”, when checking the data. However, he pressed by mistake both the buttons “switch off (select)” and “master (implement)”, when trying to switch off the display panel after checking the data. (*A breaker is activated when both “switch off” and “master” is pressed.)

- The buttons for a breaker have no sign to address they are only for the breaker operation, therefore it caused confusion between the buttons for breaker and the one for measuring display panel.
- There is no detailed instruction book on the regular patrol at the common on-site M/C, therefore points to be noted remains vague.

<Correct operation>
Measuring electrical current and voltage by pressing the button "Measure".
→Display panel will be automatically switched off afterward.

<Operation with mistake>
The operator was trying to switch off the display panel.
①: Pressing the button "switch off"
↓ (due to the remaining display panel)
②: Pressing the button "master" (double action)
↓
M/C breaker: "Released"

- We will put “Only for breaker activation” labels on the buttons. (As soon as possible)
- In addition, we will put a hard cover over the buttons, so that no one can reach the buttons by mistake. (In several days)
 - We will put hard covers to similar apparatuses.

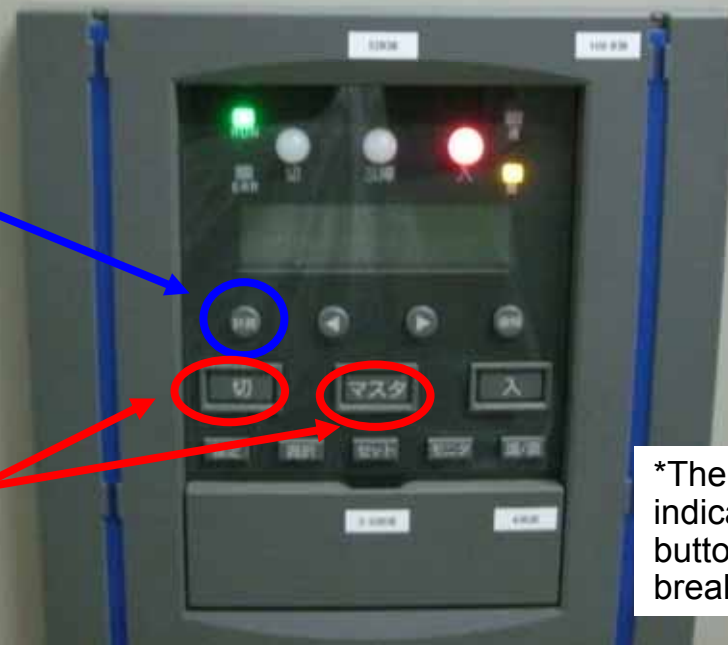
*There is no sign indicating that the buttons are "for a breaker".
