# The seawall area at Fukushima Daiichi NPS

<Reference>  
 October 30, 2013  
 Tokyo Electric Power Company

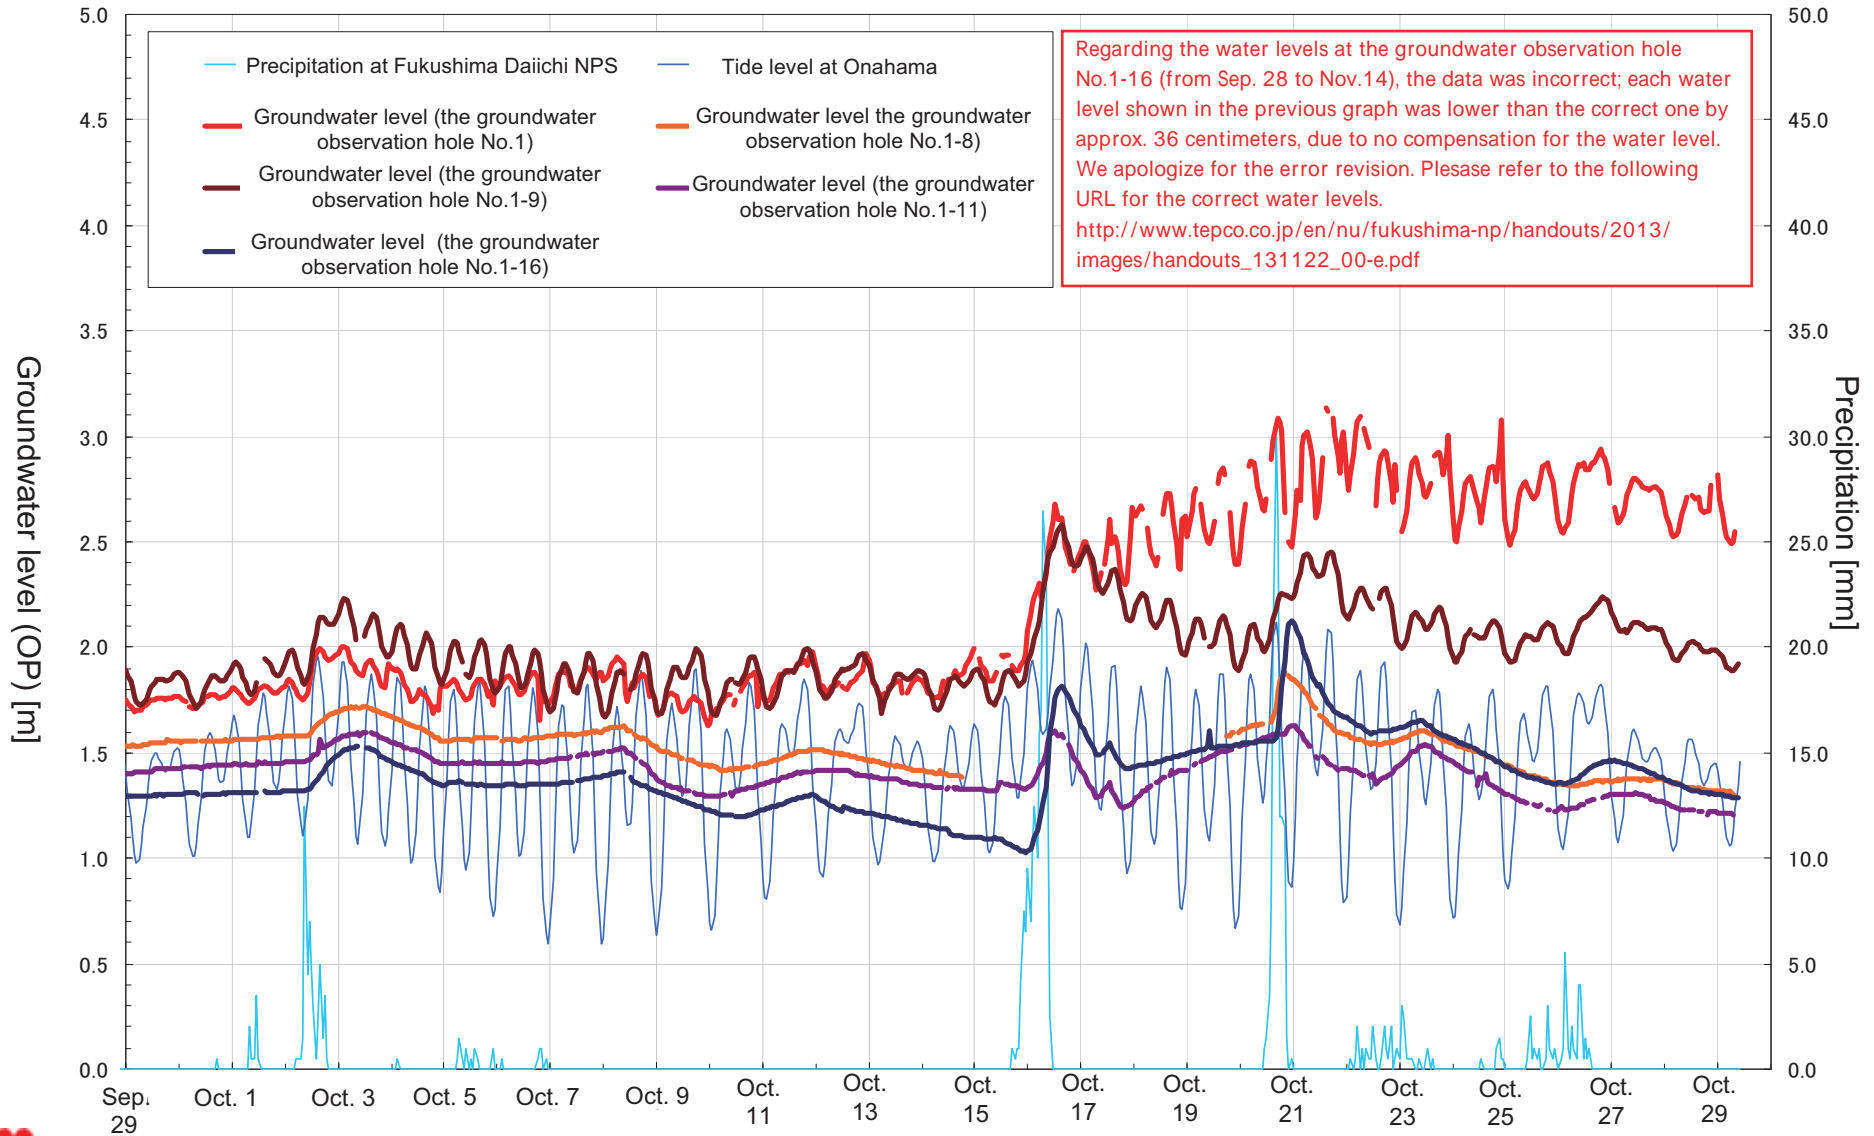
## ■ Movement in groundwater (Between Unit 1 and 2: From Sep.29 to Oct.29)

Measurement date — \*Automatic measurement through a water level indication

Regarding the water levels at the groundwater observation hole No.1-16 (from Sep. 28 to Nov.14), the data was incorrect; each water level shown in the previous graph was lower than the correct one by approx. 36 centimeters, due to no compensation for the water level. We apologize for the error revision. Please refer to the following URL for the correct water levels.  
[http://www.tepco.co.jp/en/nu/fukushima-np/handouts/2013/images/handouts\\_131122\\_00-e.pdf](http://www.tepco.co.jp/en/nu/fukushima-np/handouts/2013/images/handouts_131122_00-e.pdf)

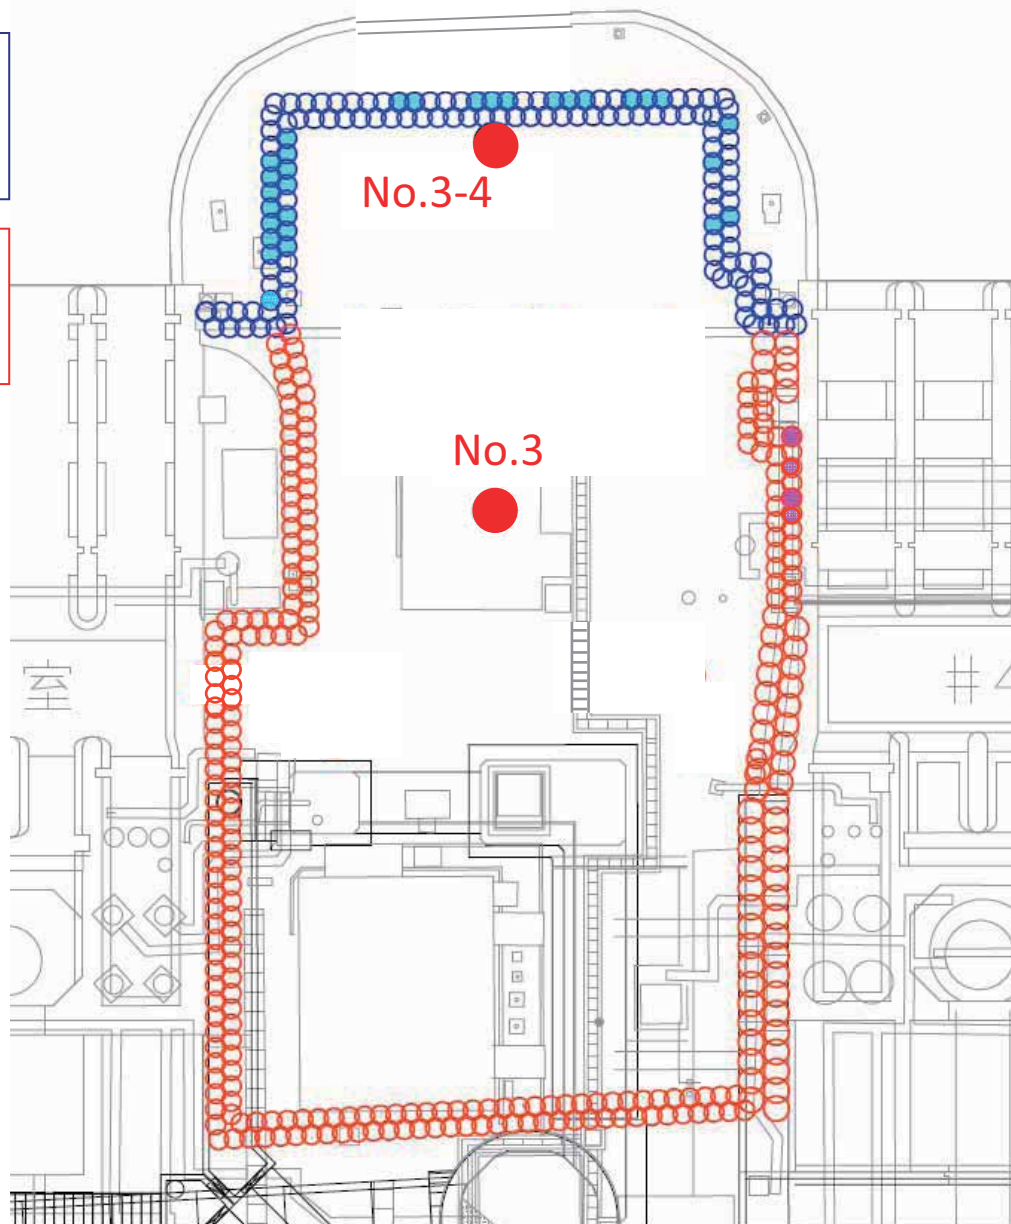
## Progress in the ground improvement work between Unit 3 and 4 (As of in the morning on October 30)

Ground improvement (sea side):  
up to 30 out of 132  
(Since Aug. 23, 2013)

Ground improvement work  
(mountain side) : up to 4 out of  
273 (Since Oct.19)
