# The seawall area at Fukushima Daiichi NPS

November 6, 2013

Tokyo Electric Power Company

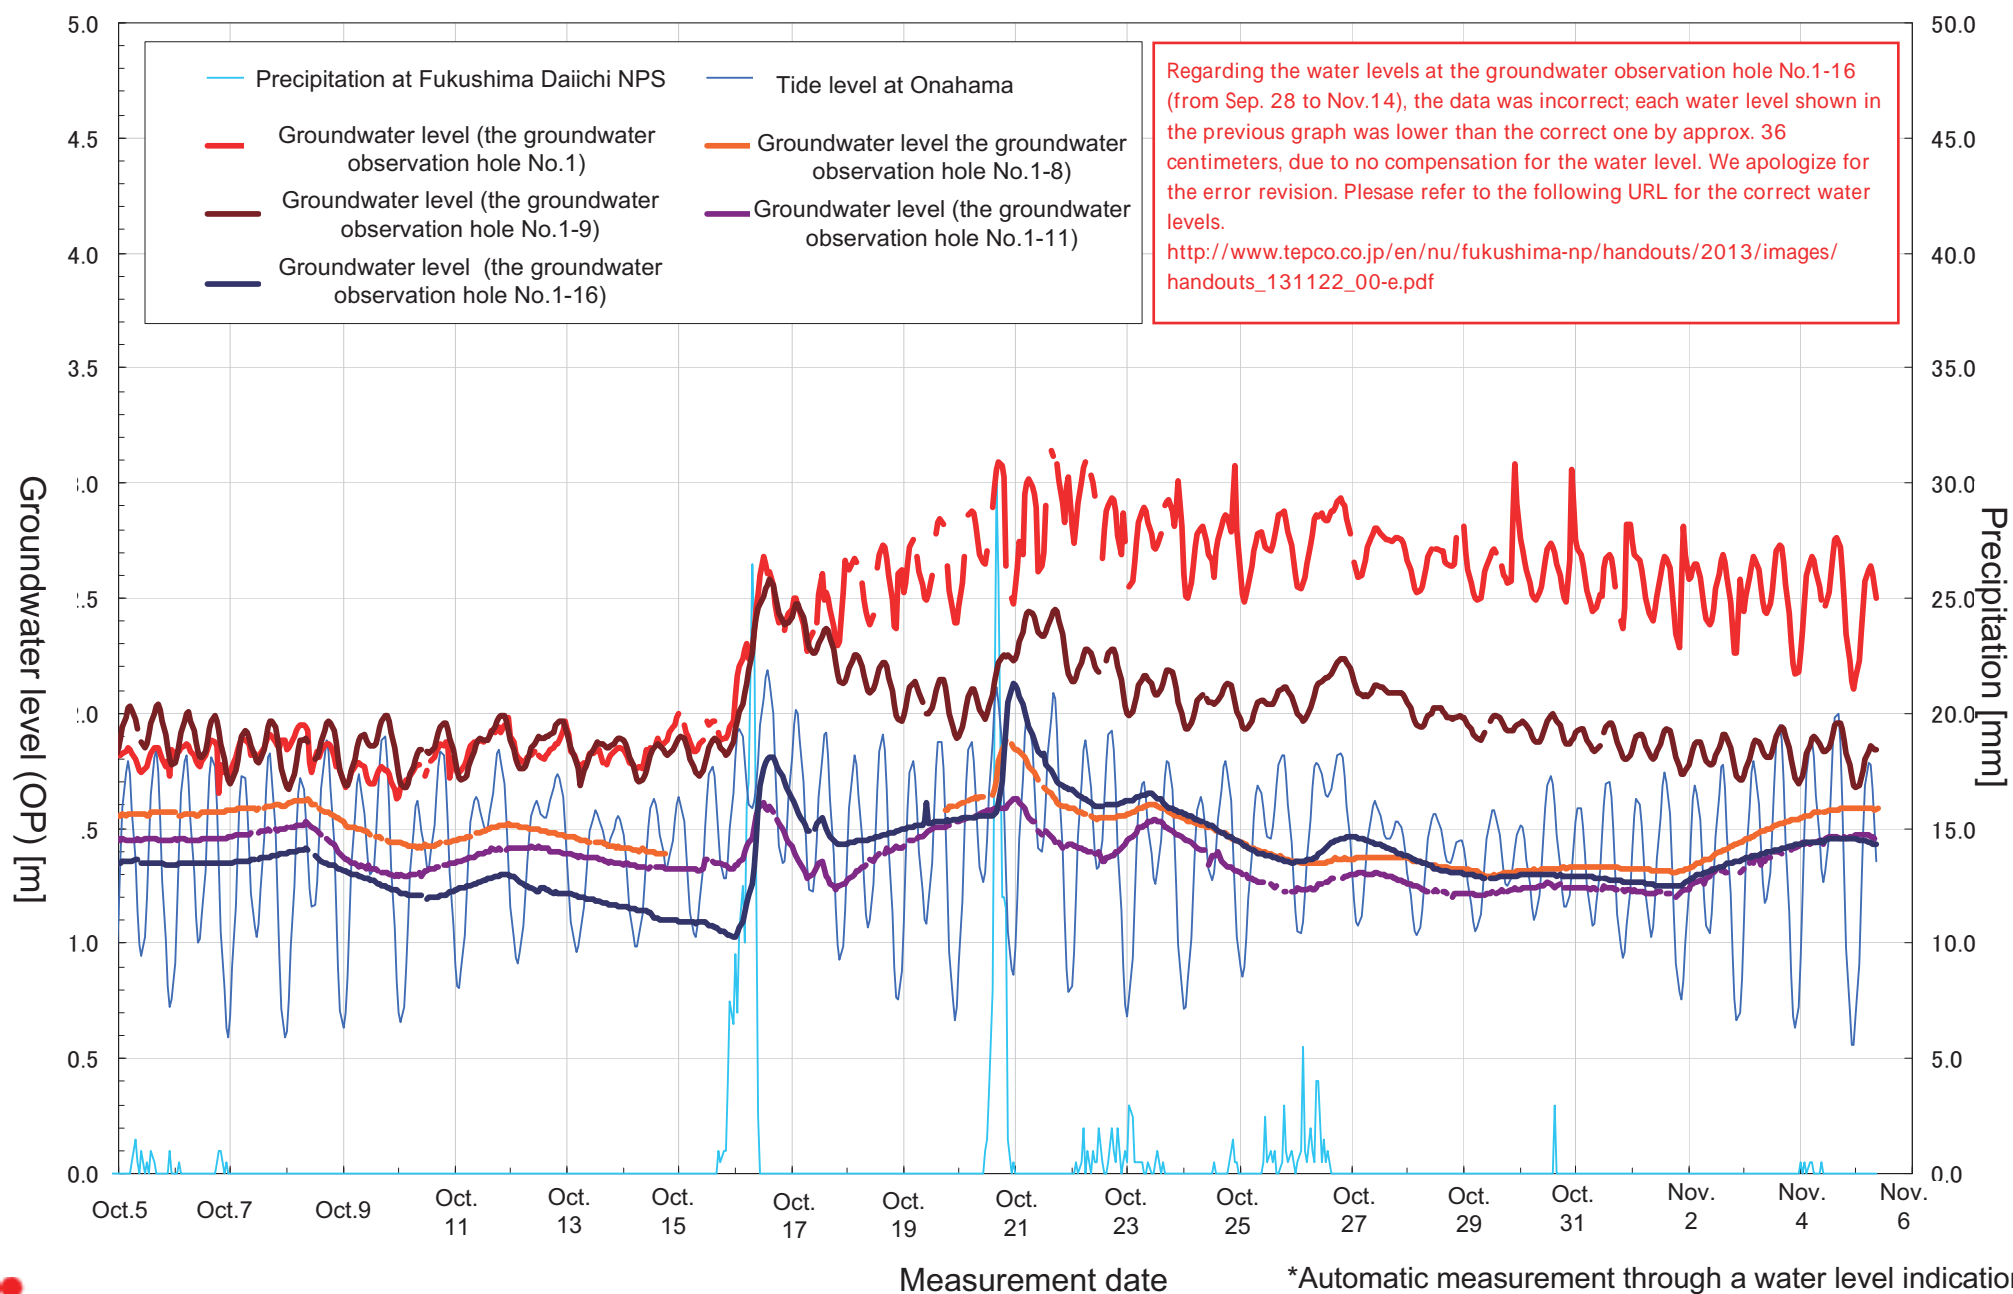
## Movement in groundwater (Between Unit 1 and 2: From Oct. 5 to Nov. 5)

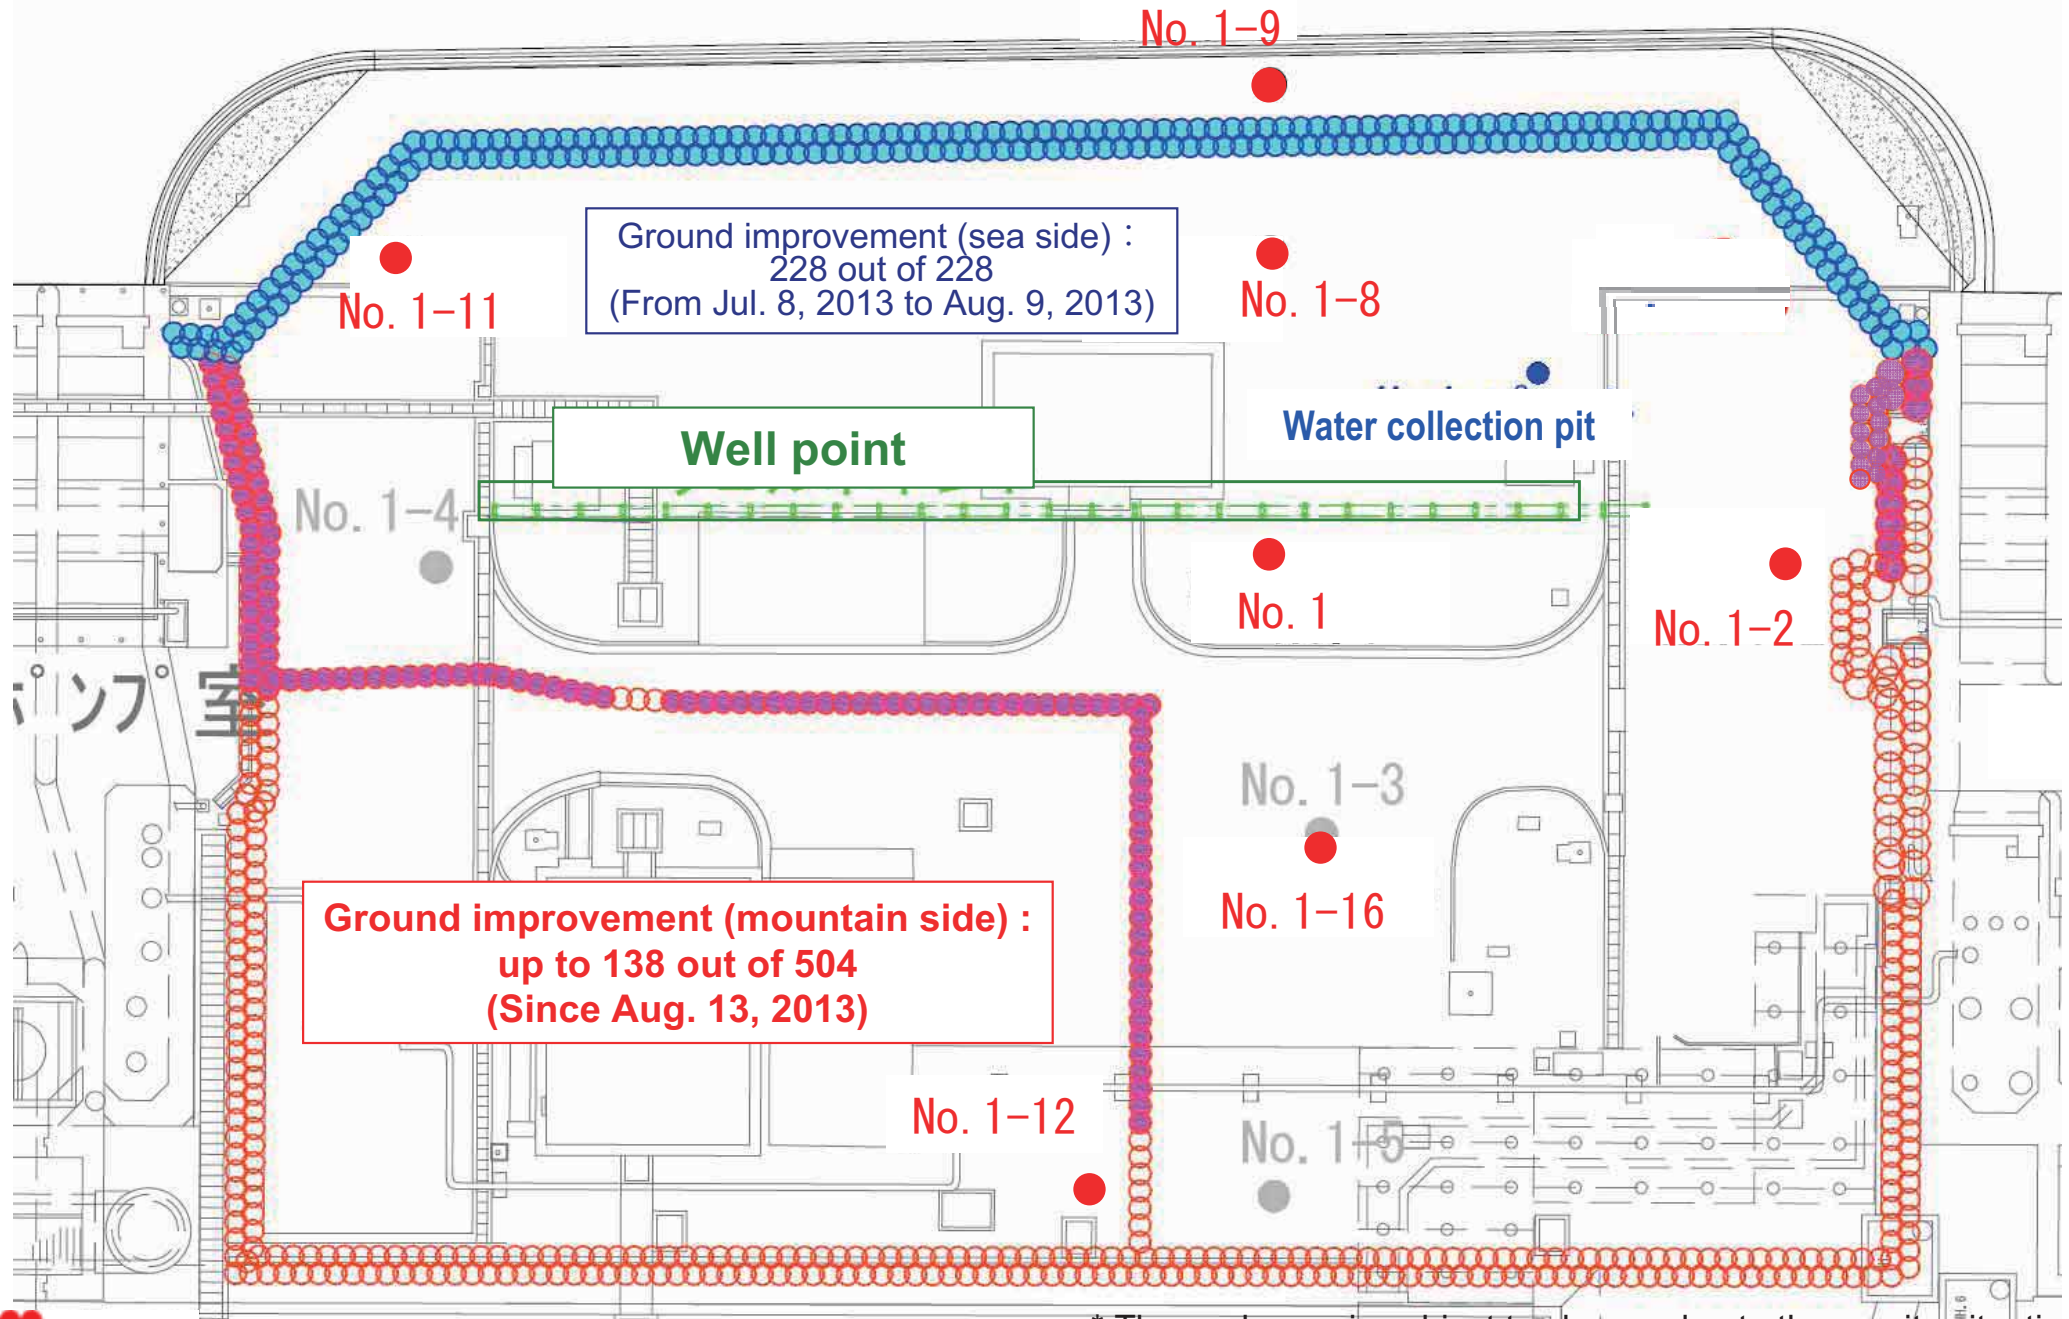
# Progress in the ground improvement work between Unit 1 and 2 (As of in the morning on November 6)

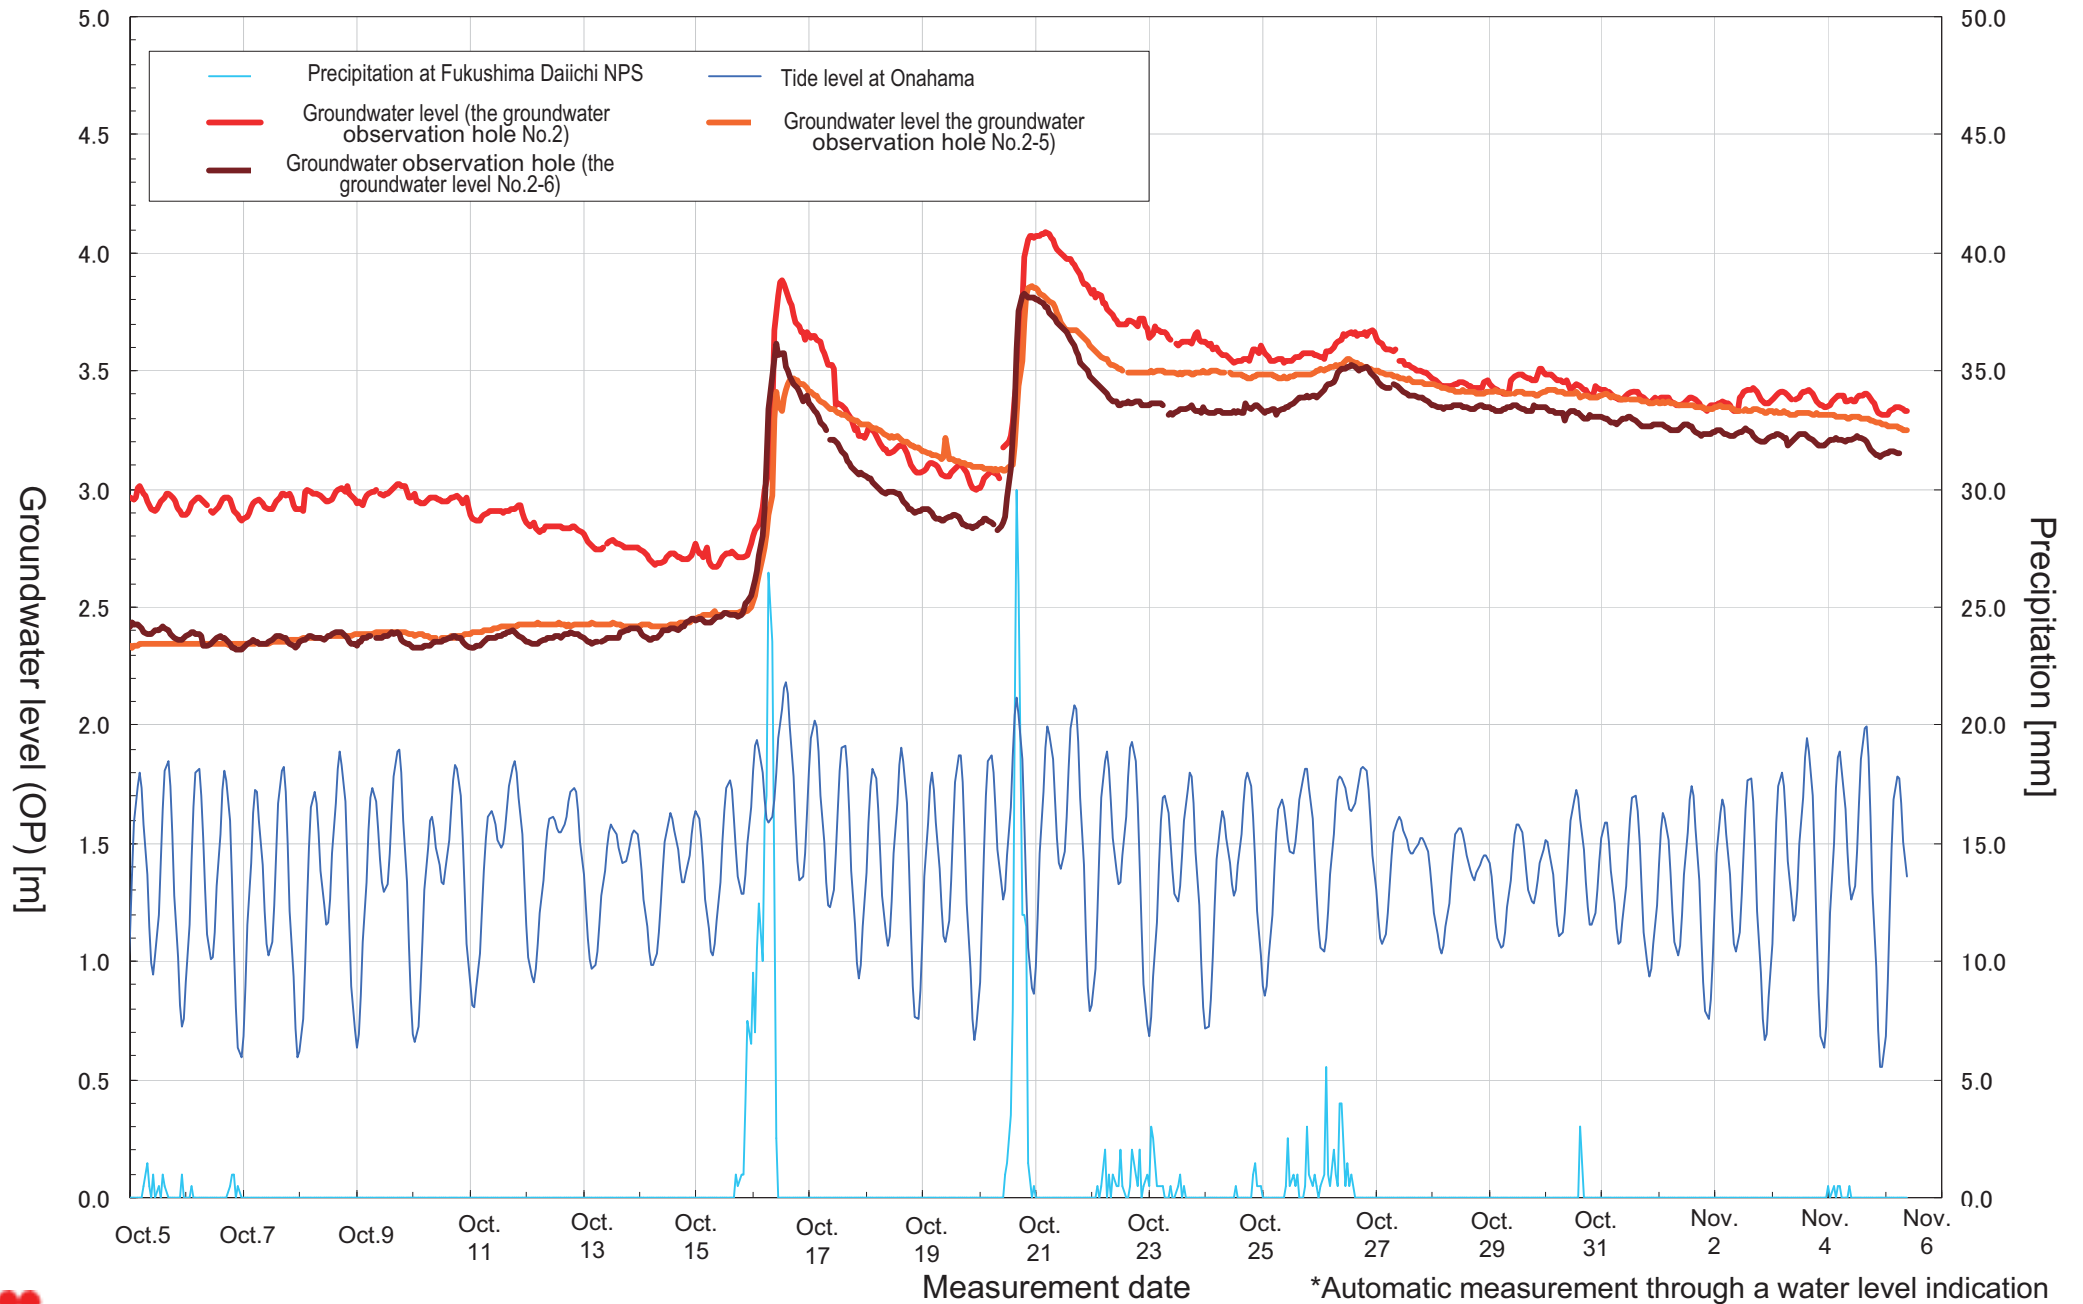
# Movement in groundwater (Between Unit 2 and 3: From Oct. 5 to Nov. 5)

\*Automatic measurement through a water level indication

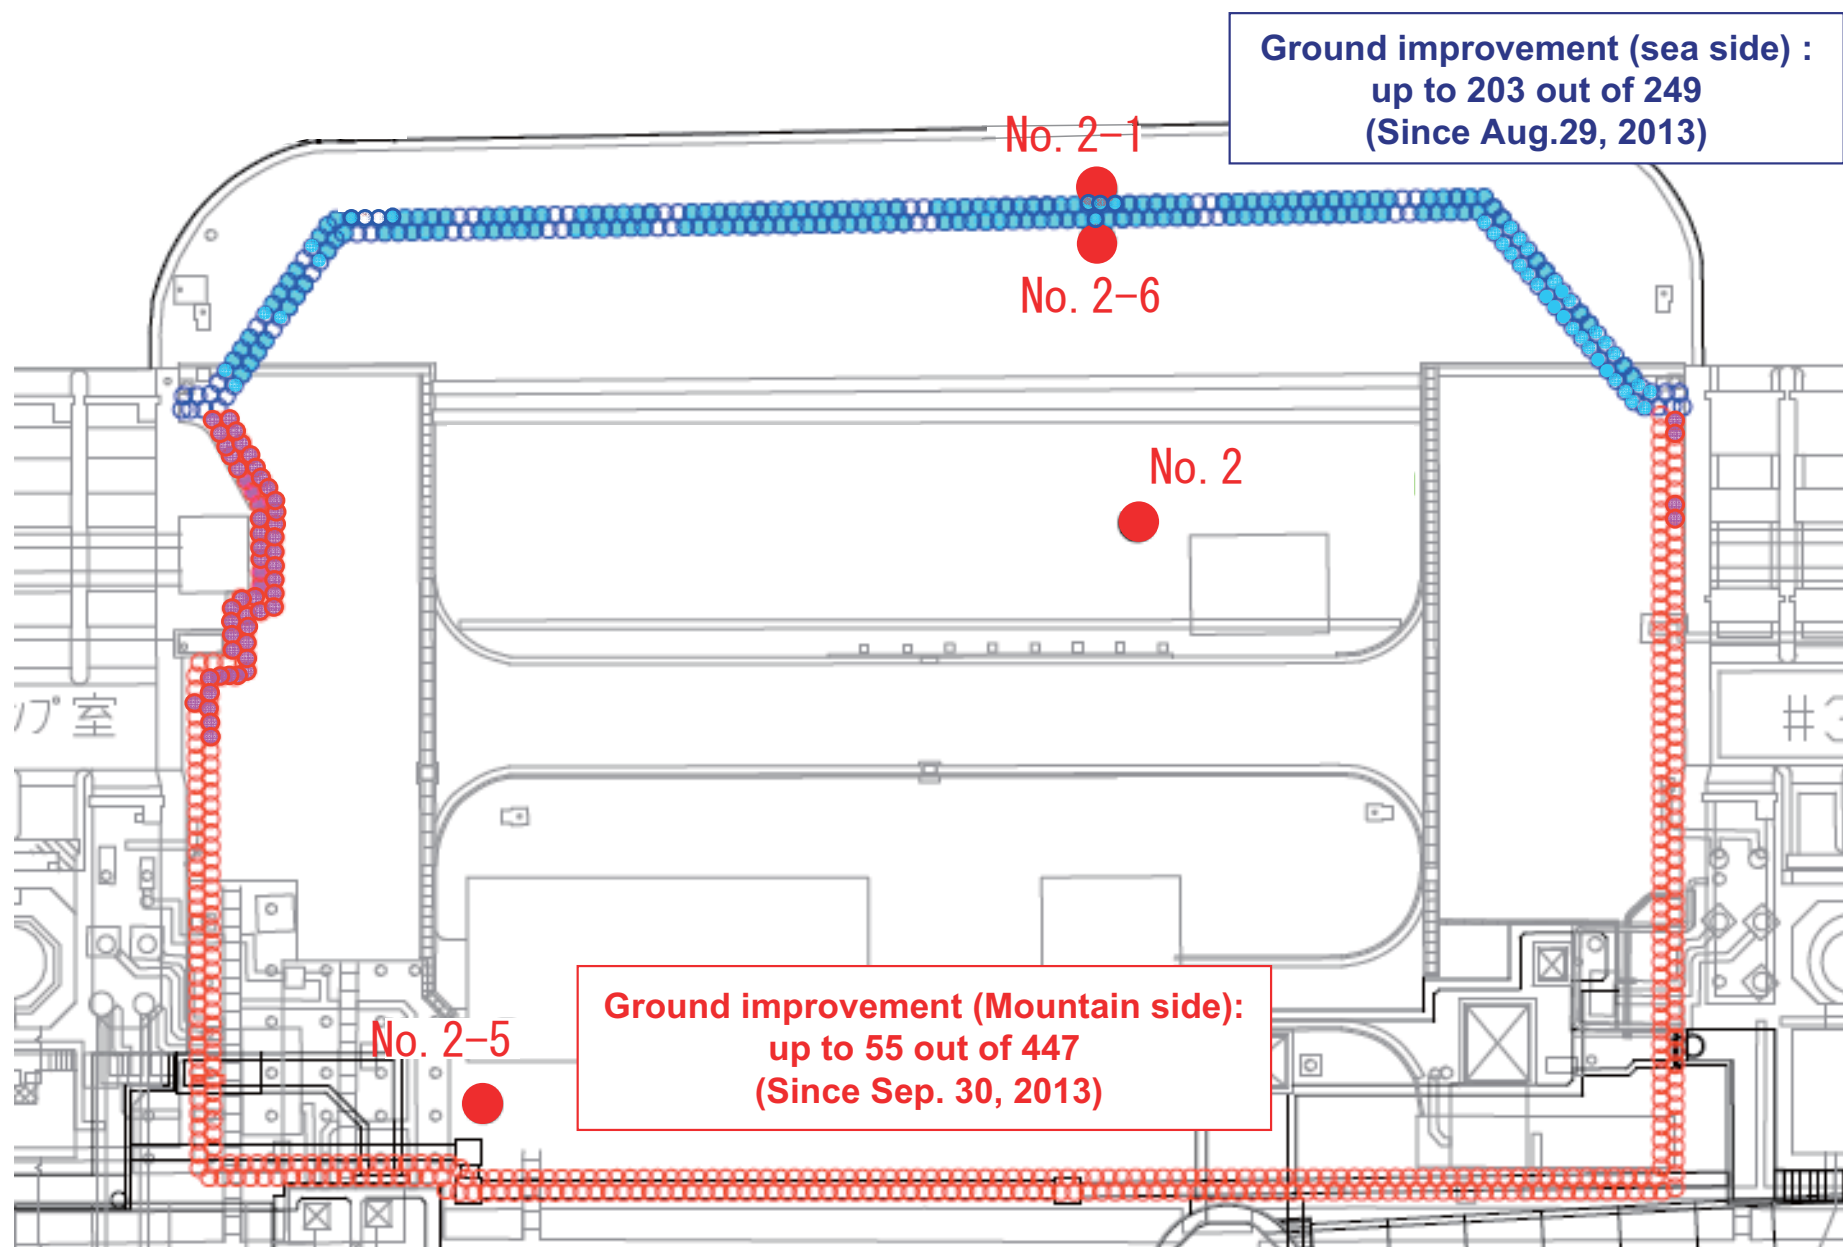
# Progress in the ground improvement work between Unit 2 and 3 (As of in the morning on November 6)

\* The work area is subject to change due to the on-site situation.

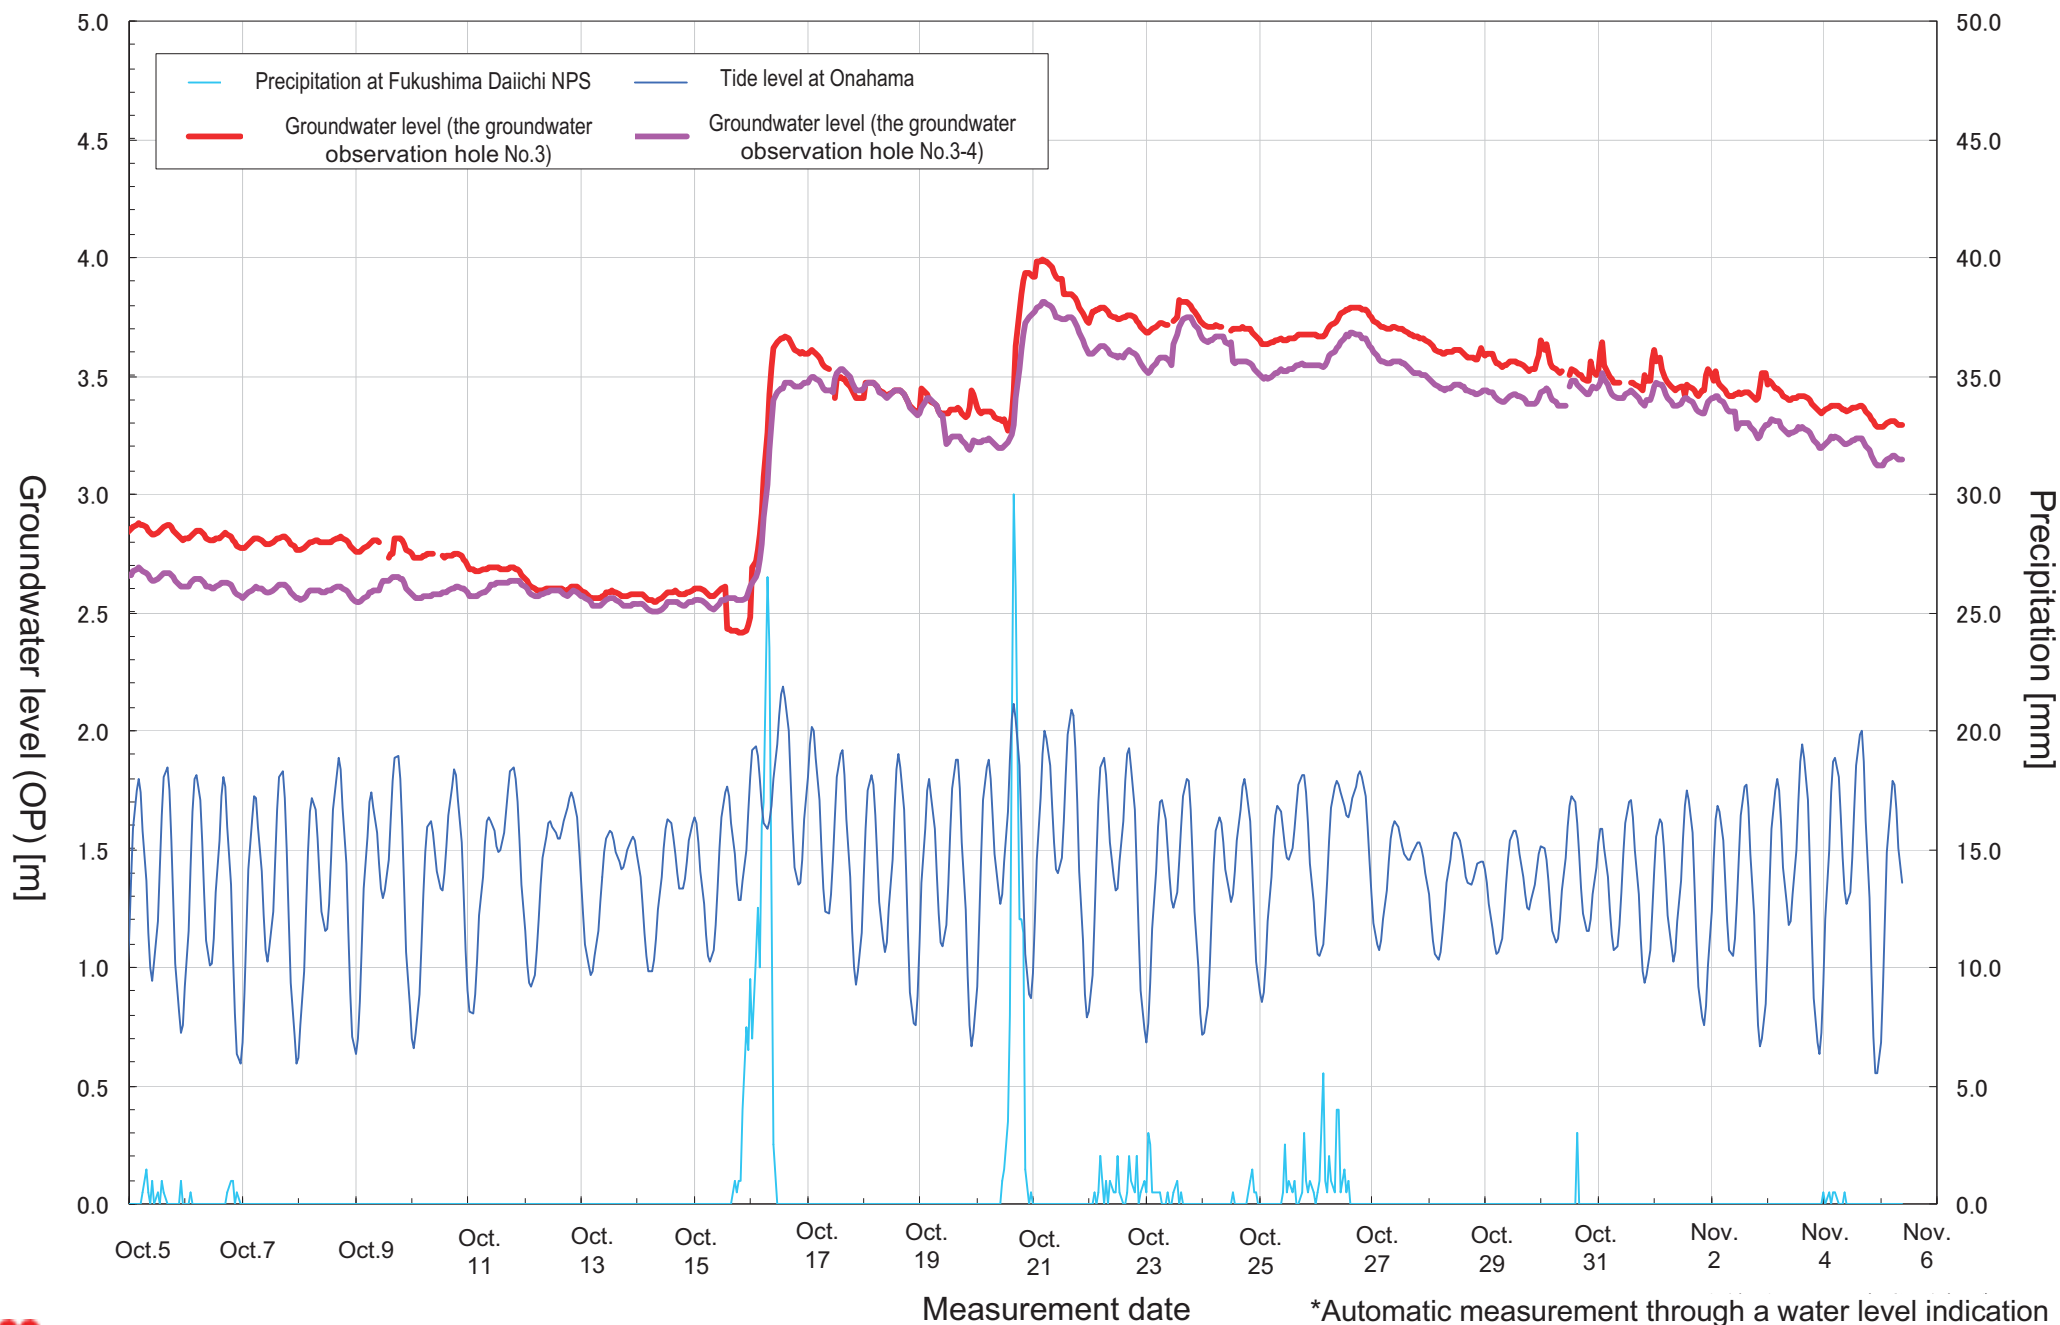
# Movement in groundwater (Between Unit 3 and 4: From Oct. 5 to Nov. 5)

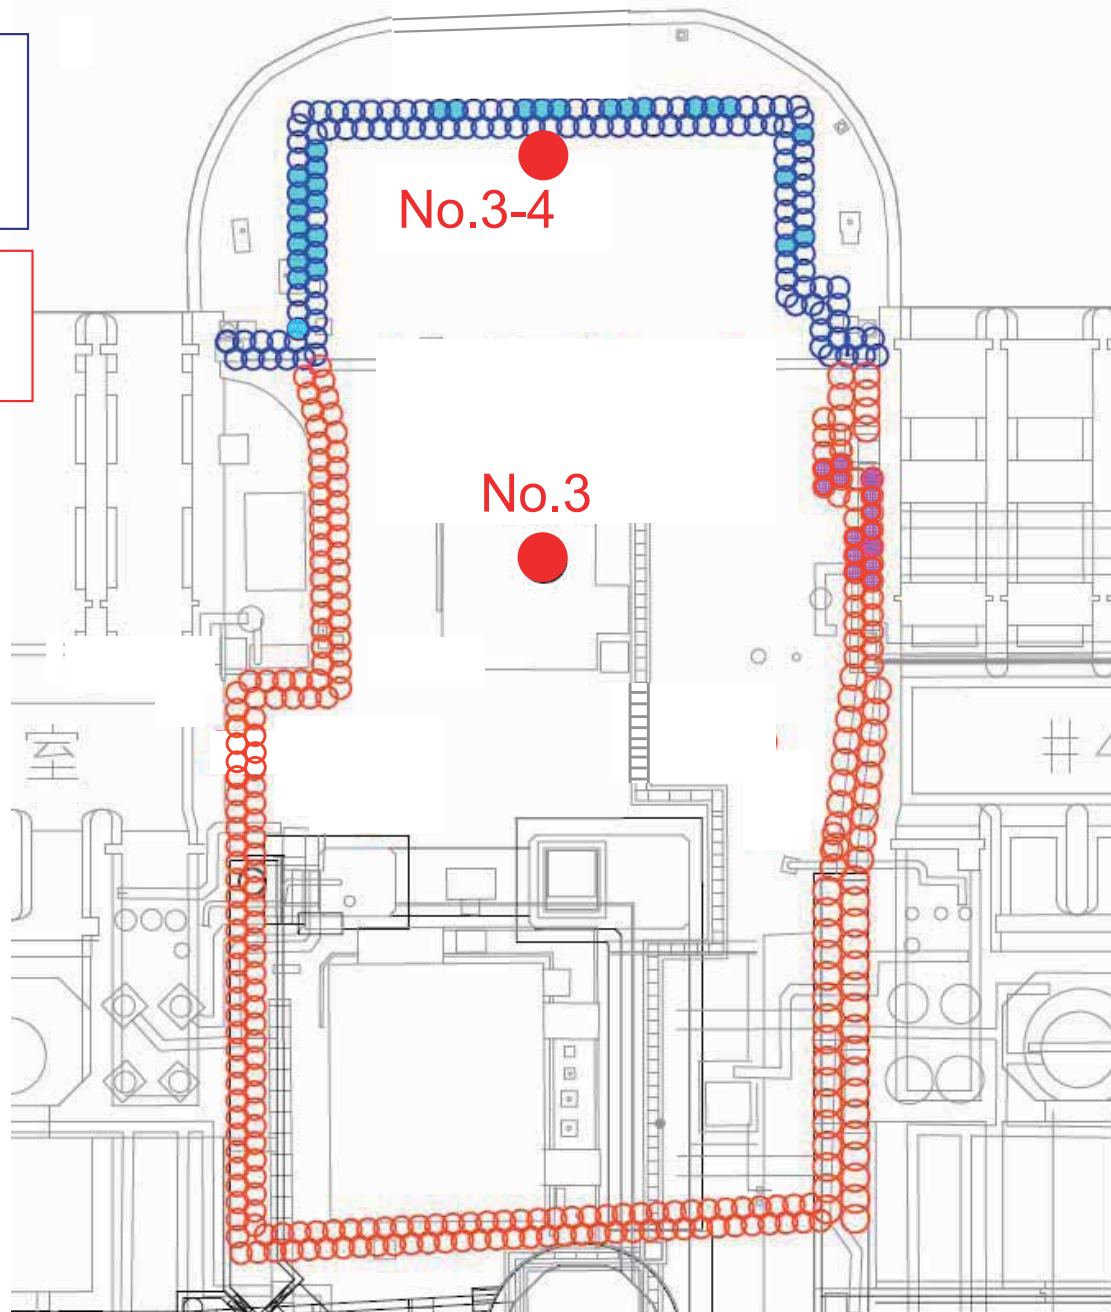
# Progress in the ground improvement work between Unit 3 and 4 (As of in the morning on November 6)

Ground improvement (sea side):  
up to 30 out of 132  
(Since Aug. 23, 2013)

Ground improvement (mountain side):  
up to 14 out of 273  
(Since Oct. 19, 2013)
