The seawall area at Fukushima Daiichi NPS

<Reference>
 November 11, 2013
 Tokyo Electric Power Company

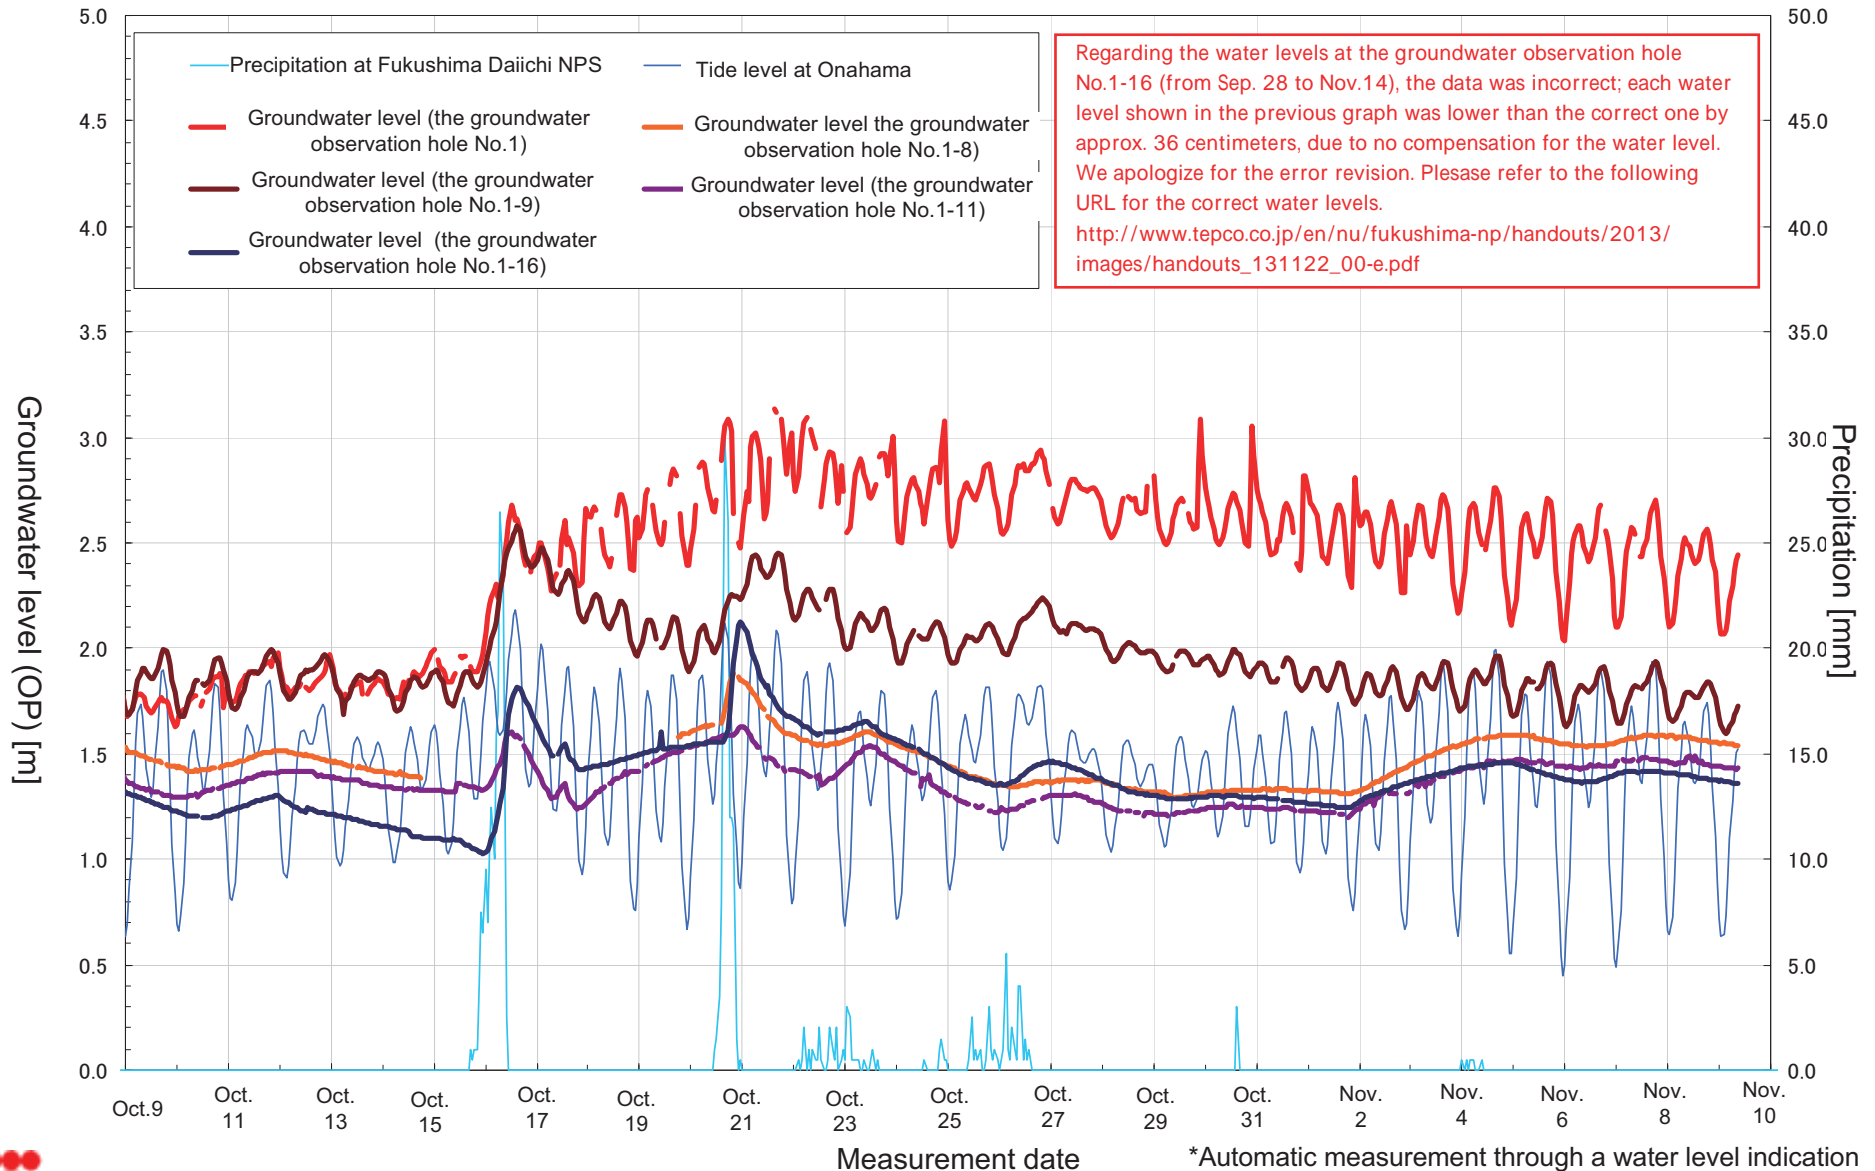
Movement in groundwater (Between Unit 1 and 2: From Oct. 9 to Nov. 9)

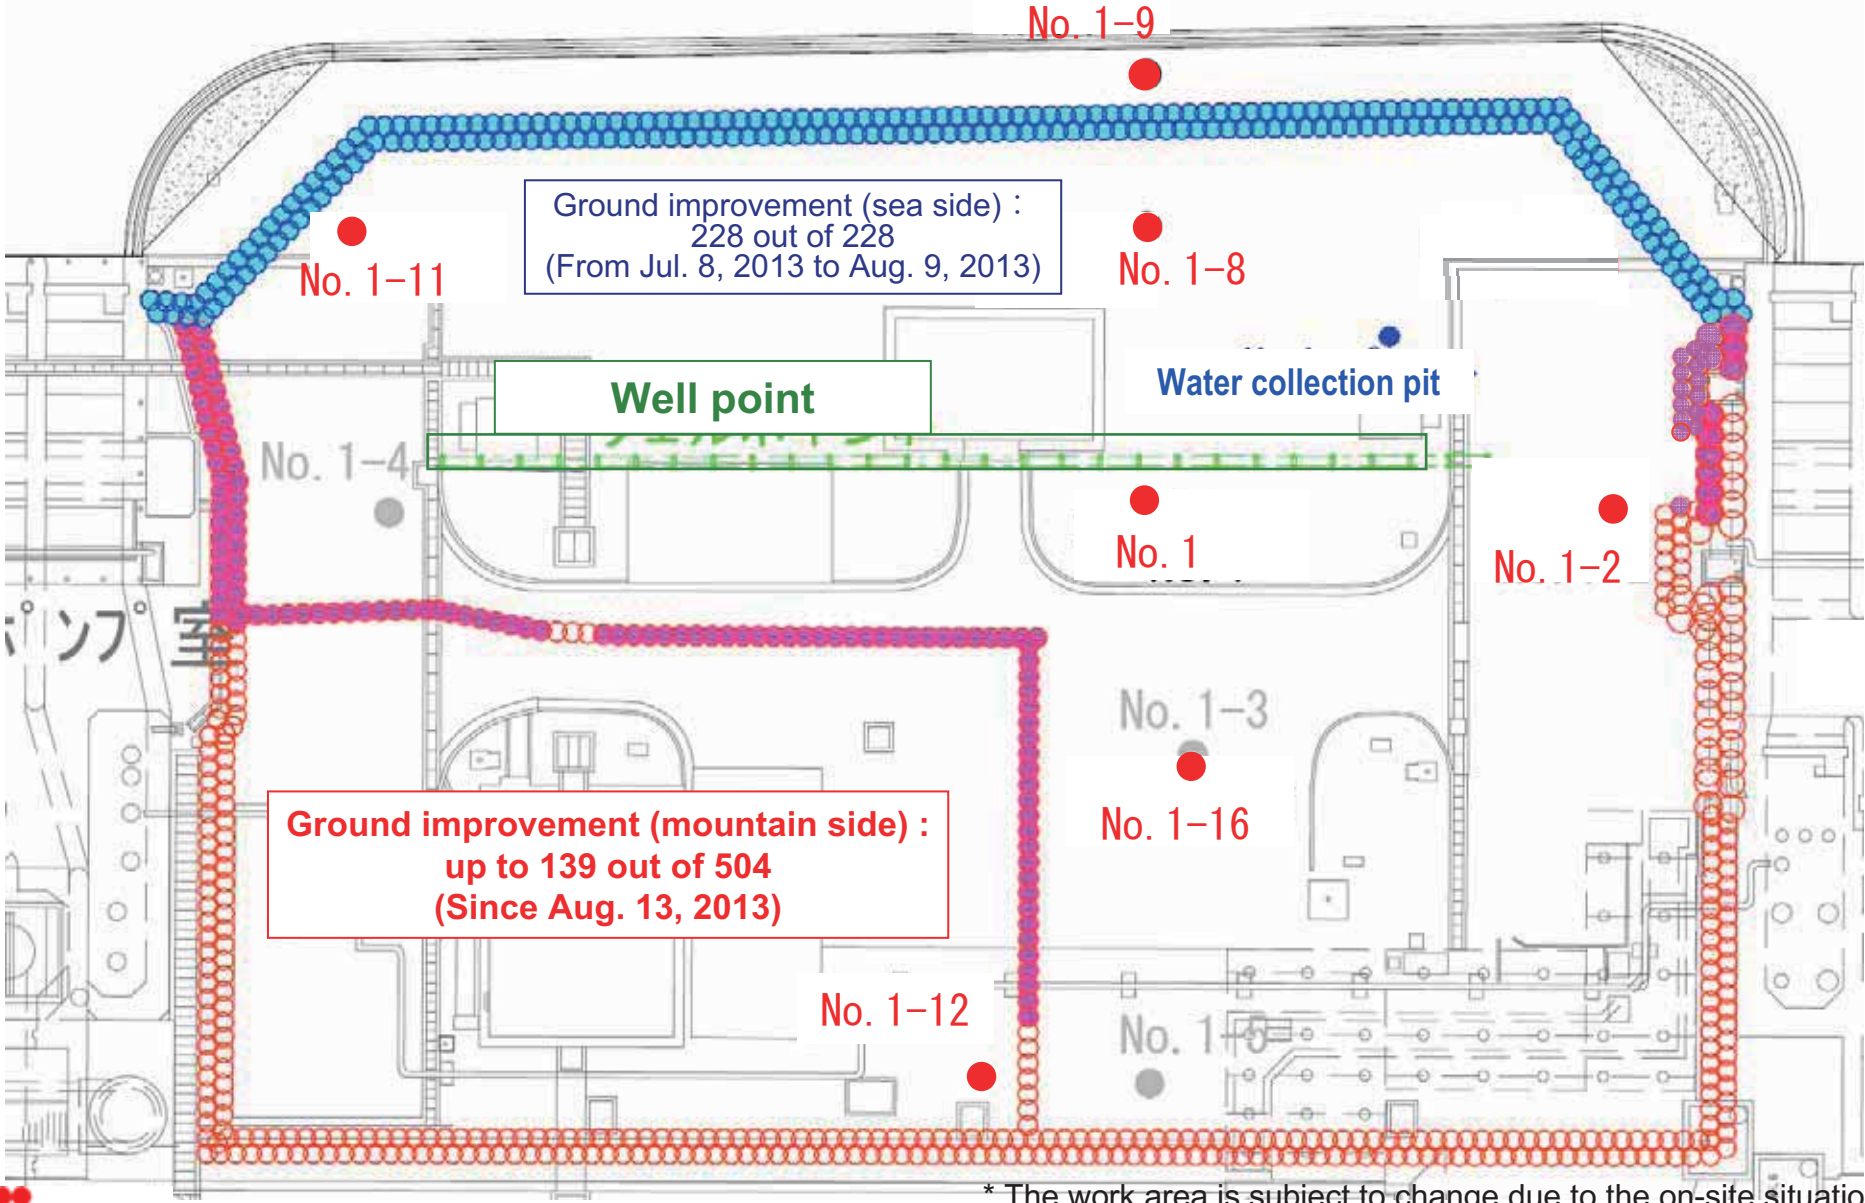
Progress in the ground improvement work between Unit 1 and 2 (As of in the morning on November 11)

* The work area is subject to change due to the on-site situation.

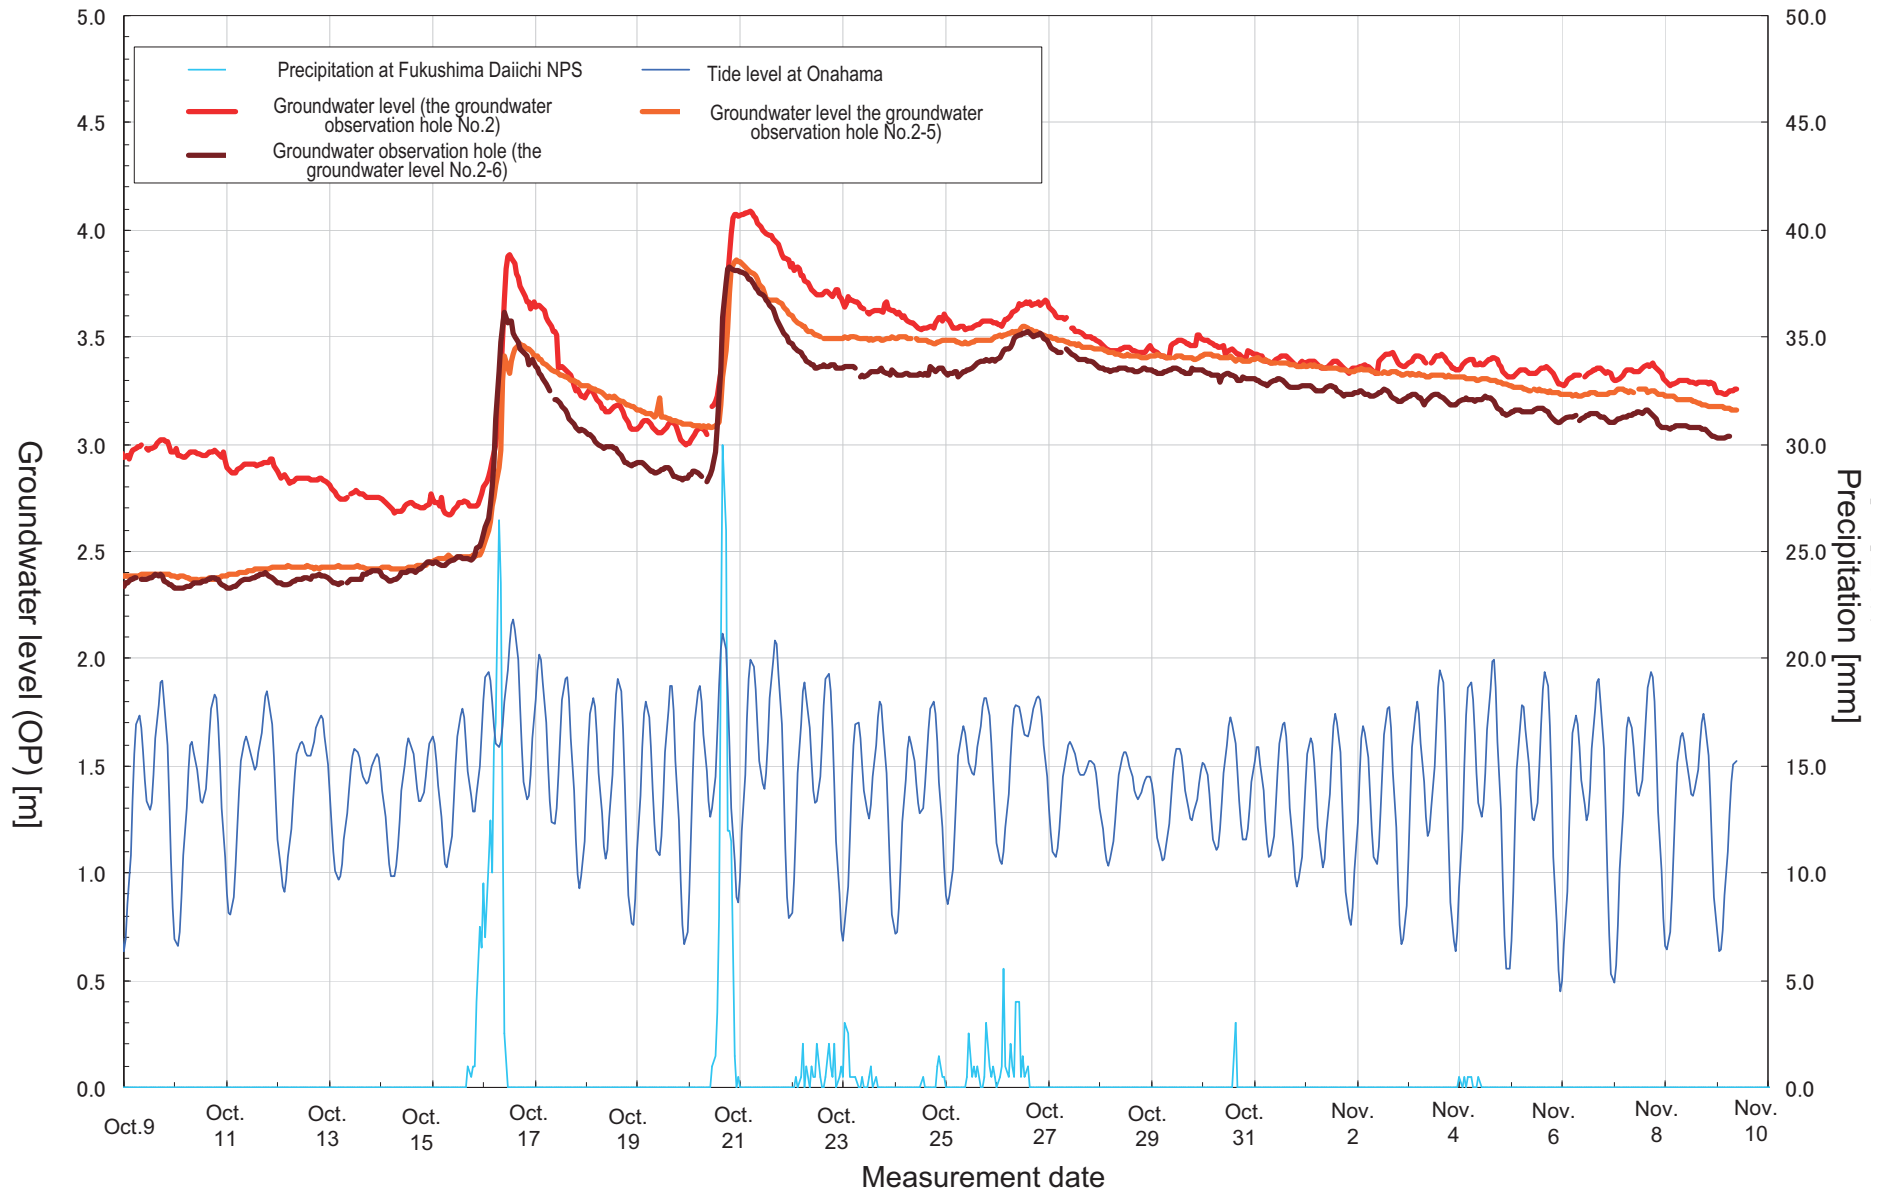
Movement in groundwater (Between Unit 2 and 3: From Oct. 9 to Nov. 9)

*Automatic measurement through a water level indication

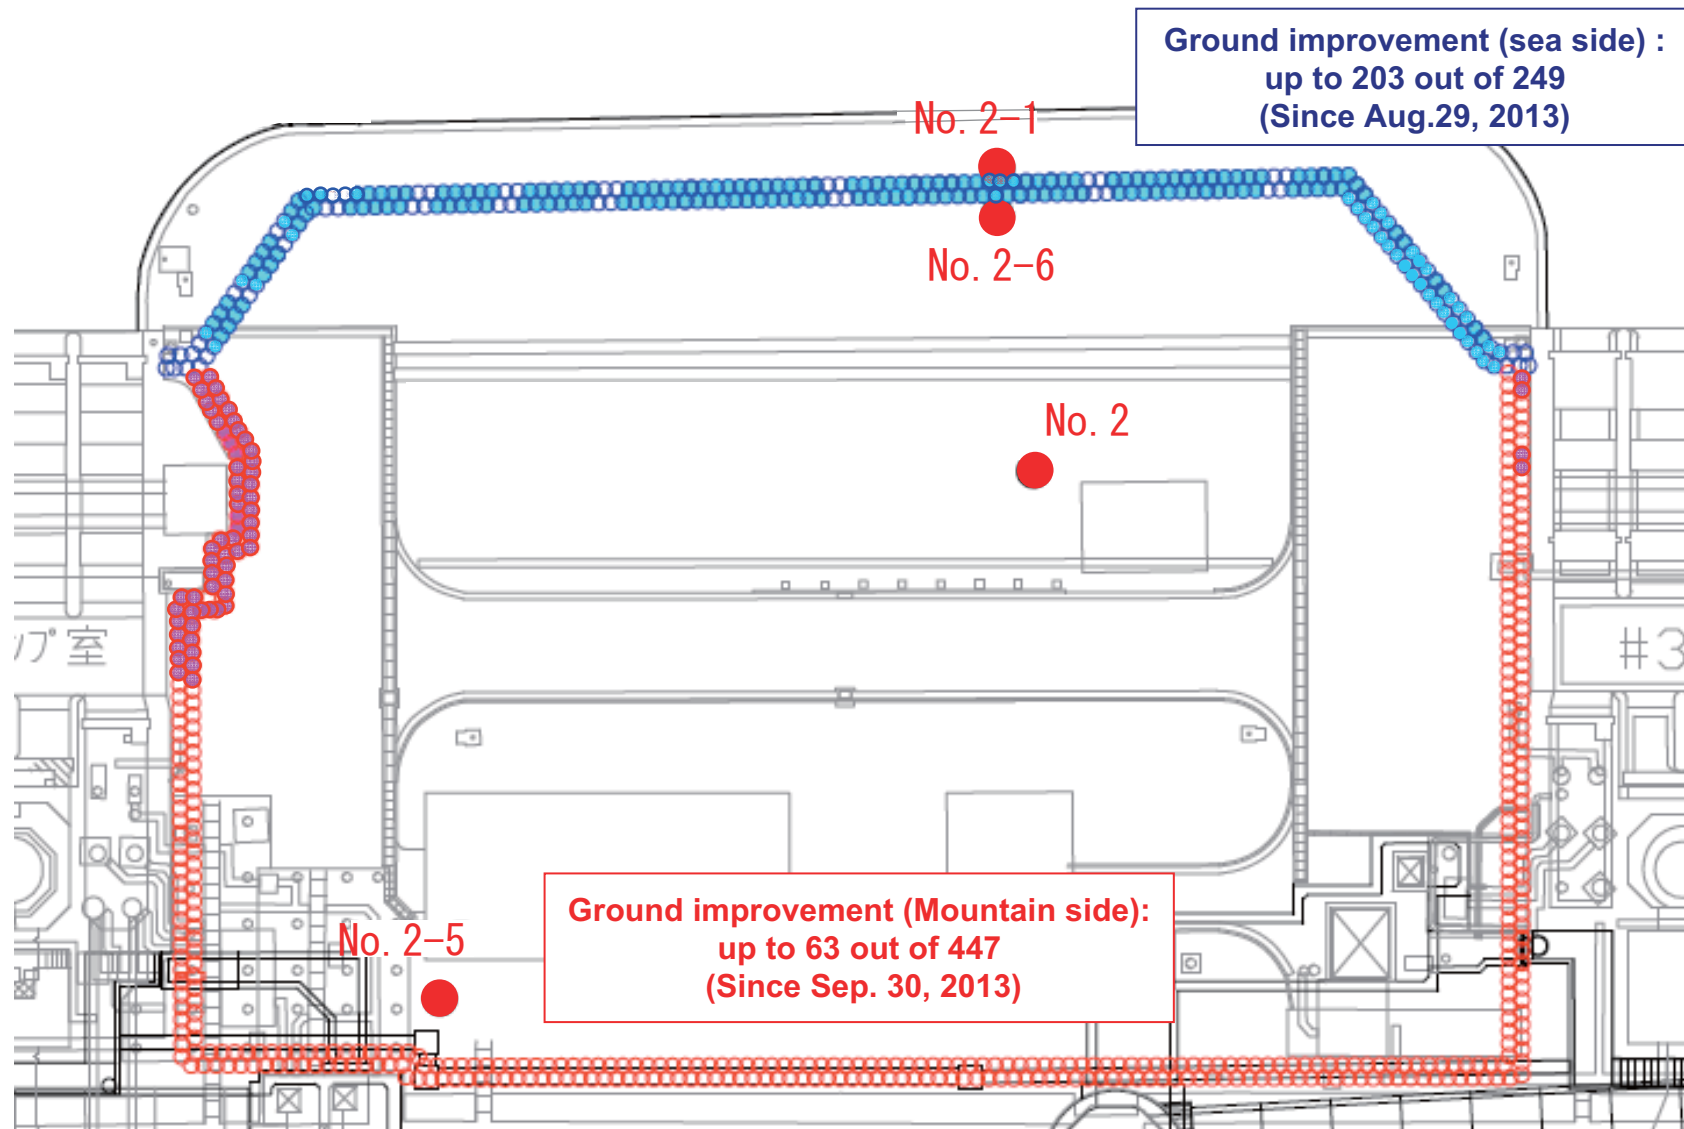
Progress in the ground improvement work between Unit 2 and 3 (As of in the morning on November 11)

* The work area is subject to change due to the on-site situation.

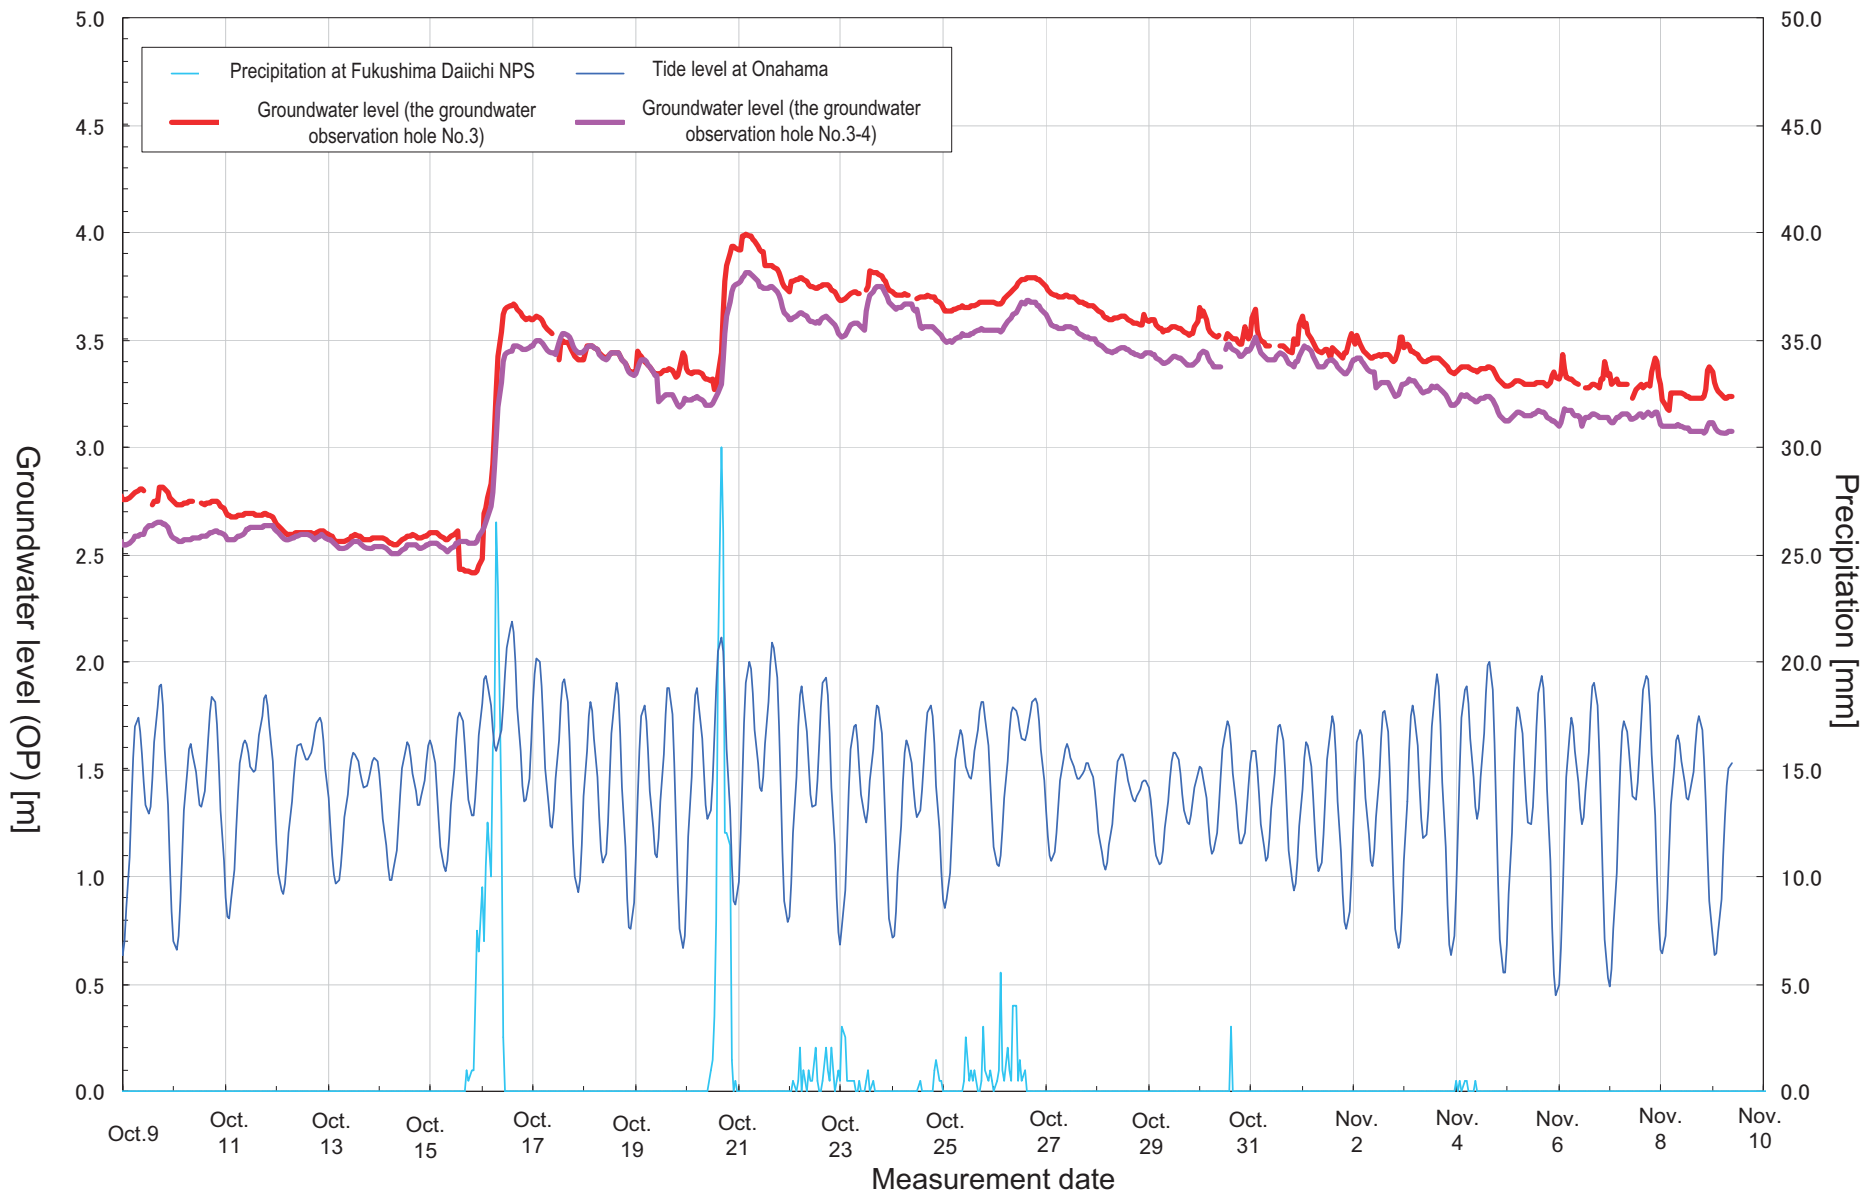
Movement in groundwater (Between Unit 3 and 4: From Oct. 9 to Nov. 9)

*Automatic measurement through a water level indication

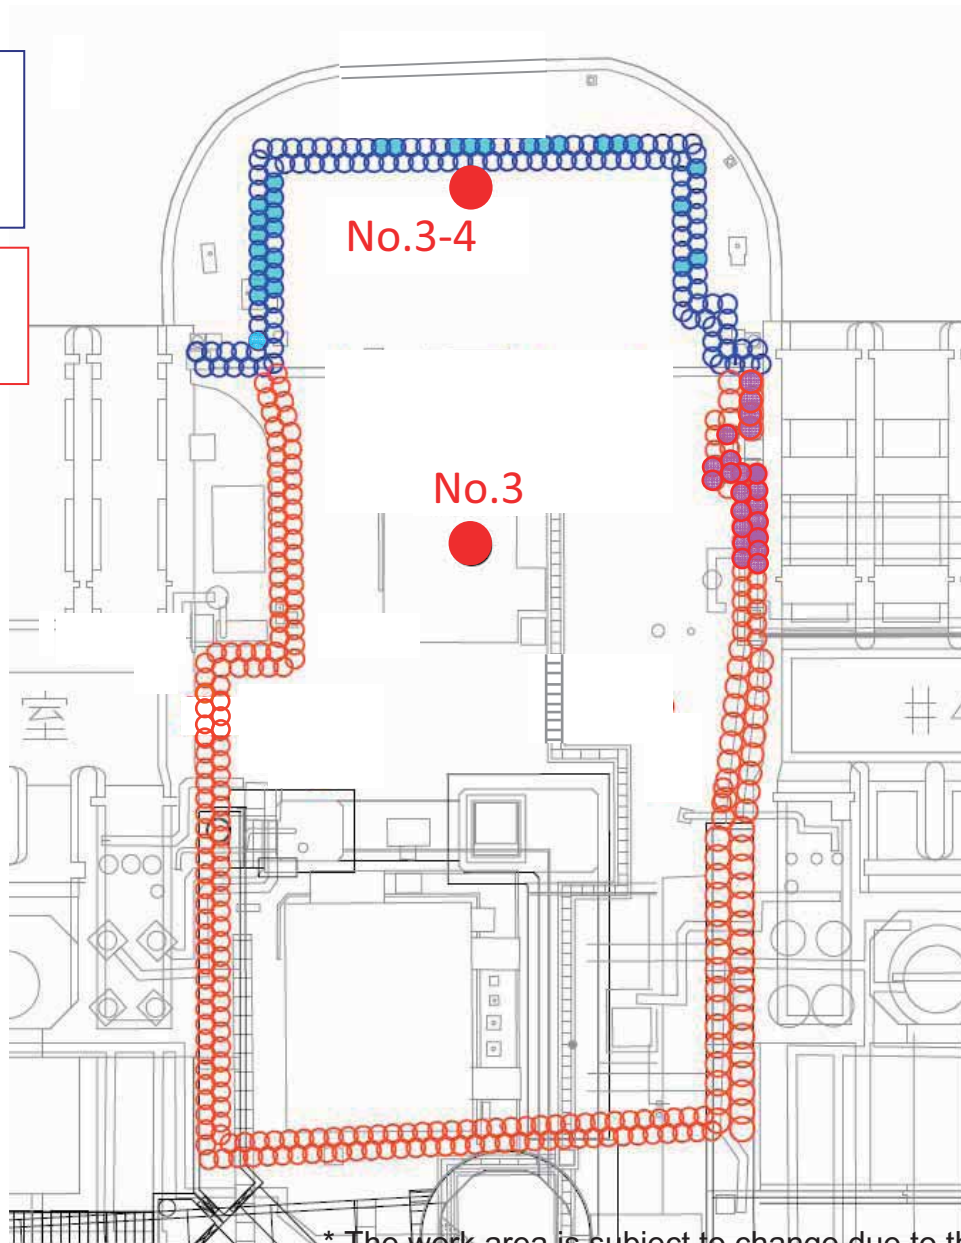
Progress in the ground improvement work between Unit 3 and 4 (As of in the morning on November 11)

Ground improvement (sea side):
up to 30 out of 132
(Since Aug. 23, 2013)

Ground improvement (mountain side):
up to 22 out of 273
(Since Oct. 19, 2013)

* The work area is subject to change due to the on-site situation.
