Water Leak from the Flange Part of the G6 South Area Tank (Steel Cylindrical Tank)

<Reference>
November 15, 2013
Tokyo Electric Power Company

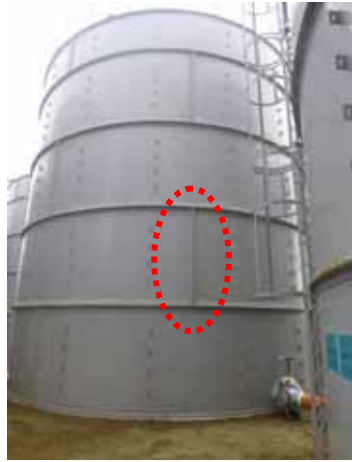
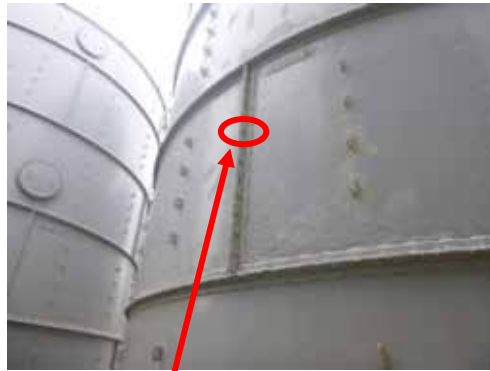
Location where the leakage was found

- Time when the incident was found: At around 8:50 AM on November 15, 2013
- Person who found the incident: An associated company worker
- Location where the leakage was found: The second joint part (flange part) from the bottom of the G6-C3 steel cylindrical tank in the G6-south area
- Chronological Order

- At around 8:50 AM: An associated company worker found water was leaking from the side plate flange of the G6-C3 tank.
- At around 9:20 AM: TEPCO employee arrived the site and found water was leaking from the vertical flange of the side plate (approx. 3m from the floor).
- At around 10:00 AM: Survey, water level measurement and water sampling were performed at the location where the leakage was found.
- At around 11:30 AM: Leakage was stopped after bolts were tightened. A receiving pan was installed at the bottom part of the leakage location just in case. No abnormality was found on this flange part after tightening of the bolts.

Status of the Site

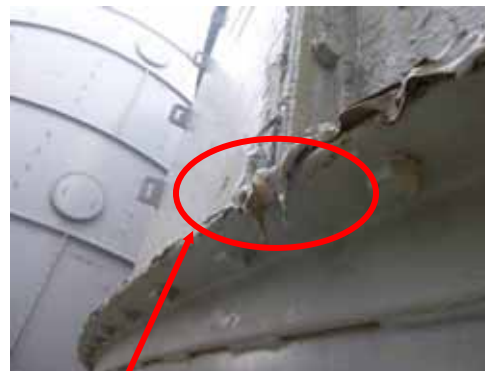
Dropped water

- Dose measurement result at the horizontal flange part where dropped water accumulated:
 - 35mSv/h ($\gamma + \beta$ (70 μ m dose equivalent rate)) (5cm distant)
 - 0.03mSv/h (γ ray) (5cm distant)
- Water level measurement result
 - G6-C3: 52cm from the top plate
 - G6-C2: 52cm from the top plate
- Sampling result
 - Water inside the tank: Under analysis
 - Water inside the dike: All β : 5.2×10^3 Bq/L, Cs134: ND (13Bq/L), Cs137: ND (18Bq/L)
- Future response (tentative)
 - Leakage location will be checked by the regular patrol (4 times a day).
 - Since water was remained inside the dike (depth: 11cm) due to the typhoon, the water has been transferred to an empty tank in the G3 area since 3:59 PM (the transfer will be completed in 1 or 2 days).

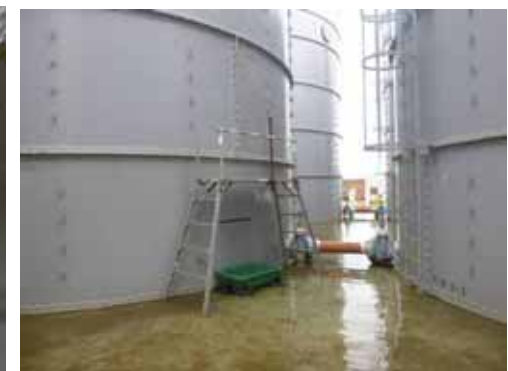
Installation of receiving pan
