Defect with Emergent Nitrogen Gas Separation Apparatus in Fukushima Daiichi NPS

<Reference>
November 20, 2013
Tokyo Electric Power Company

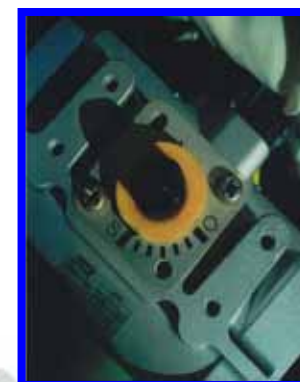
11:49 AM: When checking the can angle indicator of an air actuating ball valve, he found the indicator showing 'full closed', though it is supposed to show 'full open'

Can angle indicator indicating 'full closed'

11:05 AM: We started a regular test with that valve 'full opened'

11:40 AM: We confirmed each parameter (No abnormality for flow rate etc.)

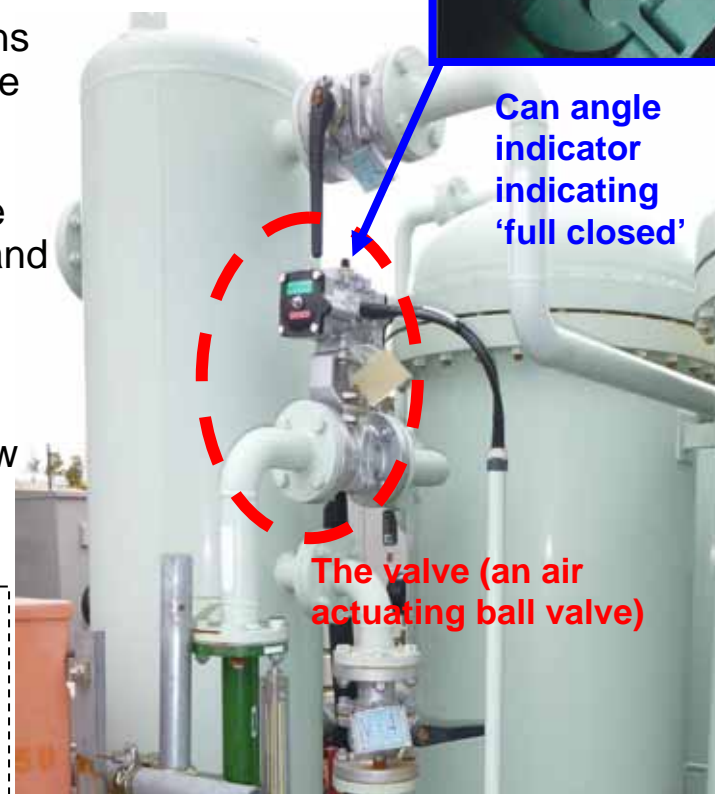
The valve (an air actuating ball valve)

Emergent nitrogen gas separation apparatus

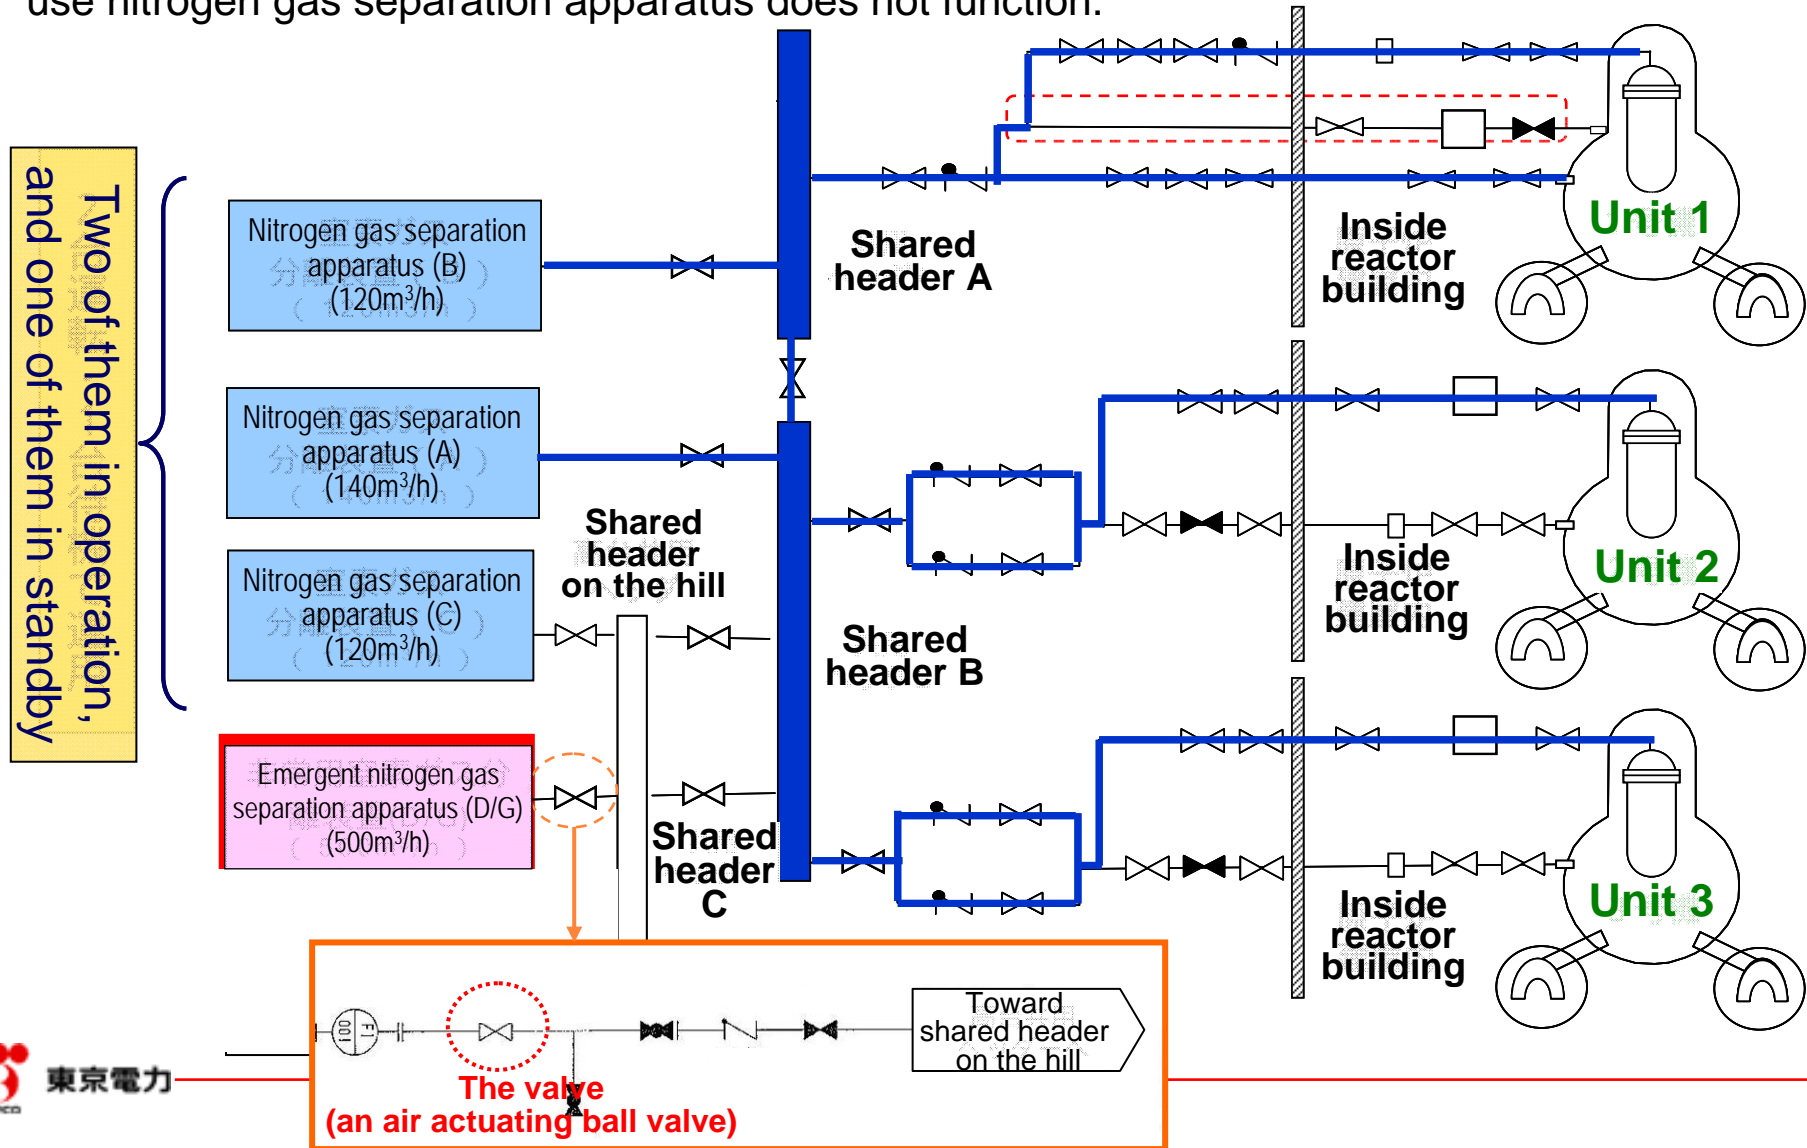
Nitrogen Filled Equipment (Schematic Diagram)

A person on a duty confirms the emergent nitrogen gas separation apparatus functions in a monthly surveillance, and it refers to an equipment which needs operating, in case a common-use nitrogen gas separation apparatus does not function.
