The seawall area at Fukushima Daiichi NPS

<Reference>
November 20, 2013
Tokyo Electric Power Company

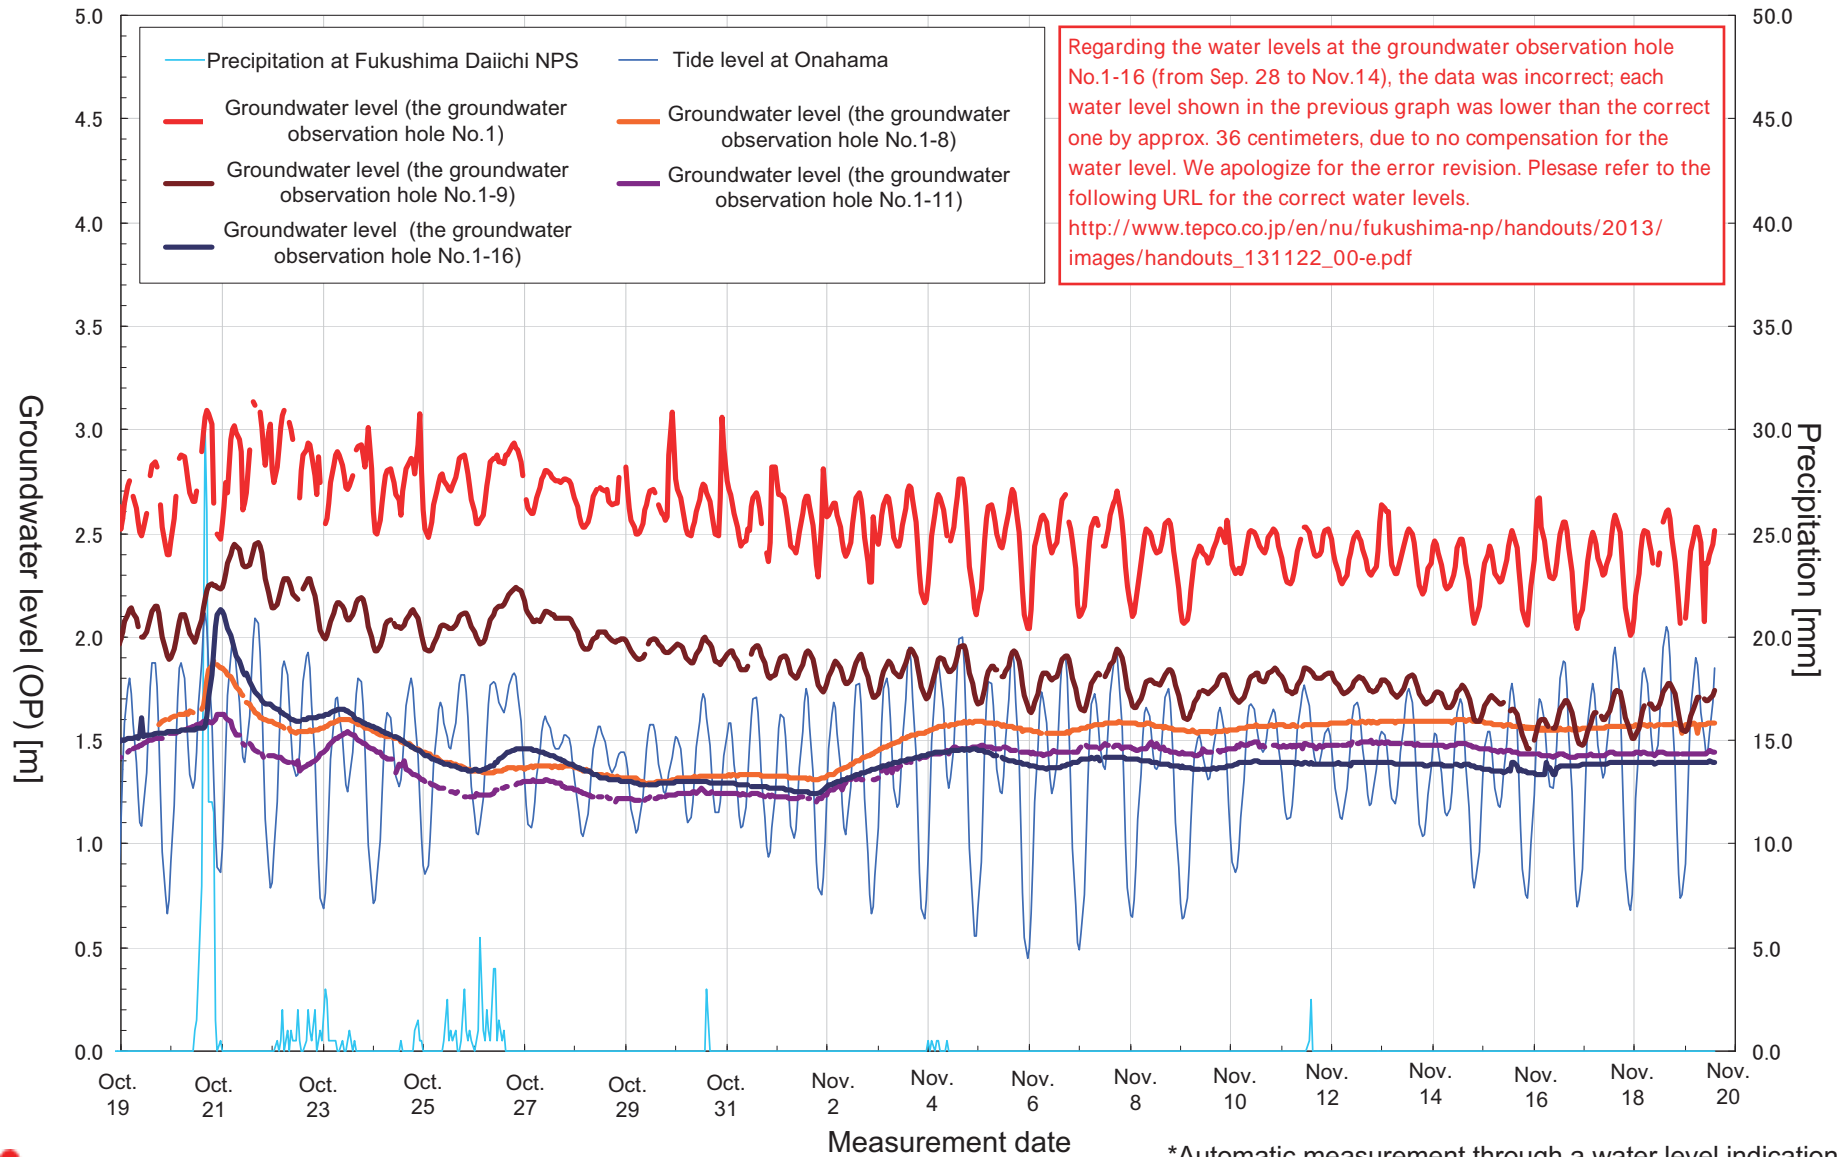
Movement in groundwater (Between Unit 1 and 2: From Oct. 19 to Nov. 19)

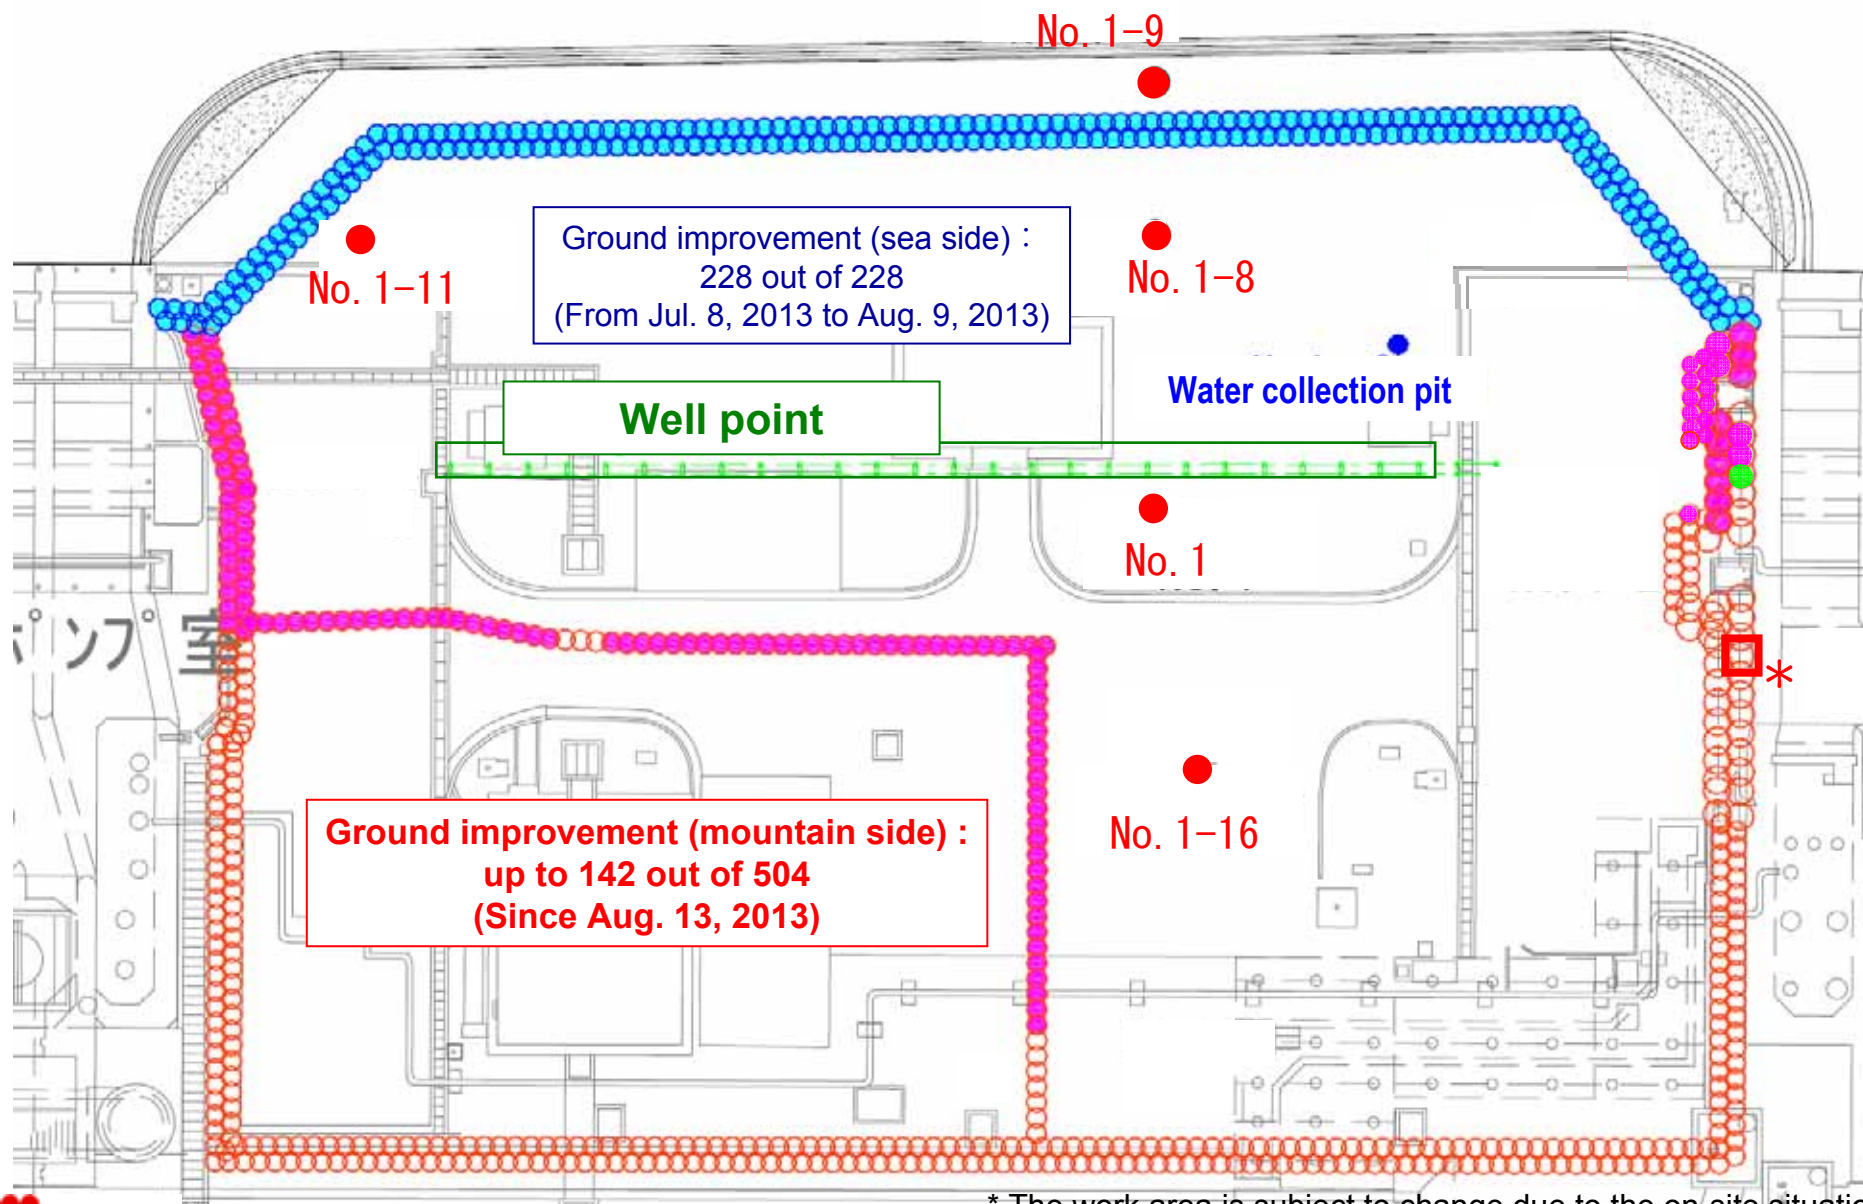
Progress in the ground improvement work between Unit 1 and 2 (As of in the morning on Nov. 20)

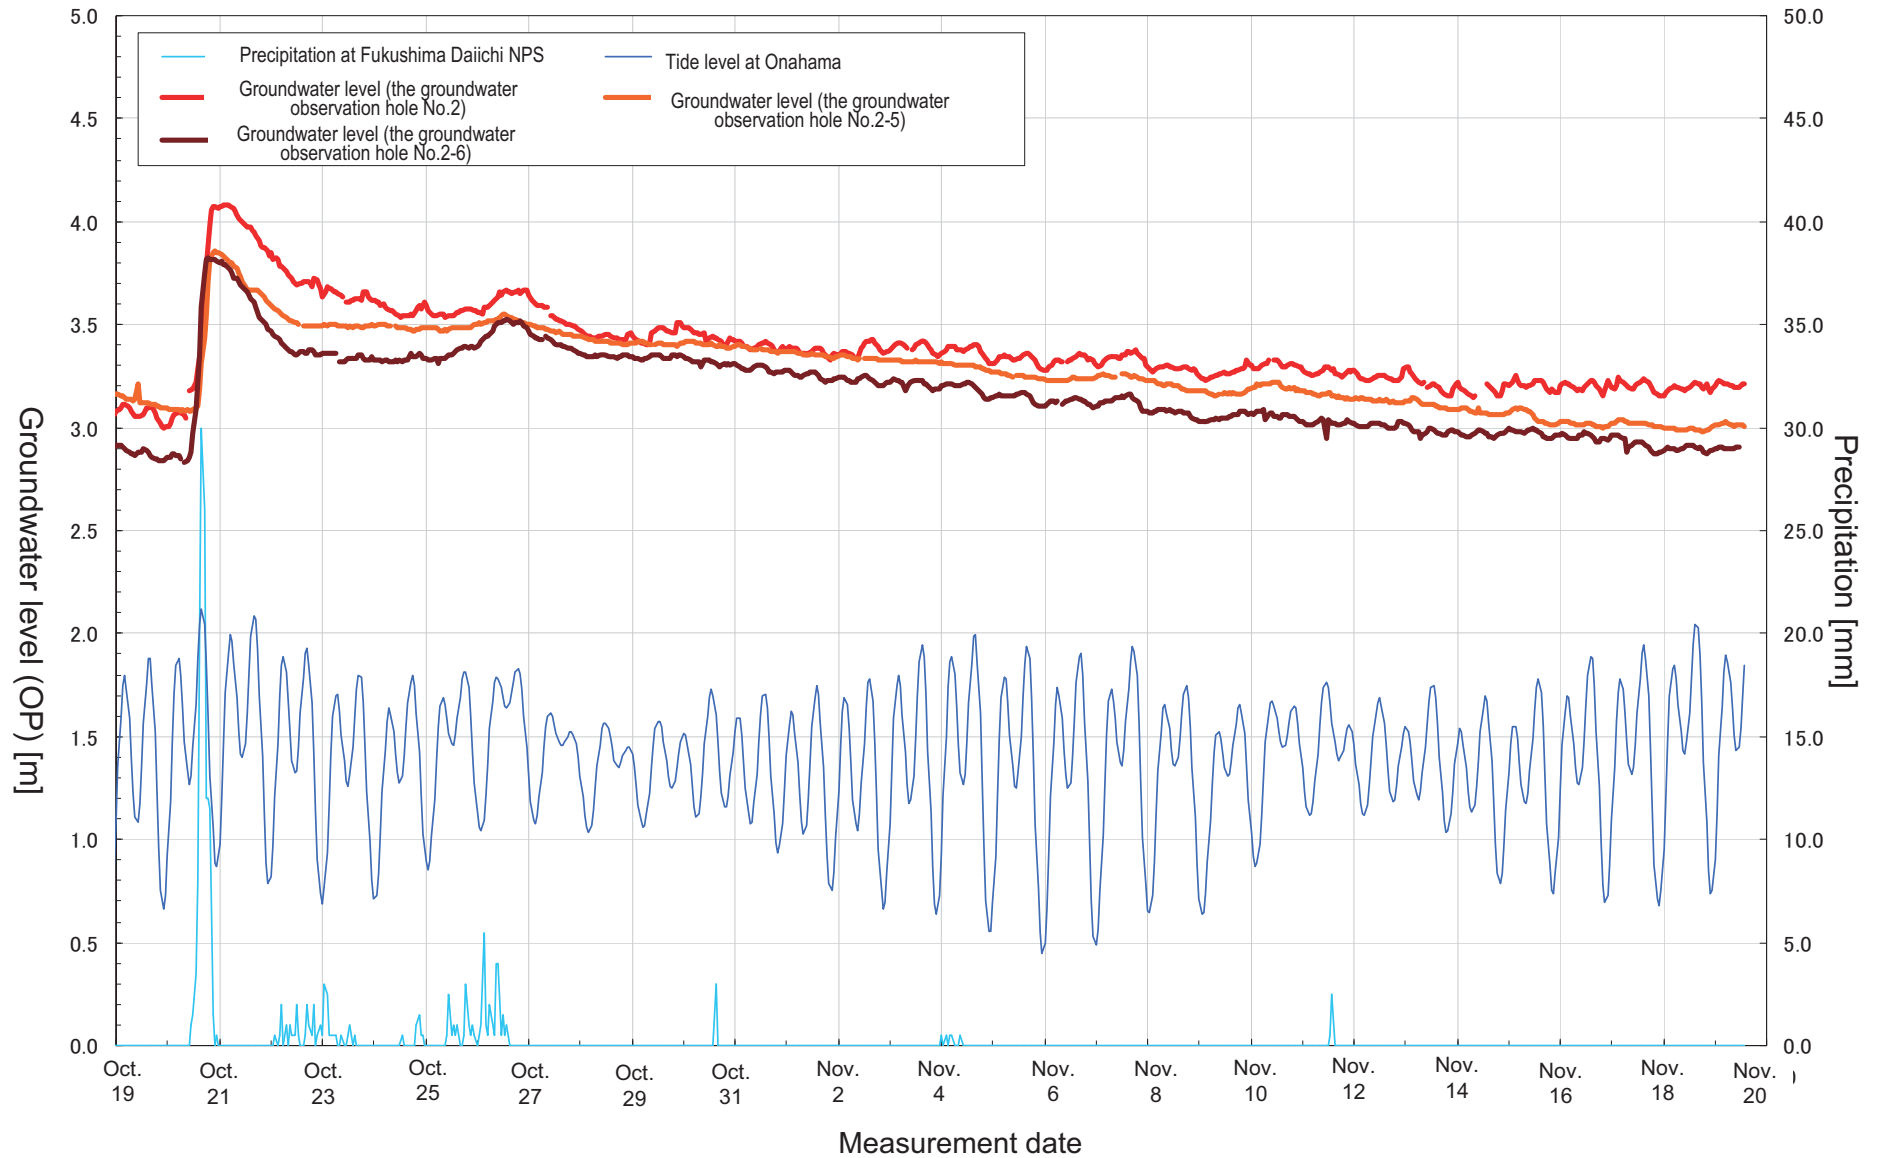
Movement in groundwater (Between Unit 2 and 3: From Oct. 19 to Nov. 19)

*Automatic measurement through a water level indication

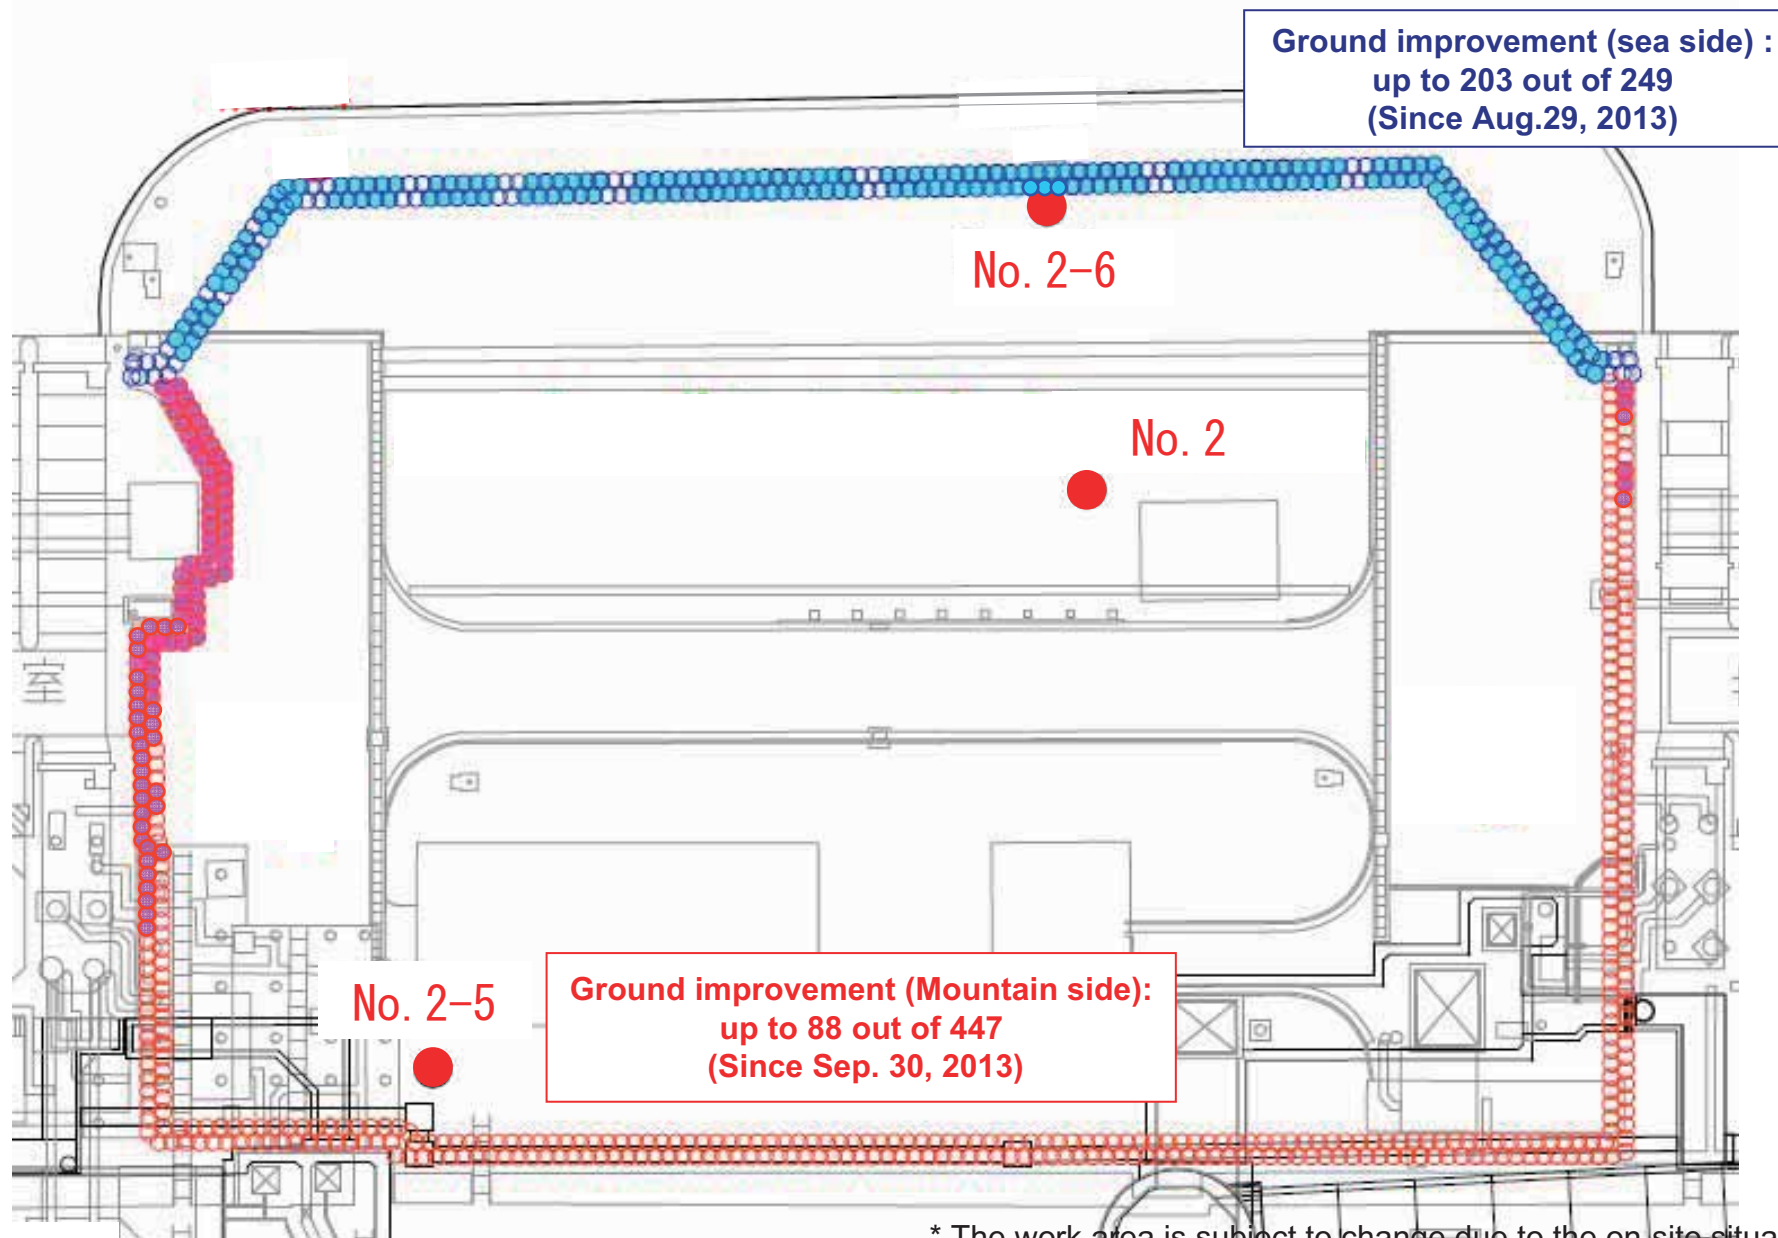
Progress in the ground improvement work between Unit 2 and 3 (As of in the morning on Nov. 20)

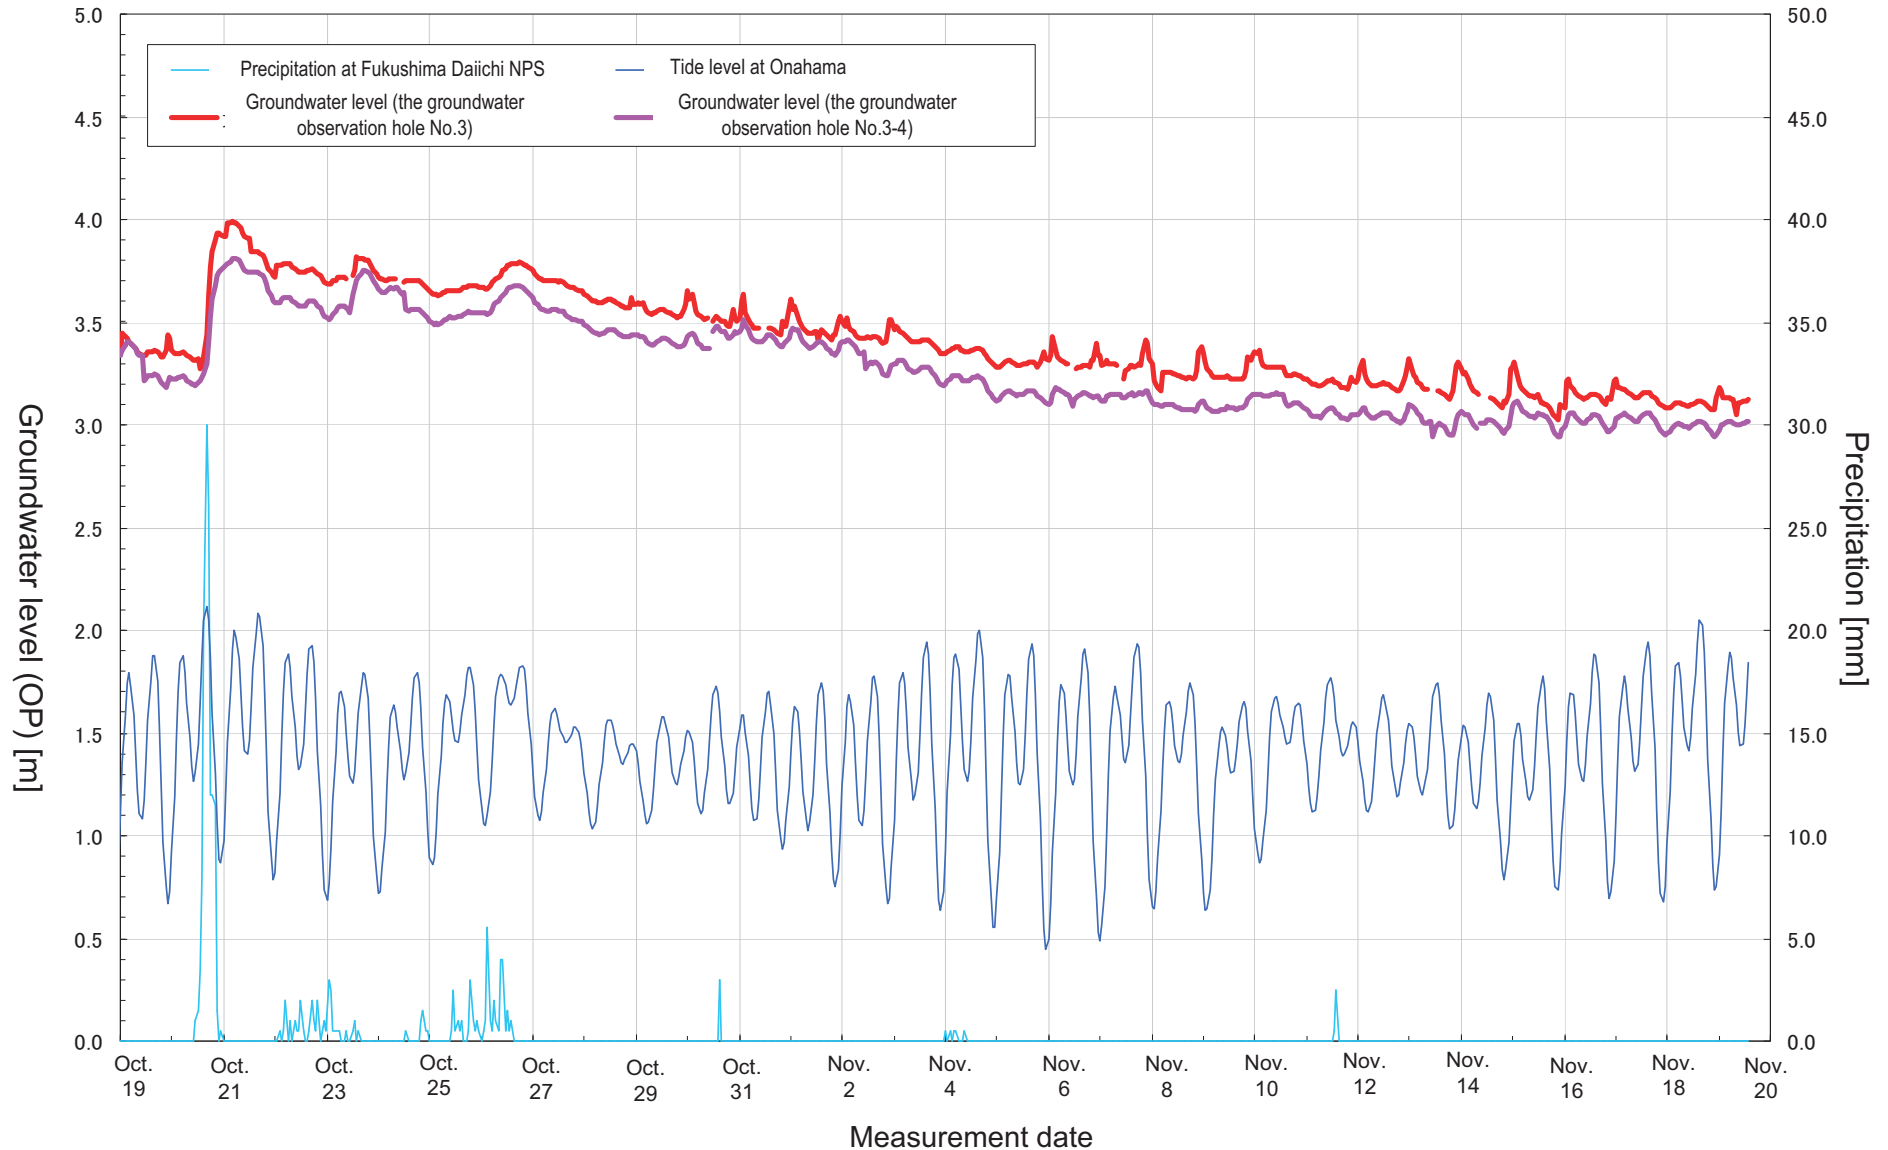
Movement in groundwater (Between Unit 3 and 4: From Oct. 19 to Nov. 19)

*Automatic measurement through a water level indication

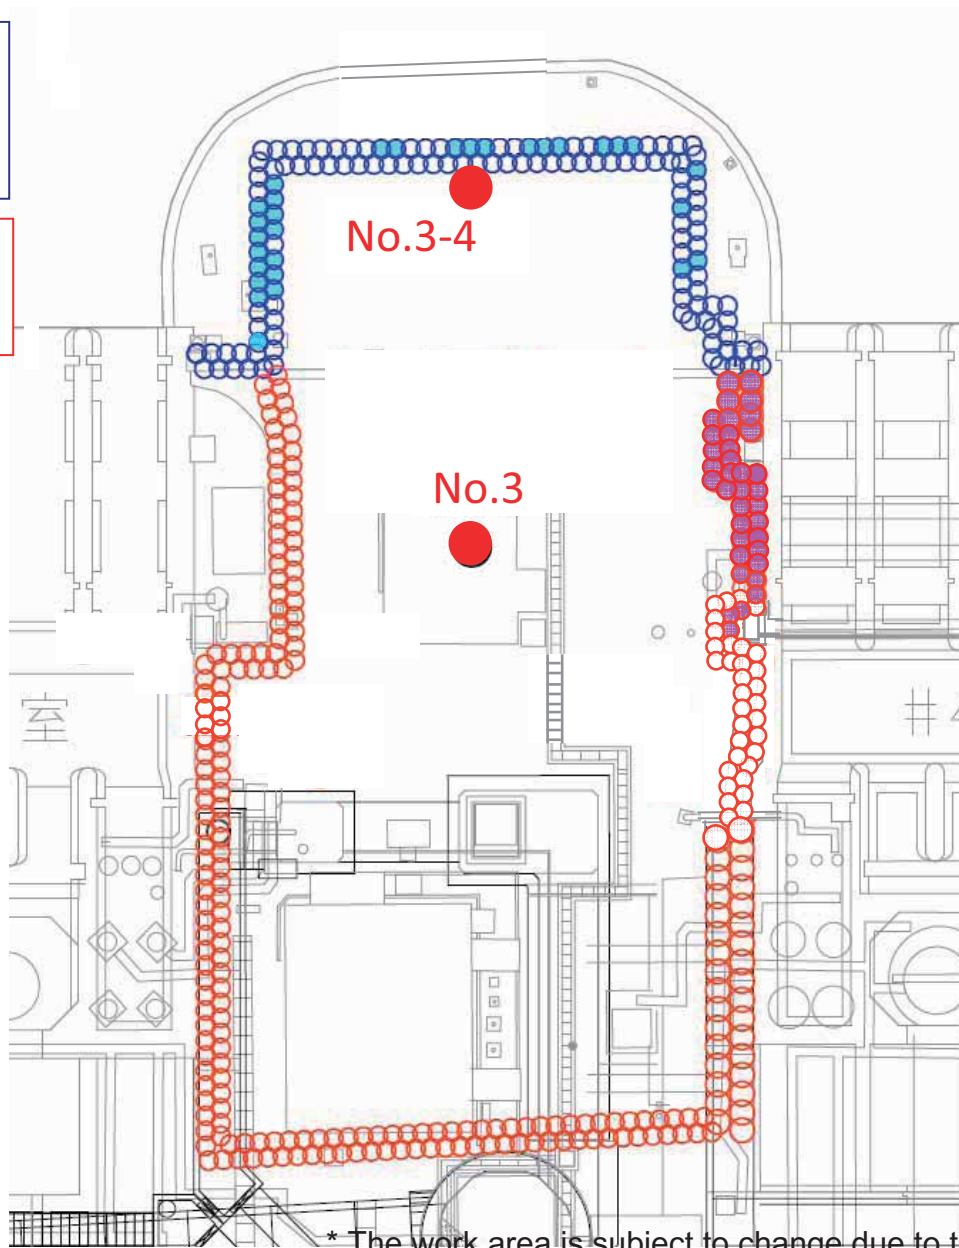
Progress in the ground improvement work between Unit 3 and 4 (As of in the morning on Nov. 20)

Ground improvement (sea side):
up to 30 out of 132
(Since Aug. 23, 2013)

Ground improvement (mountain side):
up to 36 out of 273
(Since Oct. 19, 2013)
