The seawall area at Fukushima Daiichi NPS

<Reference>
November 25, 2013
Tokyo Electric Power Company

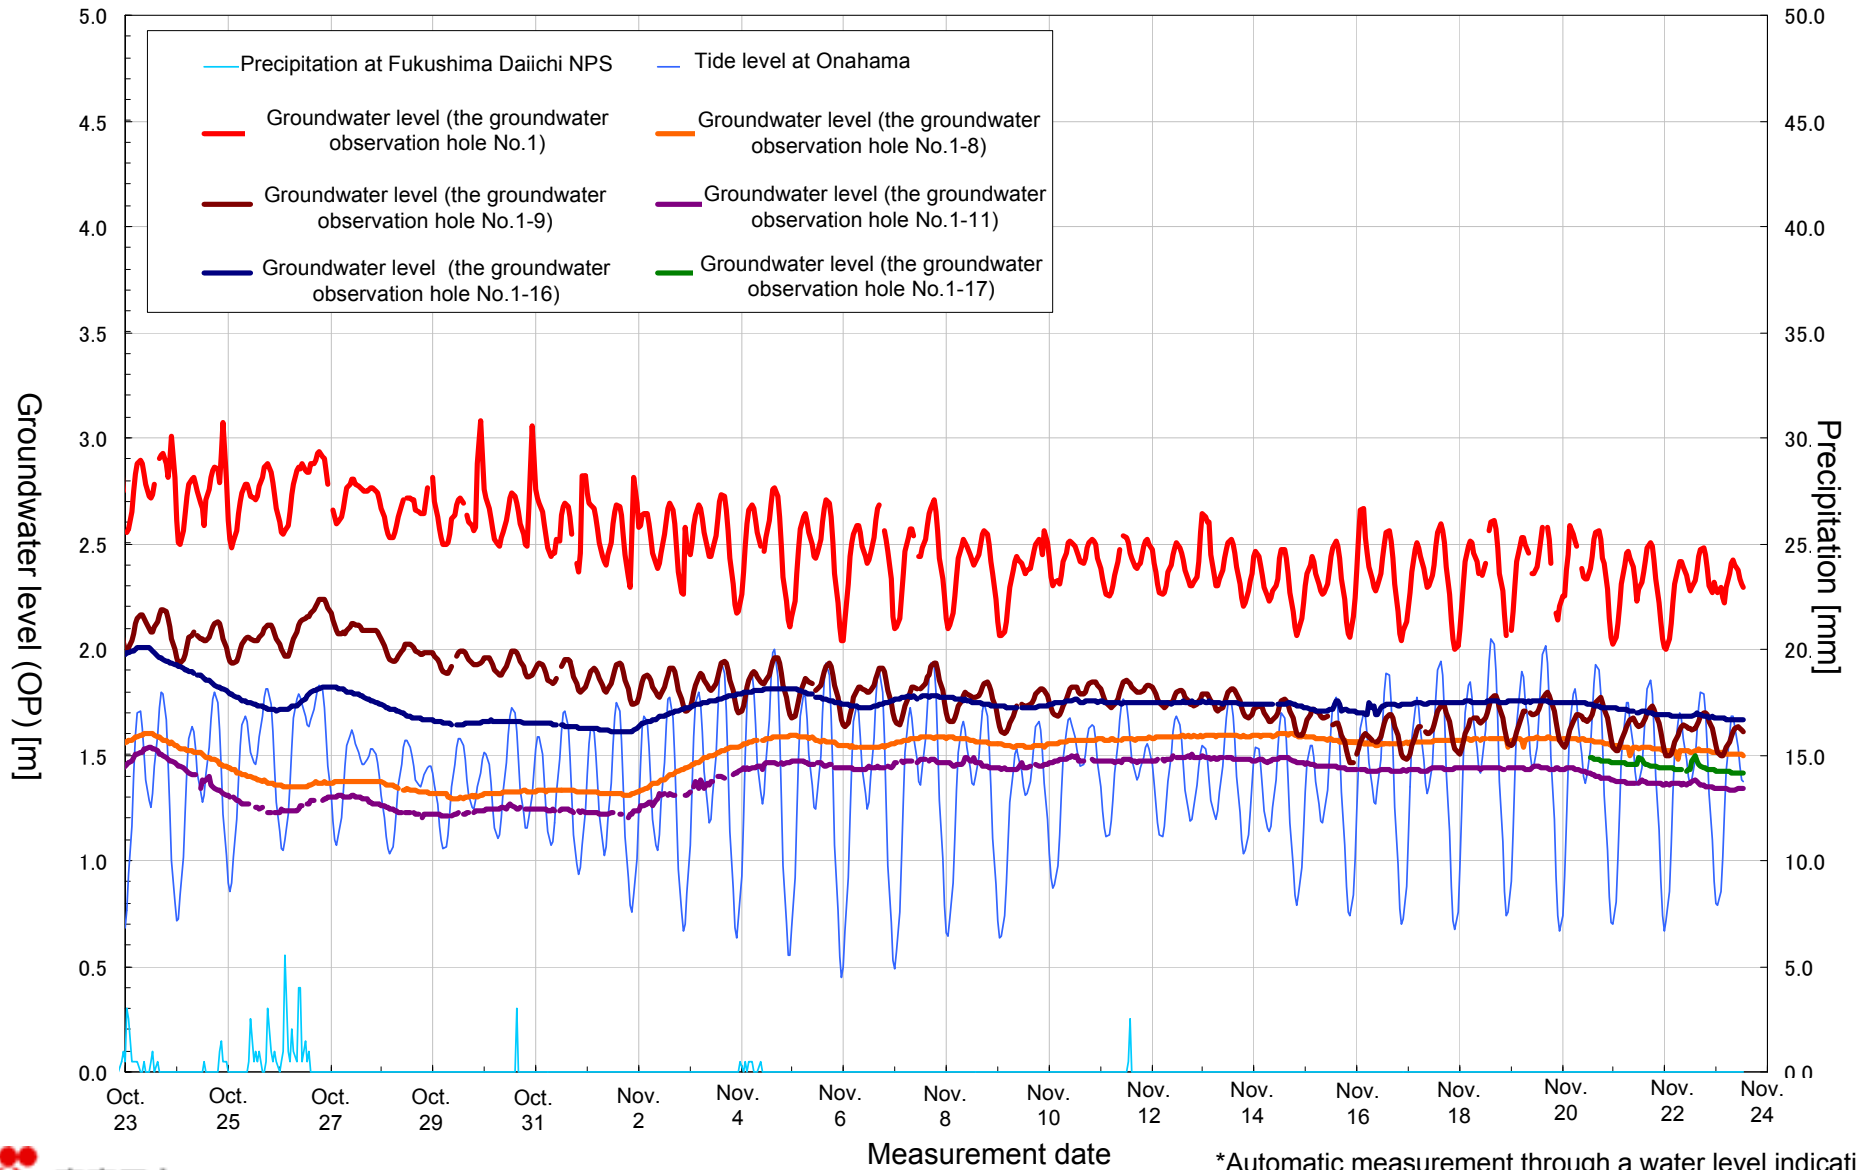
Movement in groundwater (Between Unit 1 and 2: From Oct. 23 to Nov. 23)

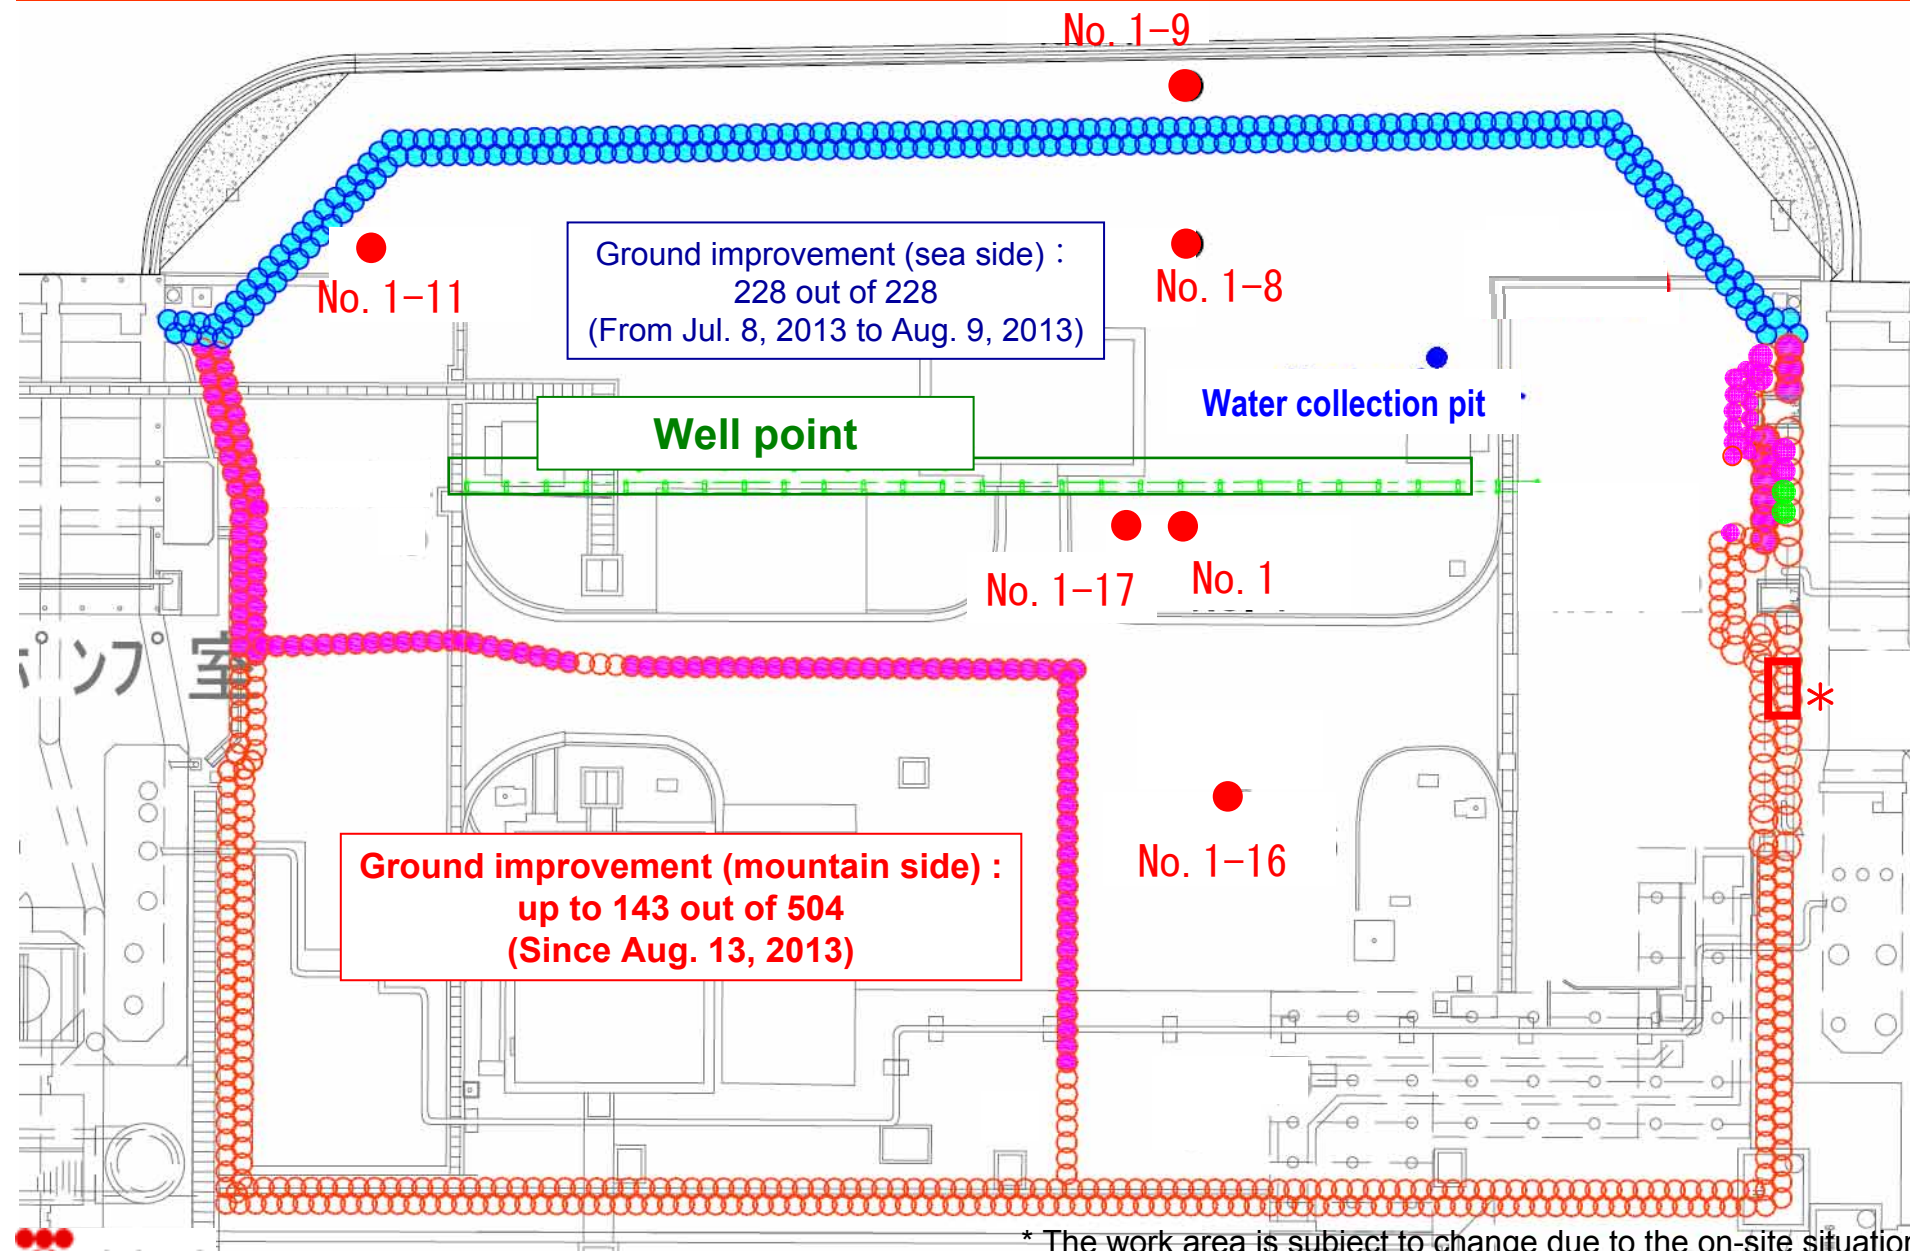
Progress in the ground improvement work between Unit 1 and 2 (As of in the morning on Nov. 25)

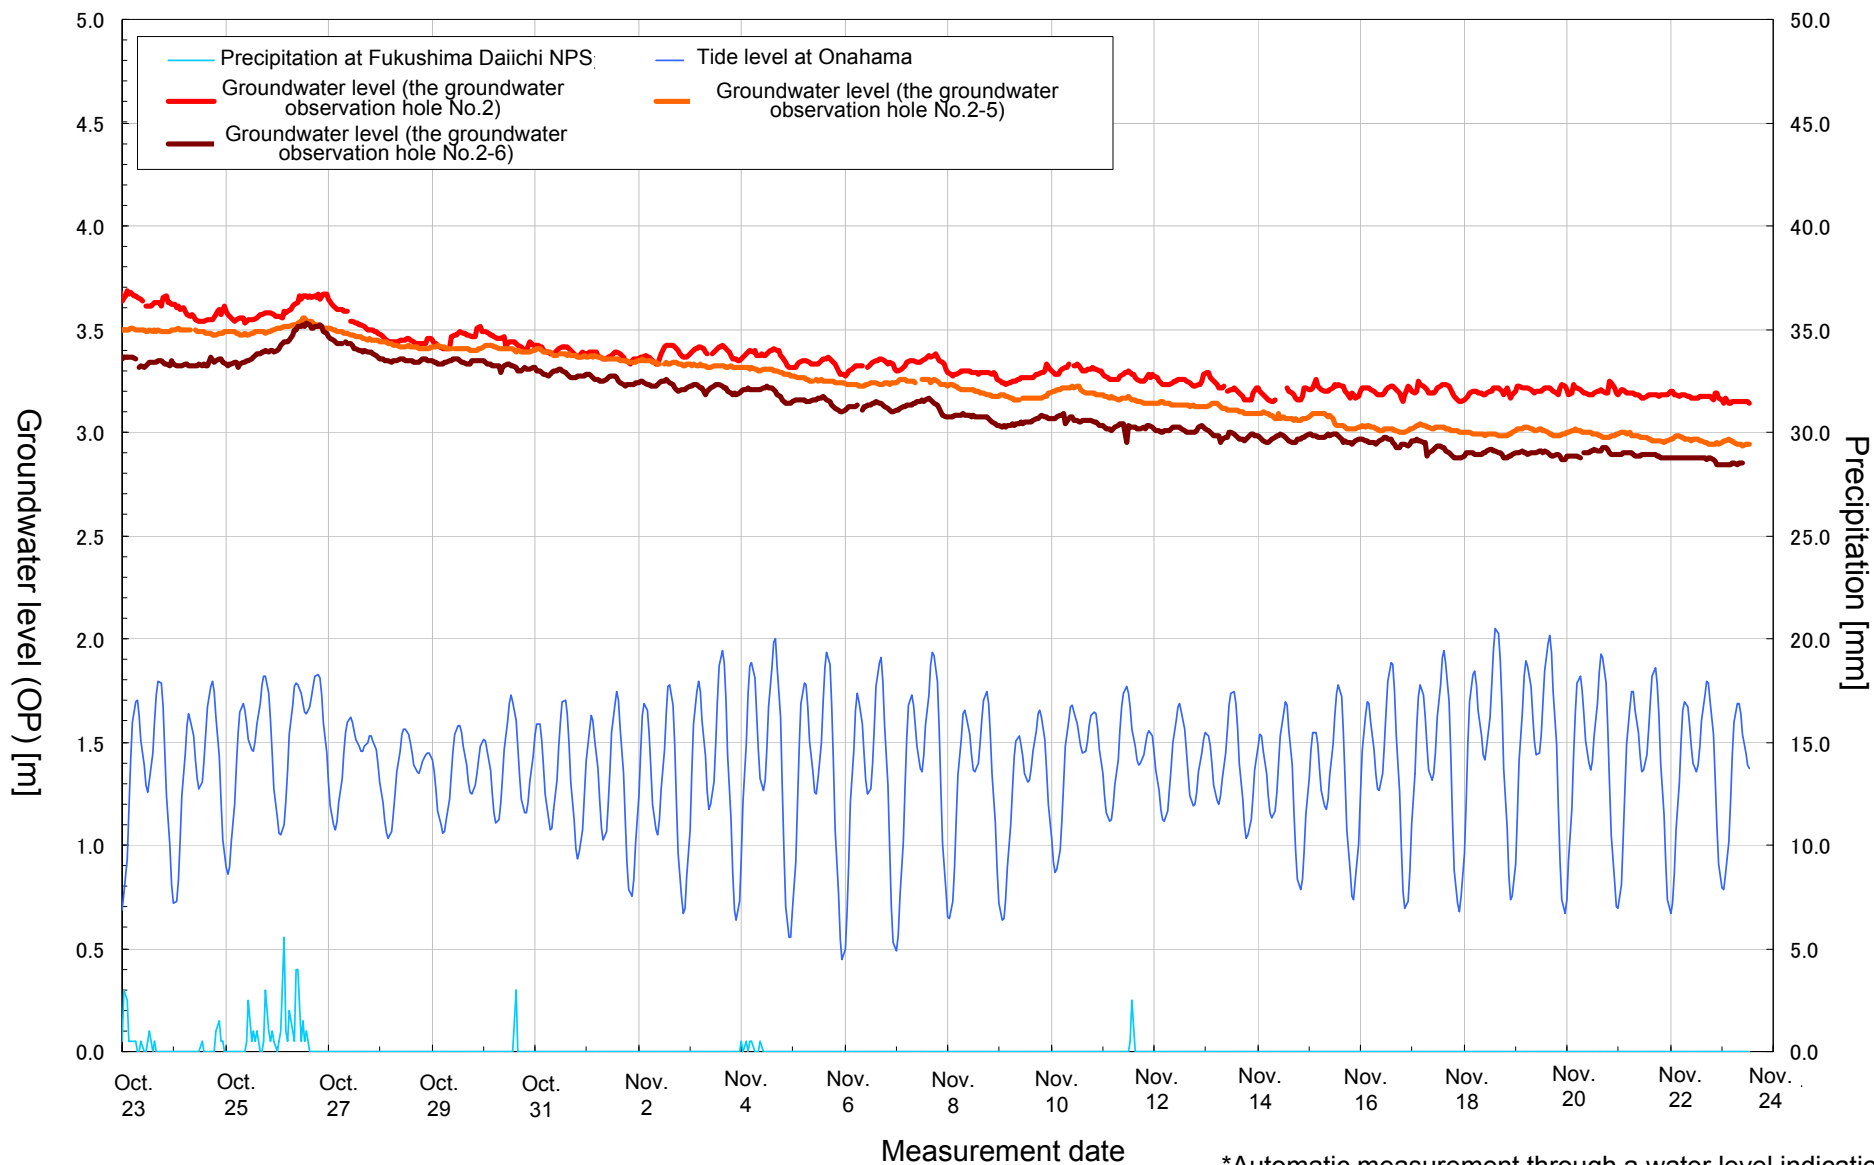
Movement in groundwater (Between Unit 2 and 3: From Oct. 23 to Nov. 23)

*Automatic measurement through a water level indication

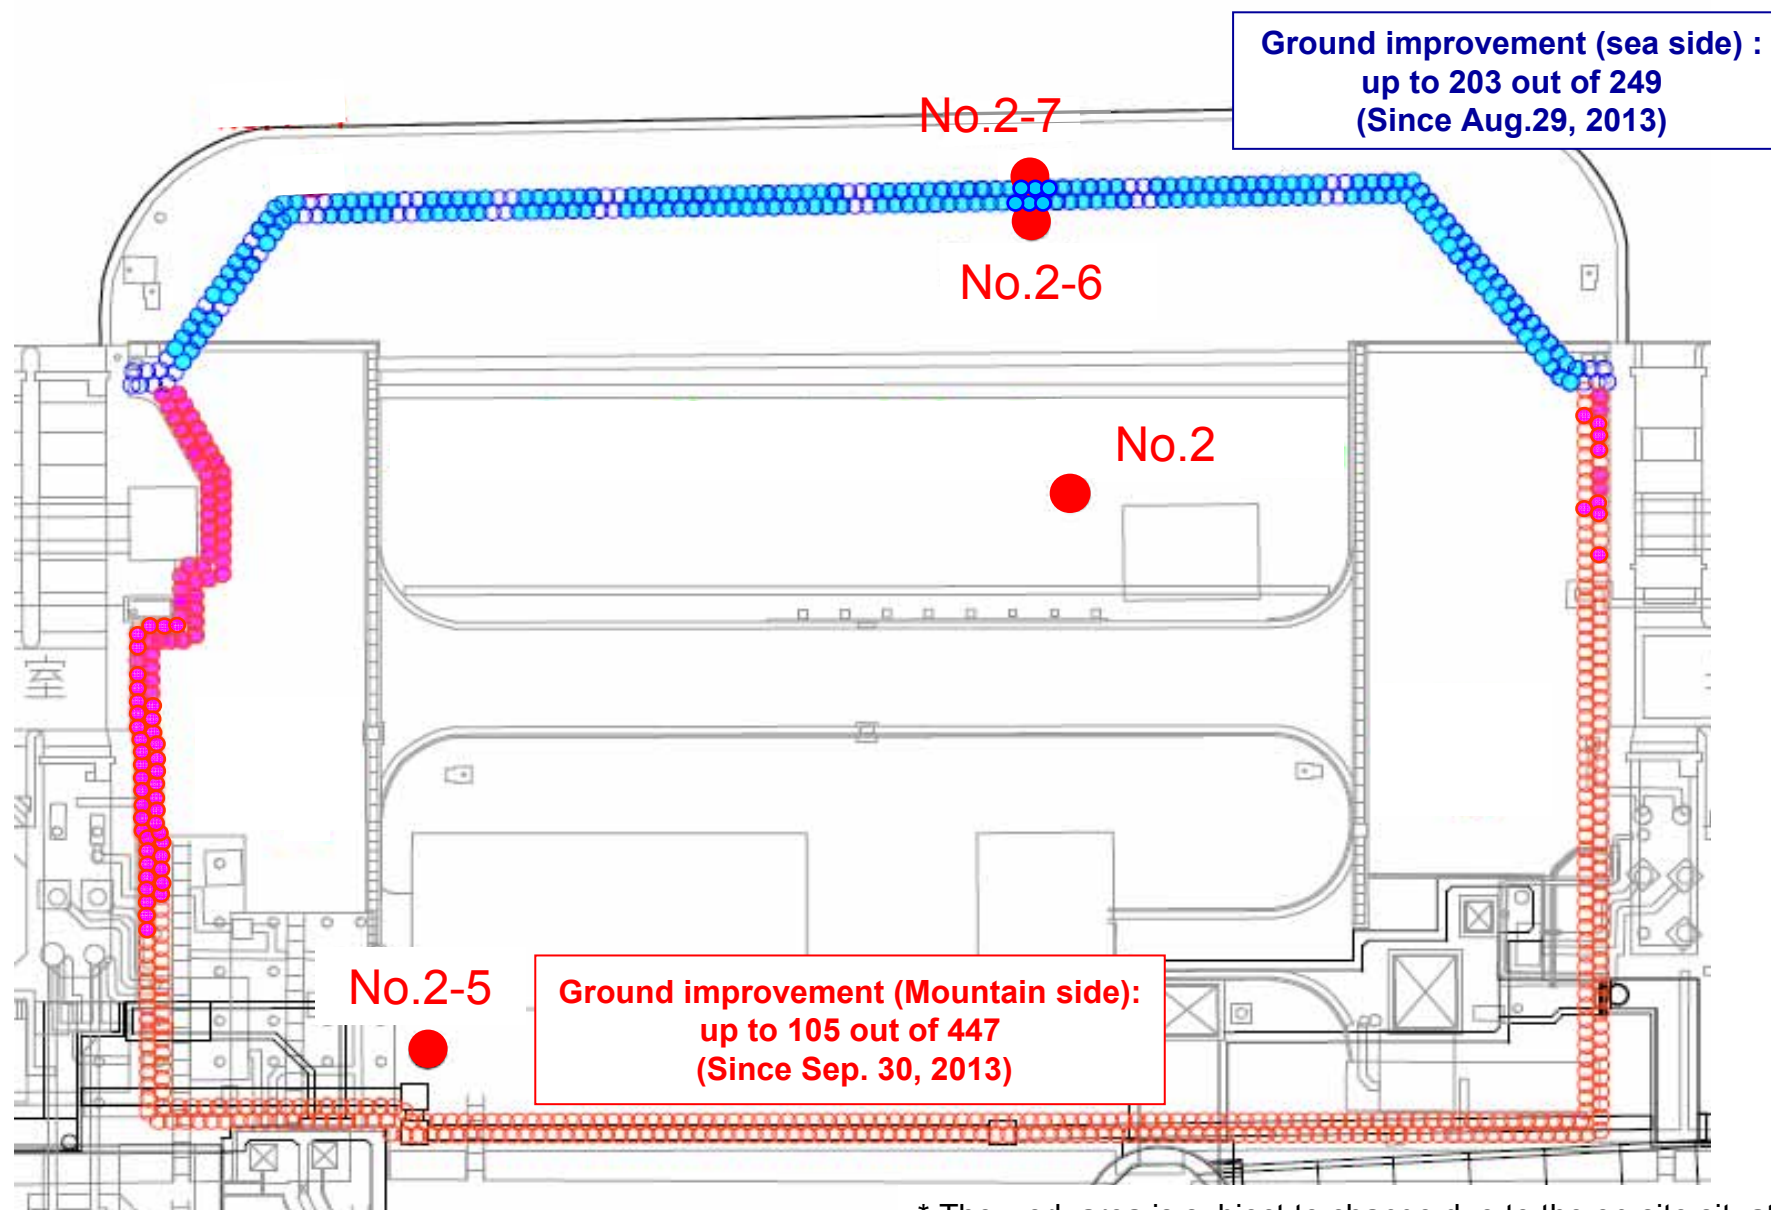
Progress in the ground improvement work between Unit 2 and 3 (As of in the morning on Nov. 25)

* The work area is subject to change due to the on-site situation.

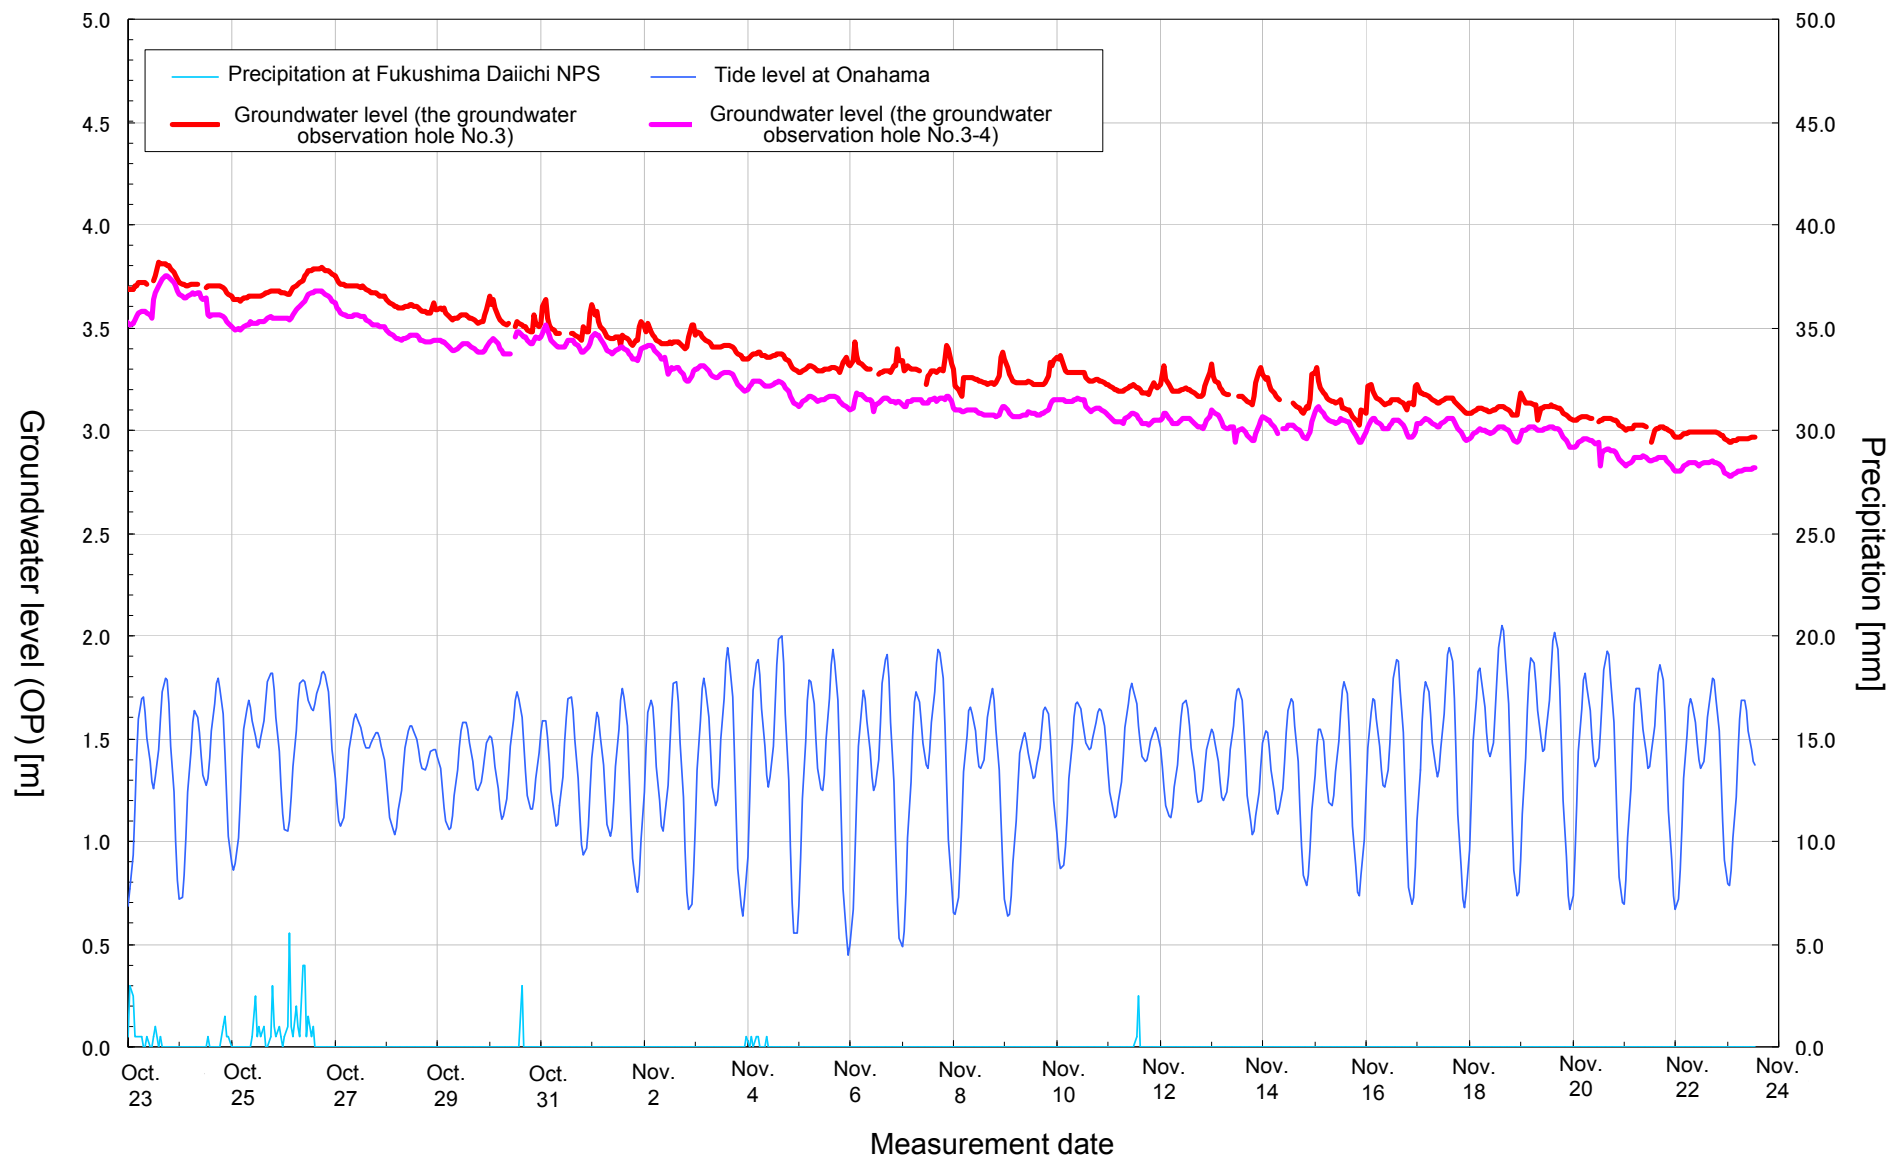
Movement in groundwater (Between Unit 3 and 4: From Oct. 23 to Nov. 23)

*Automatic measurement through a water level indication

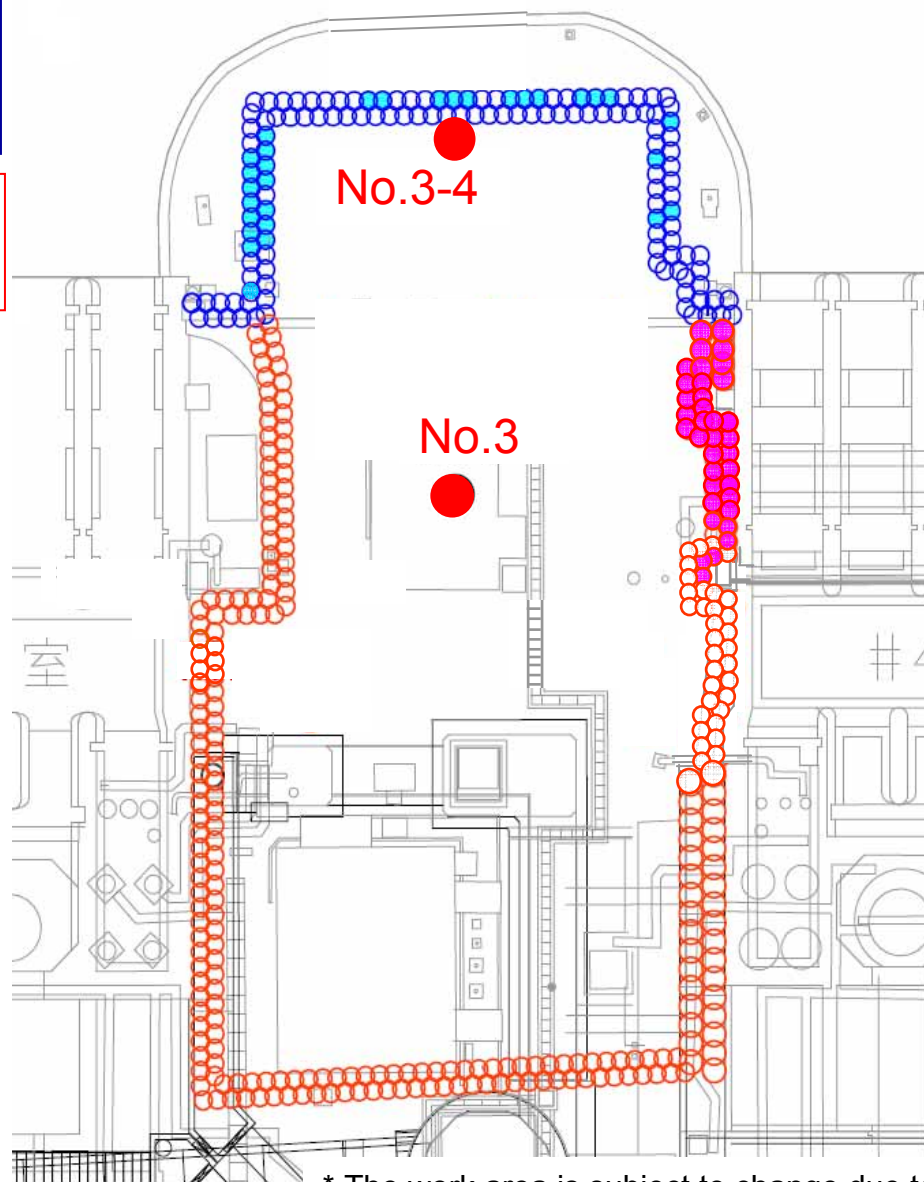
Progress in the ground improvement work between Unit 3 and 4 (As of in the morning on Nov. 25)

Ground improvement (sea side):
up to 30 out of 132
(Since Aug. 23, 2013)

Ground improvement (mountain side):
up to 36 out of 273
(Since Oct. 19, 2013)

* The work area is subject to change due to the on-site situation.
