The seawall area at Fukushima Daiichi NPS

<Reference>
December 2, 2013
Tokyo Electric Power Company

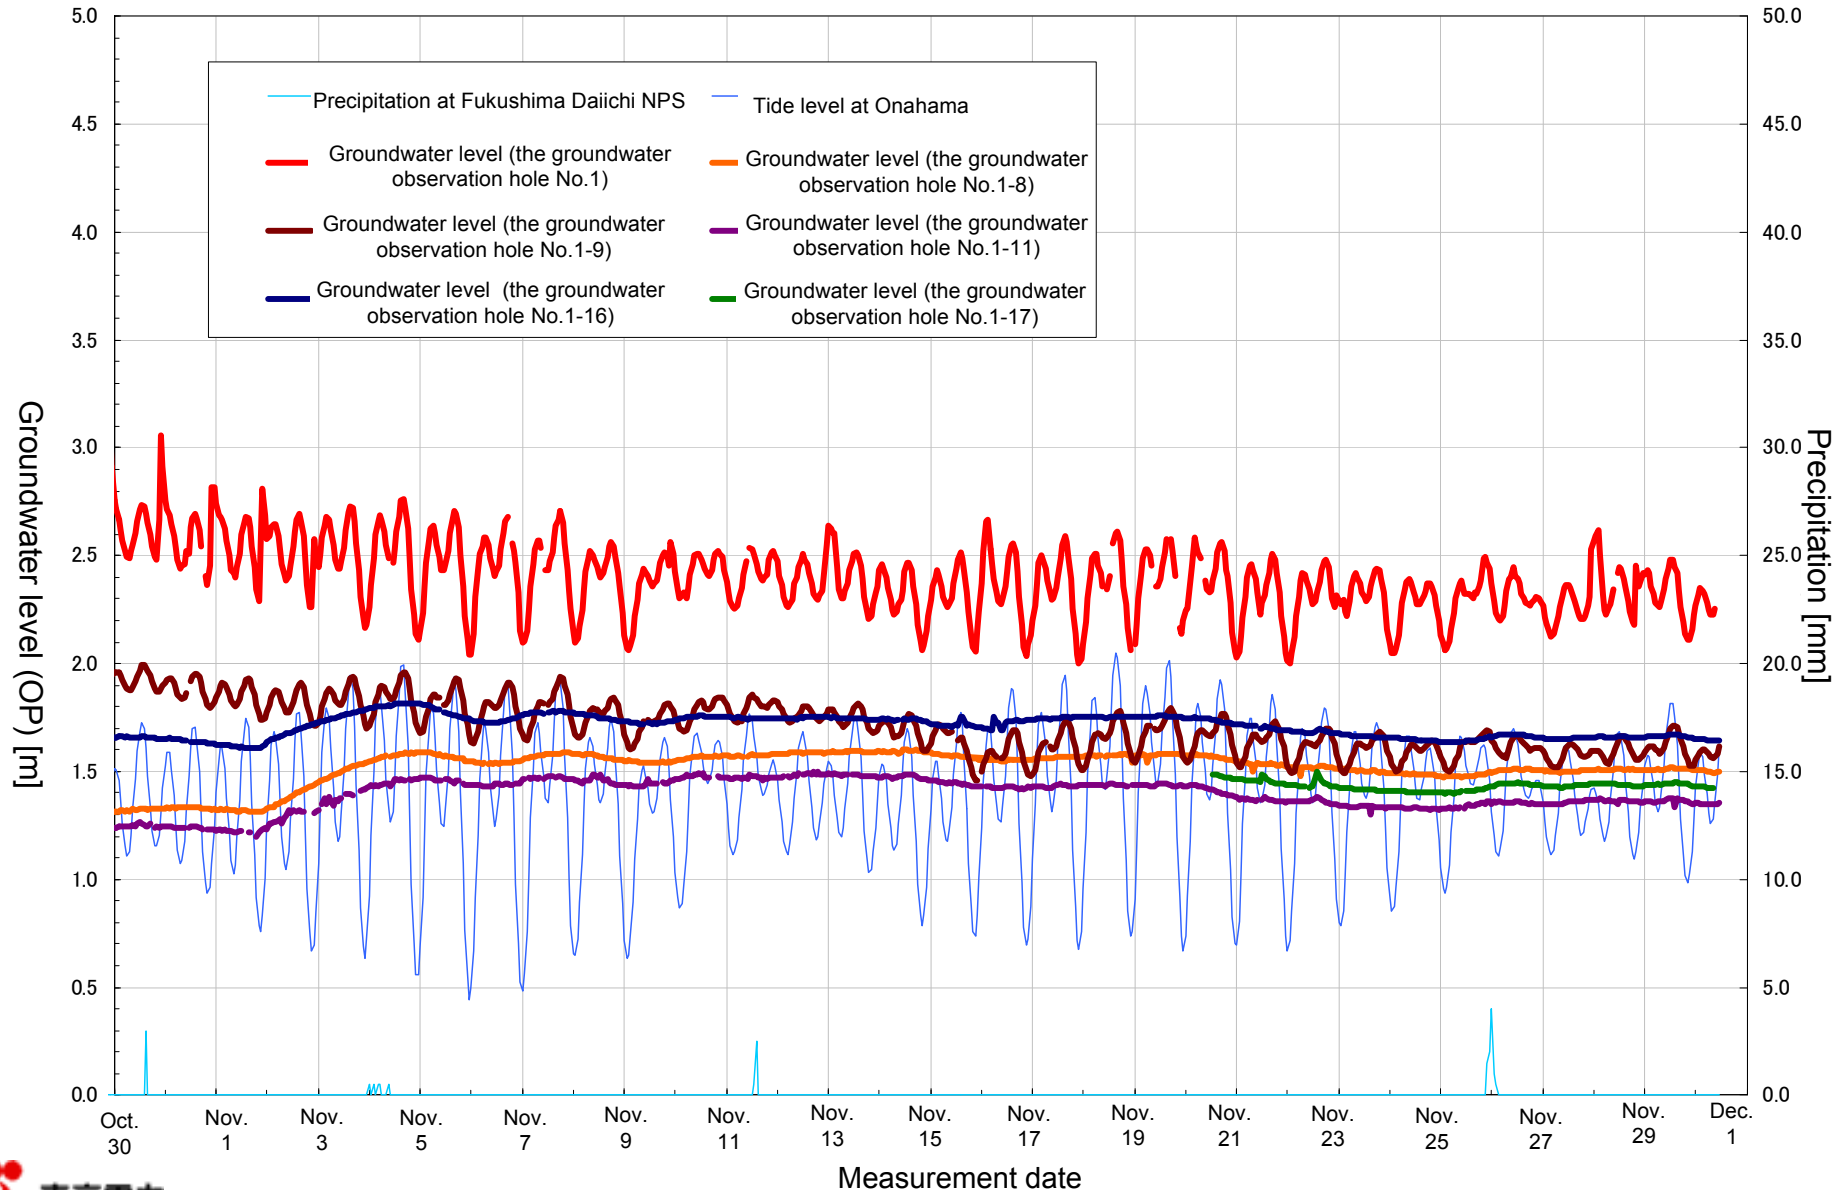
Movement in groundwater (Between Unit 1 and 2: From Oct. 30 to Nov. 30)

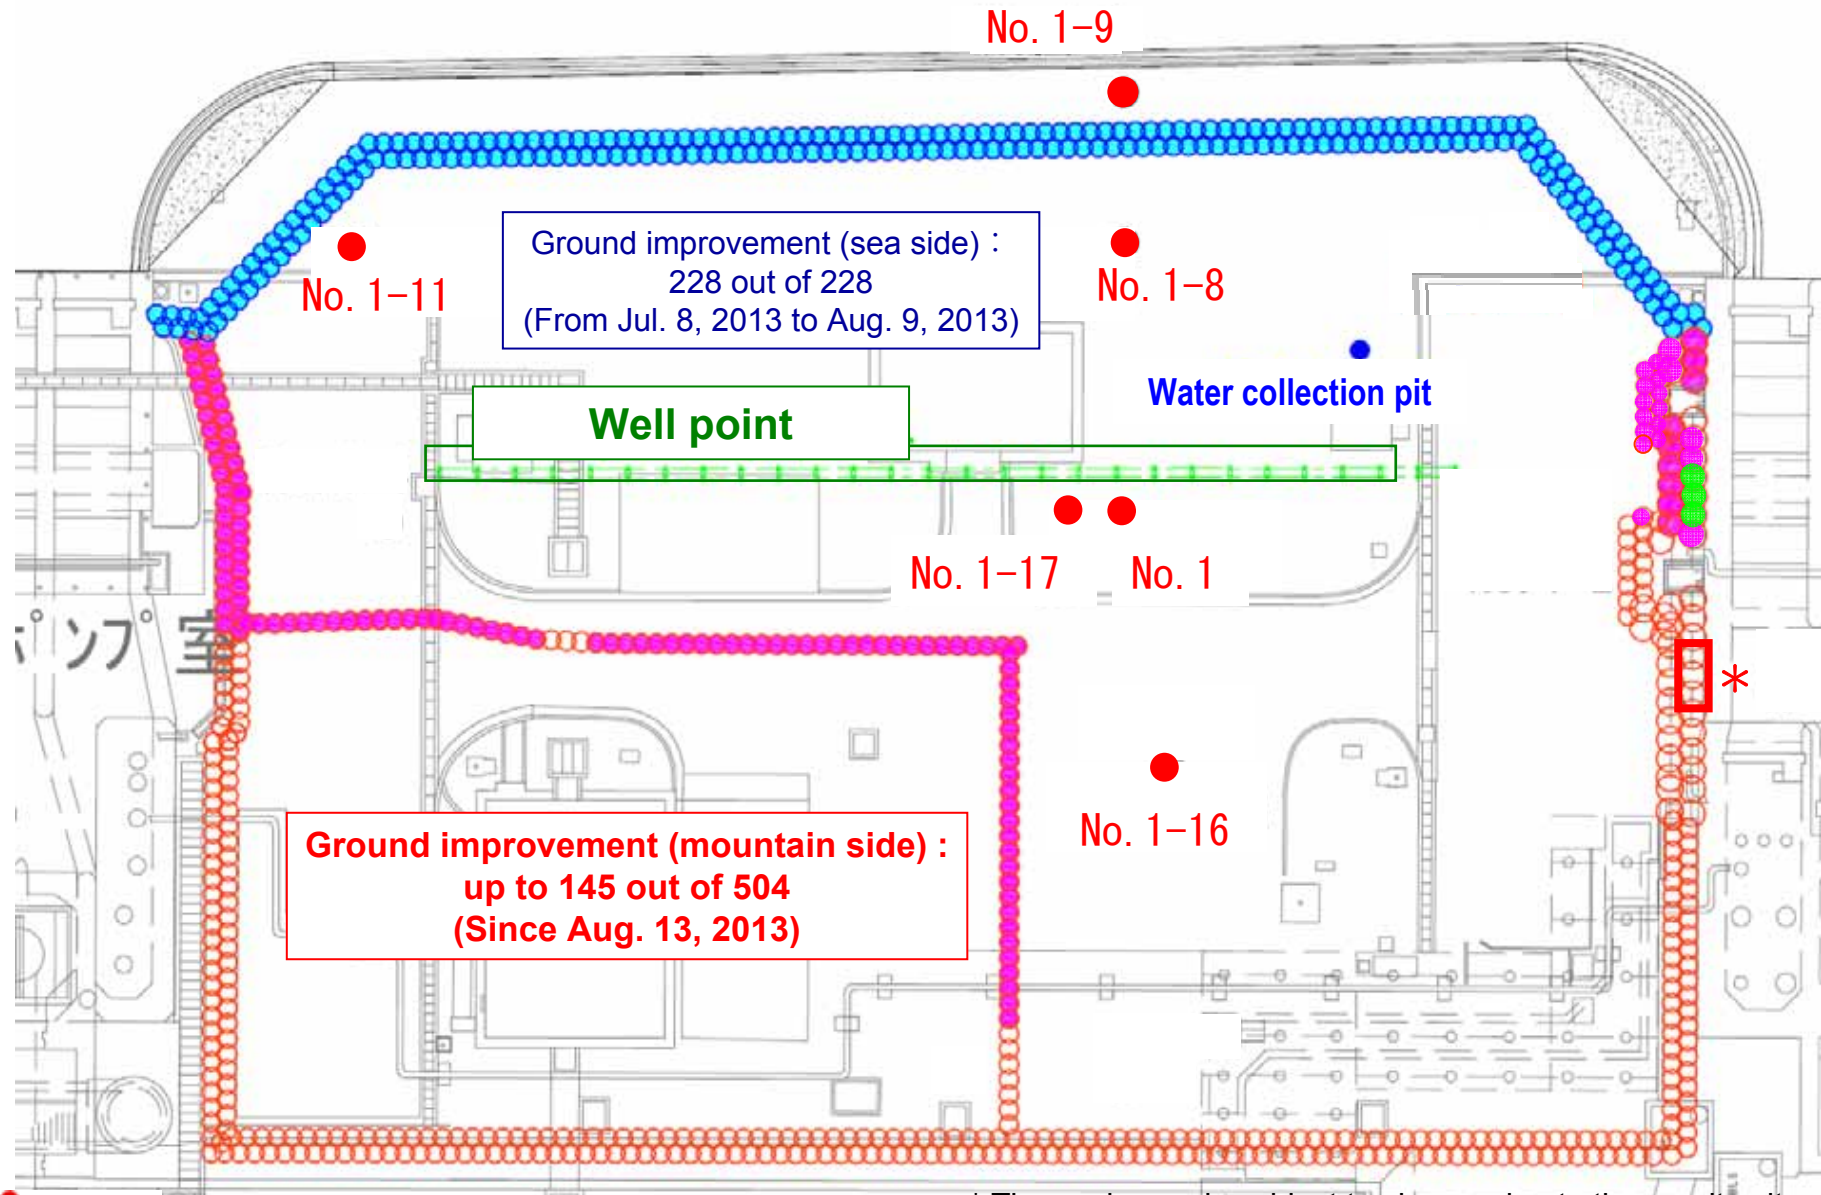
Progress in the ground improvement work between Unit 1 and 2 (As of in the morning on Dec. 2)

* The work area is subject to change due to the on-site situation.

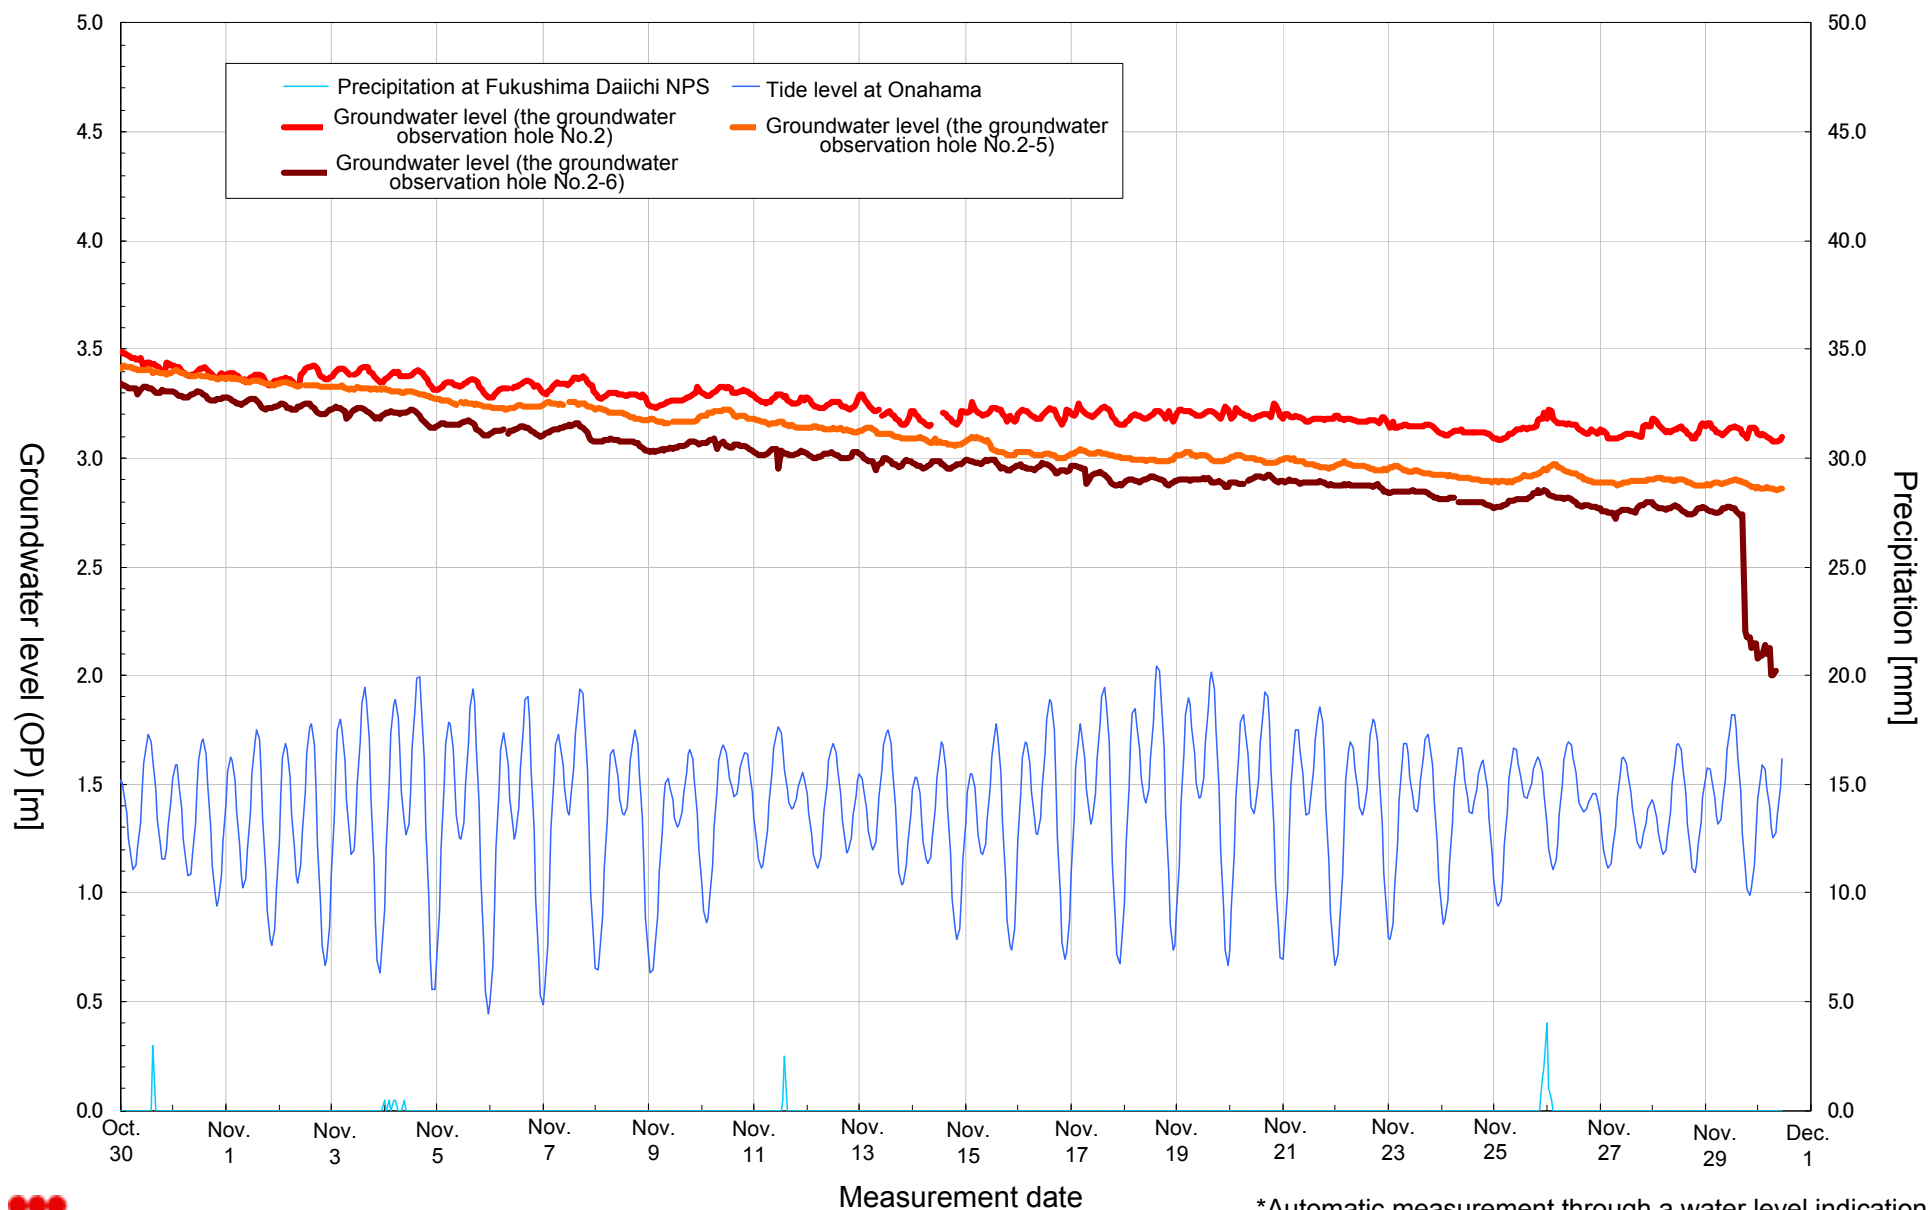
Movement in groundwater (Between Unit 2 and 3: From Oct. 30 to Nov. 30)

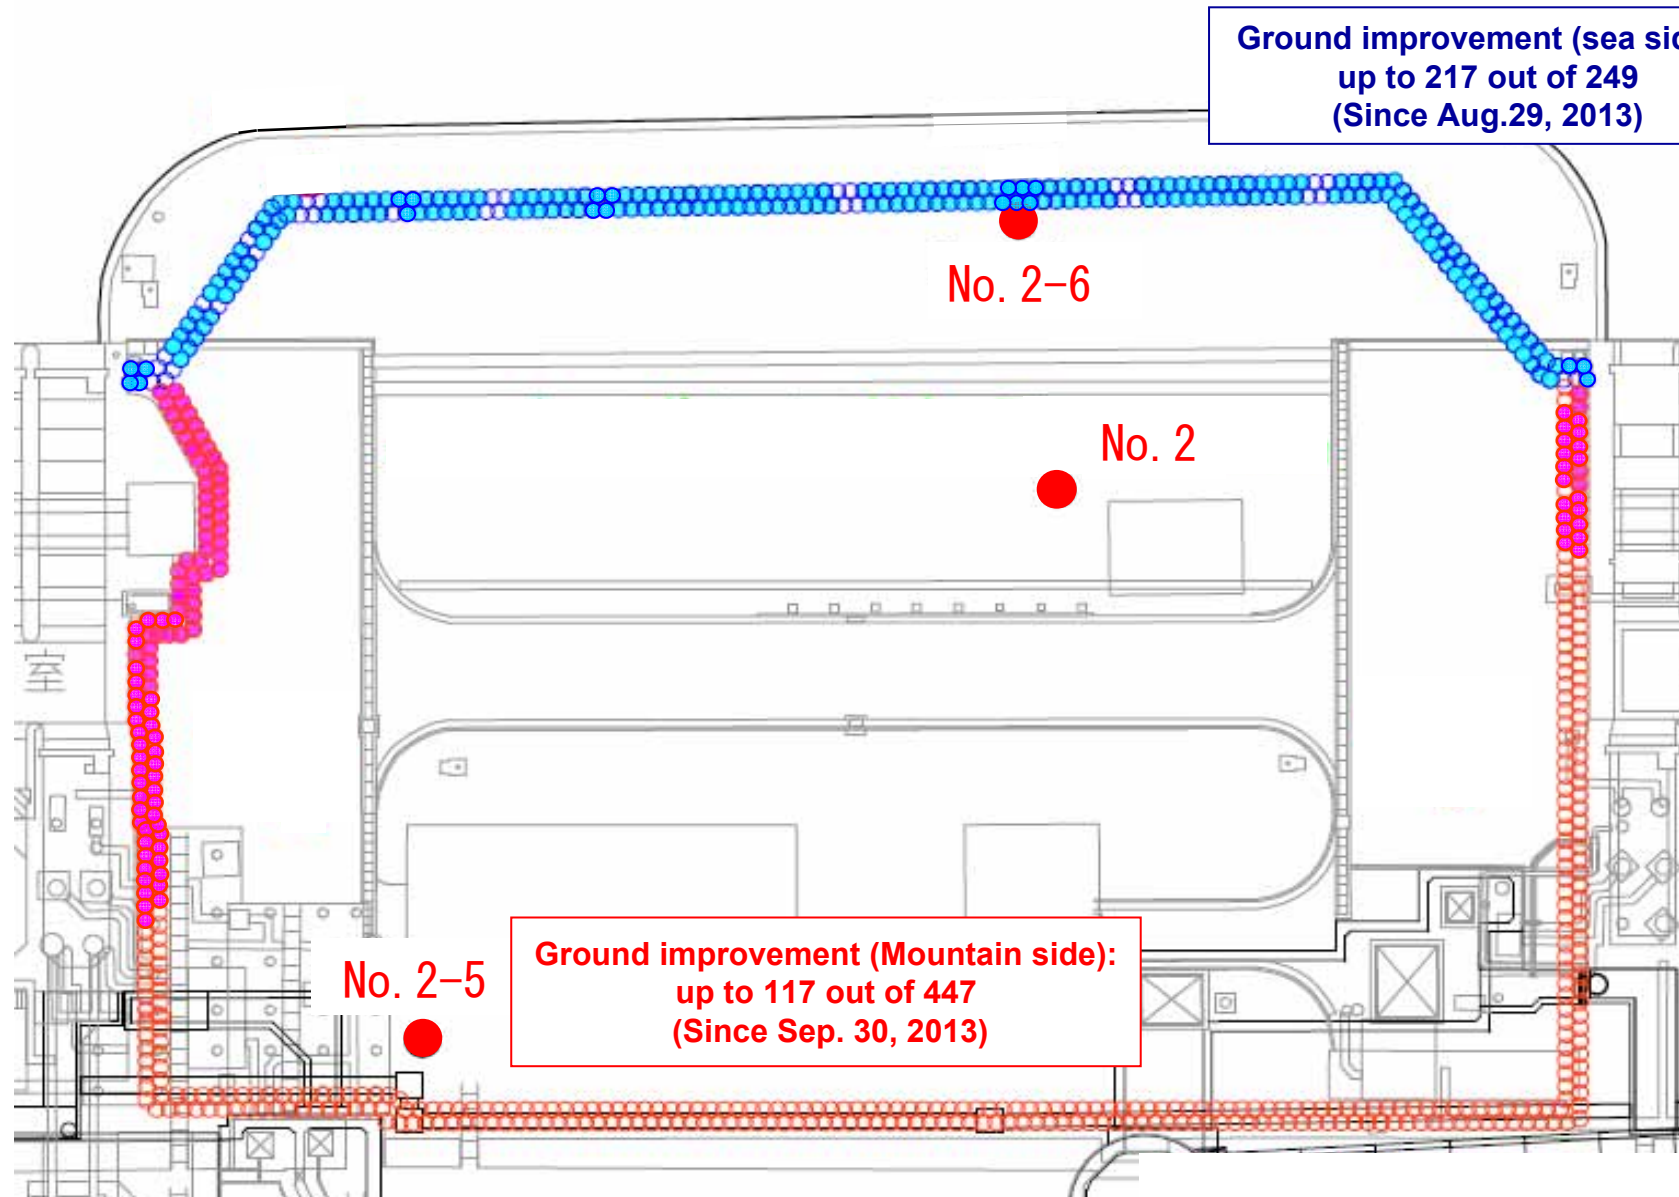
Progress in the ground improvement work between Unit 2 and 3 (As of in the morning on Dec. 2)

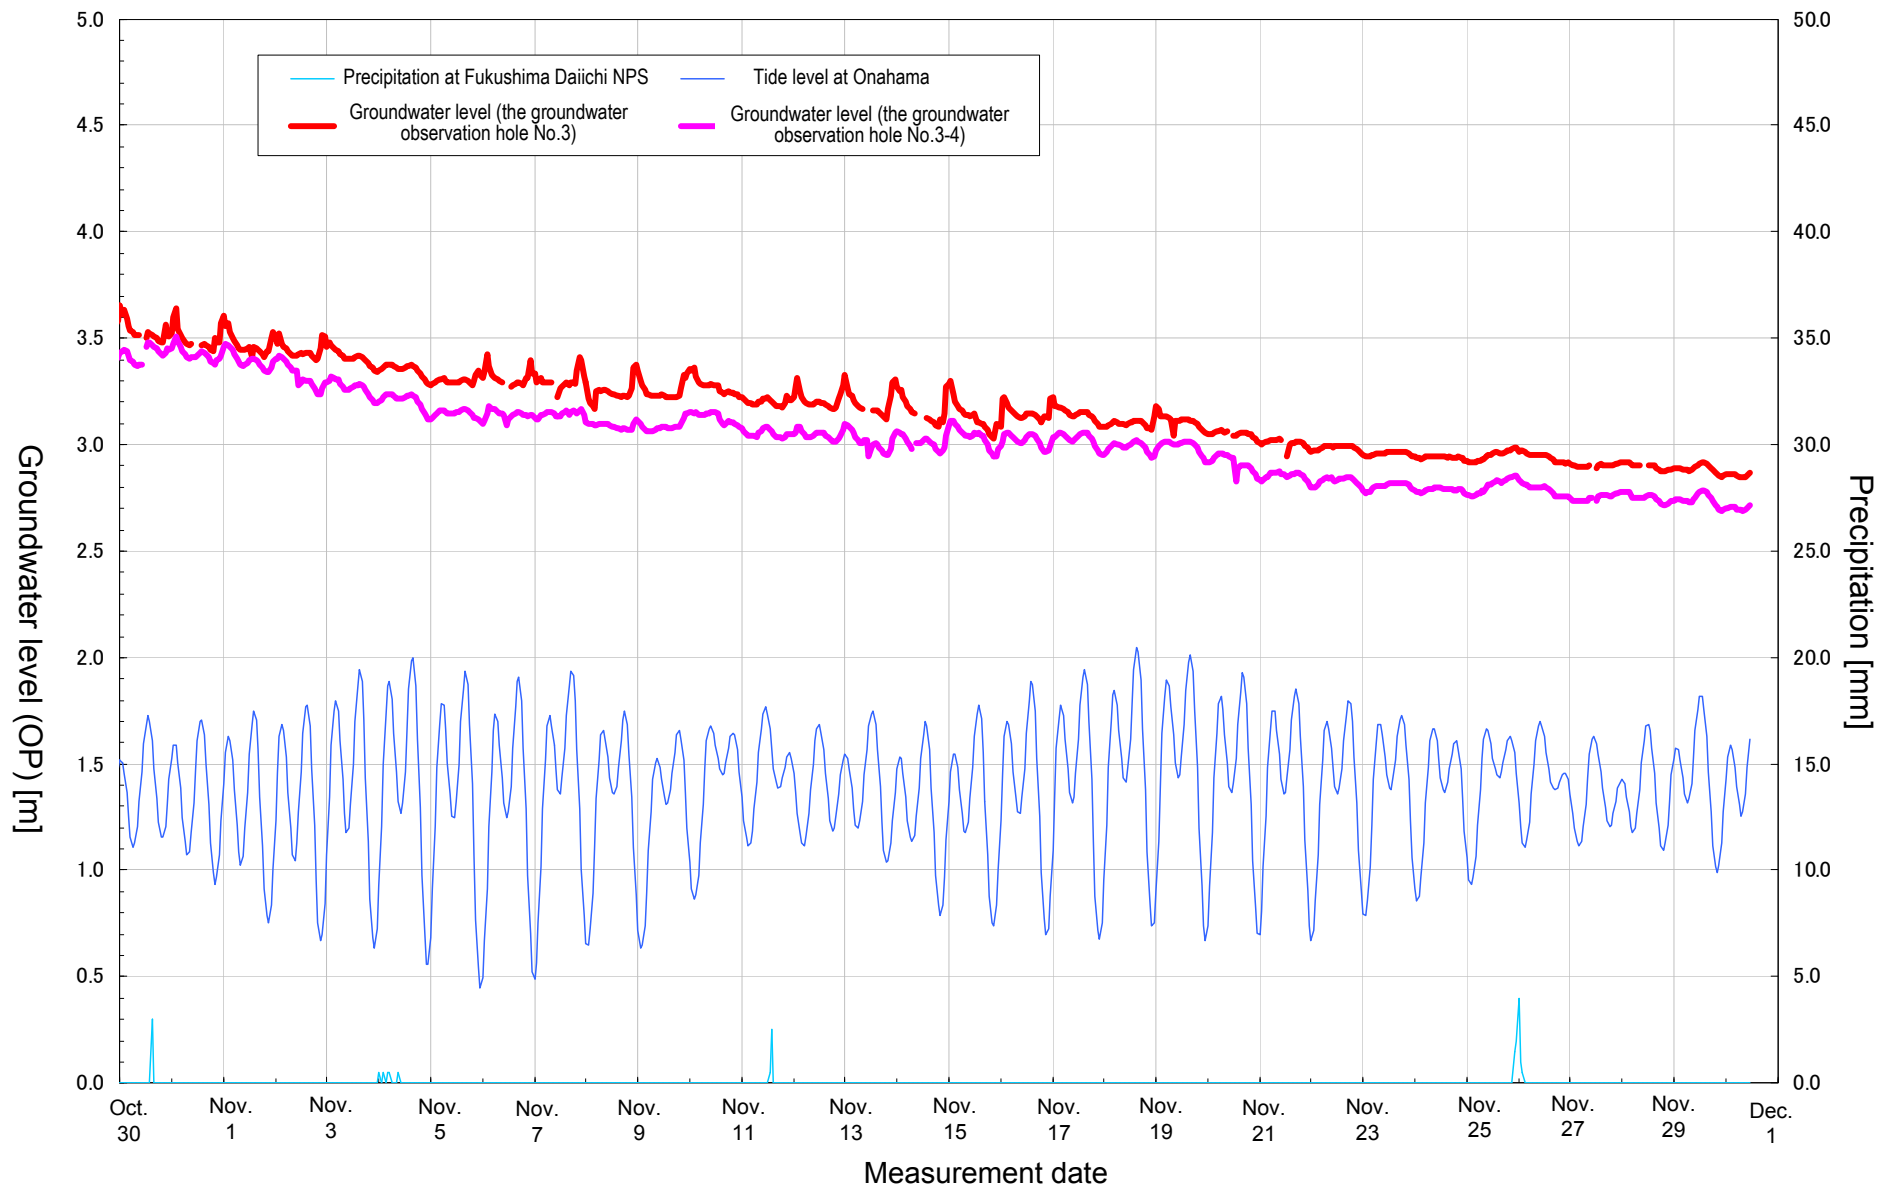
Movement in groundwater (Between Unit 3 and 4: From Oct. 30 to Nov. 30)

*Automatic measurement through a water level indication

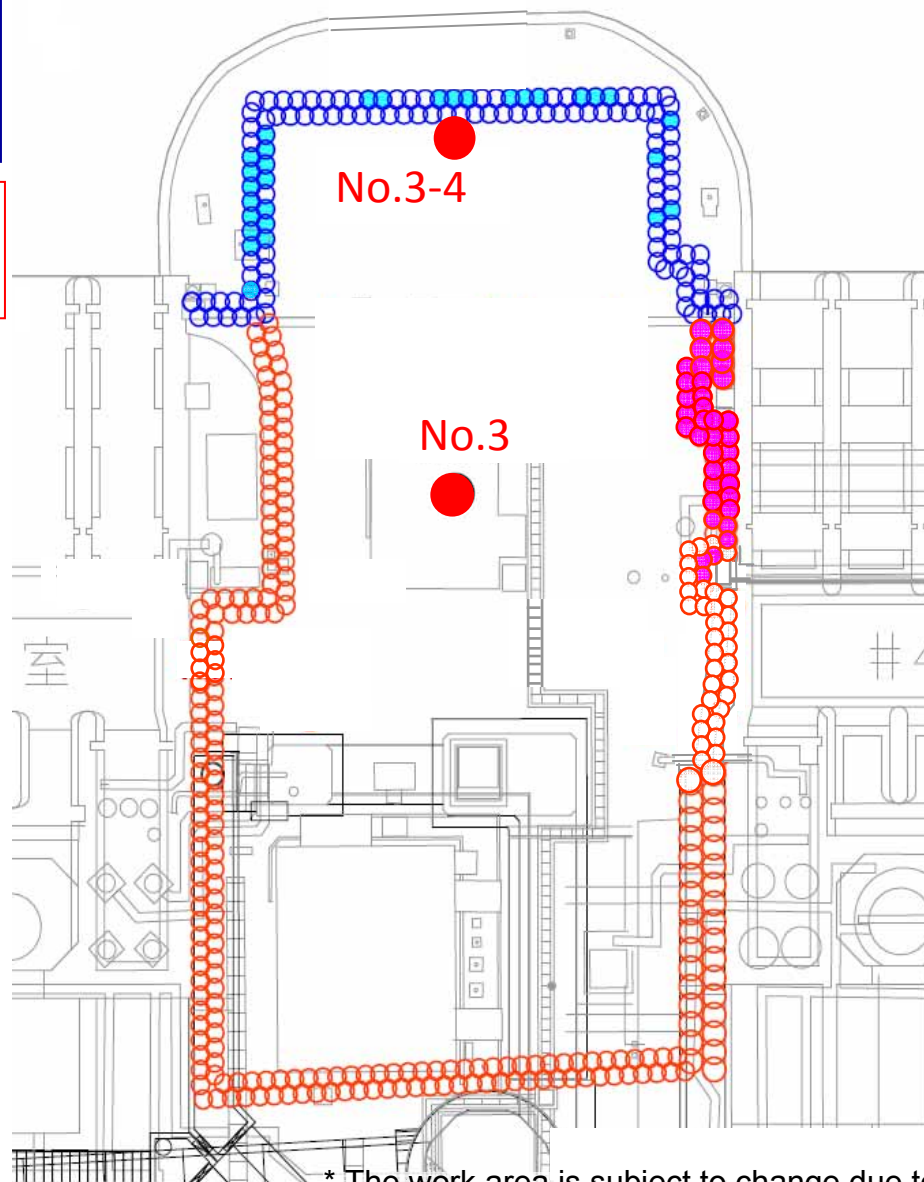
Progress in the ground improvement work between Unit 3 and 4 (As of in the morning on Nov. 29)

Ground improvement (sea side):
up to 30 out of 132
(Since Aug. 23, 2013)

Ground improvement (mountain side):
up to 36 out of 273
(Since Oct. 19, 2013)

* The work area is subject to change due to the on-site situation.
