# The seawall area at Fukushima Daiichi NPS

<Reference>  
December 4, 2013  
Tokyo Electric Power Company

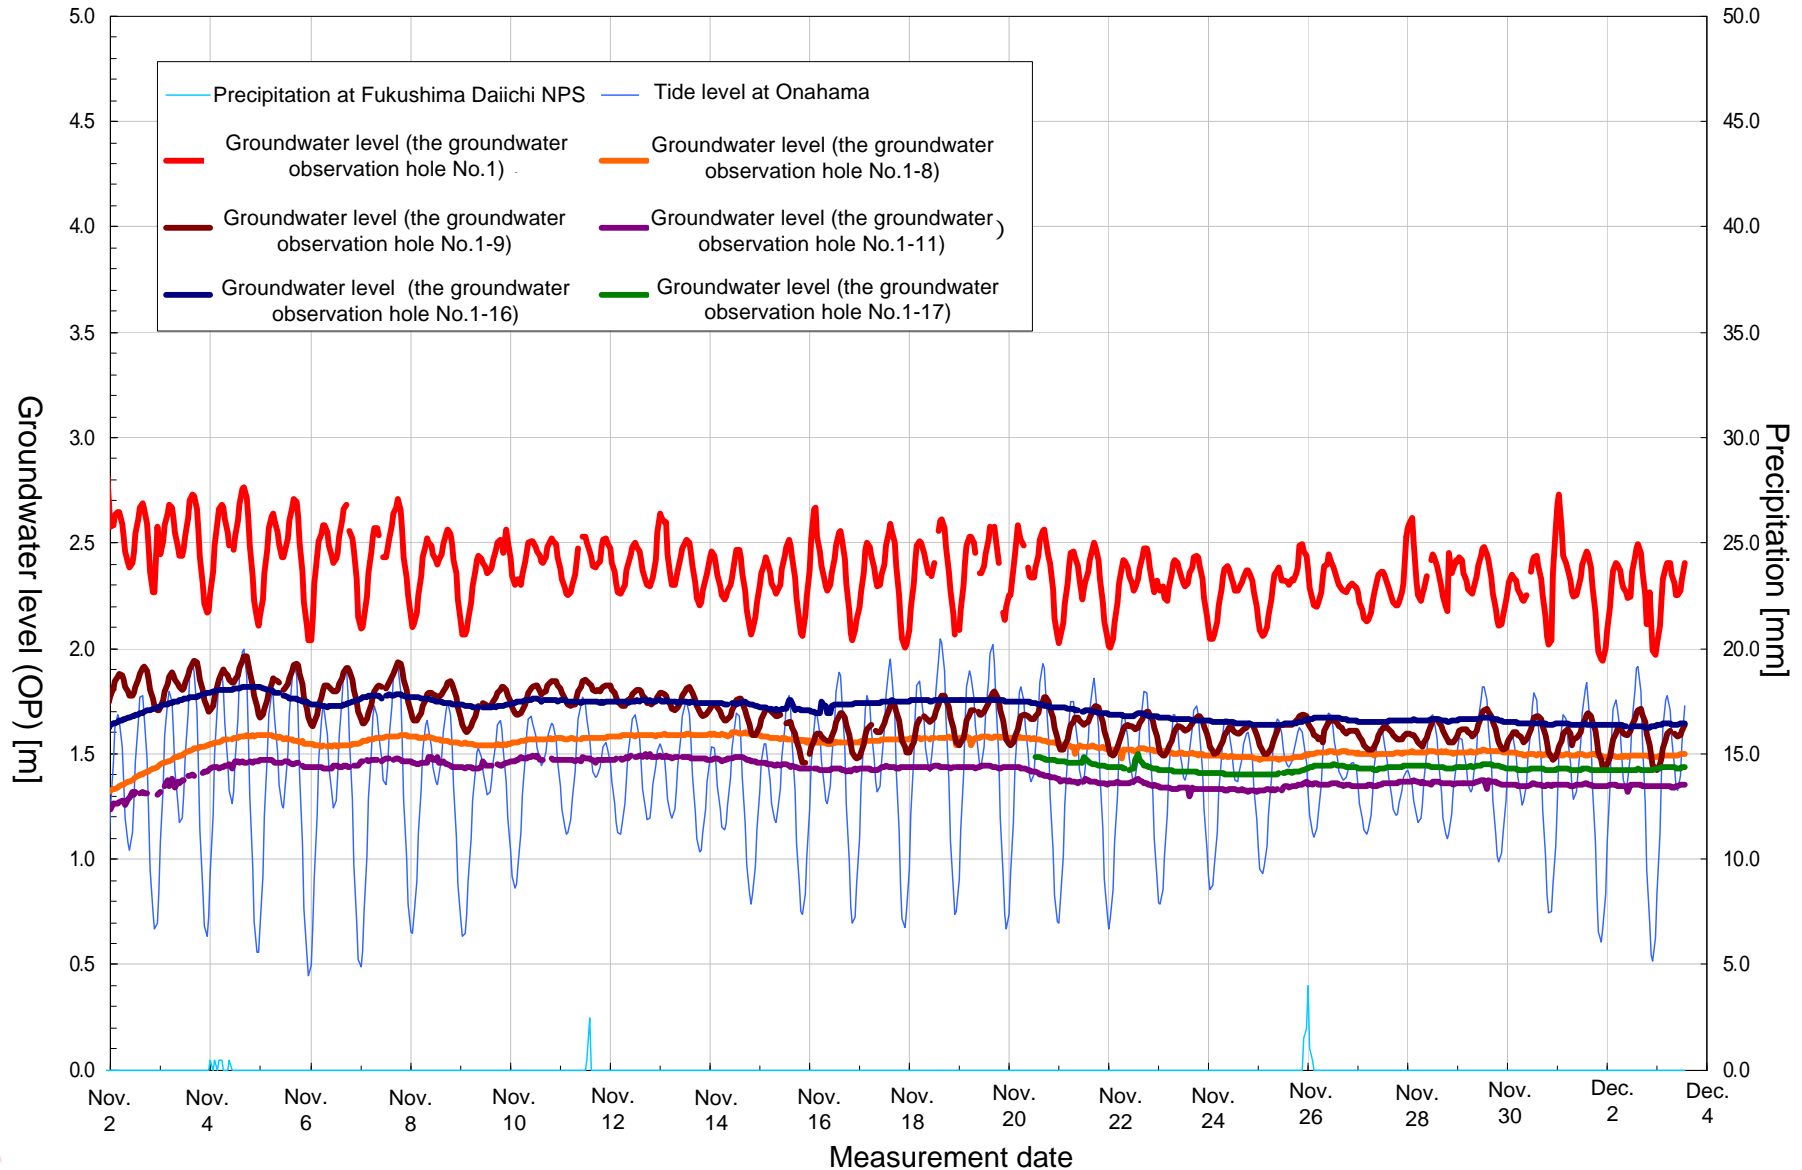
## Movement in groundwater (Between Unit 1 and 2: From Nov. 3 to Dec. 3)

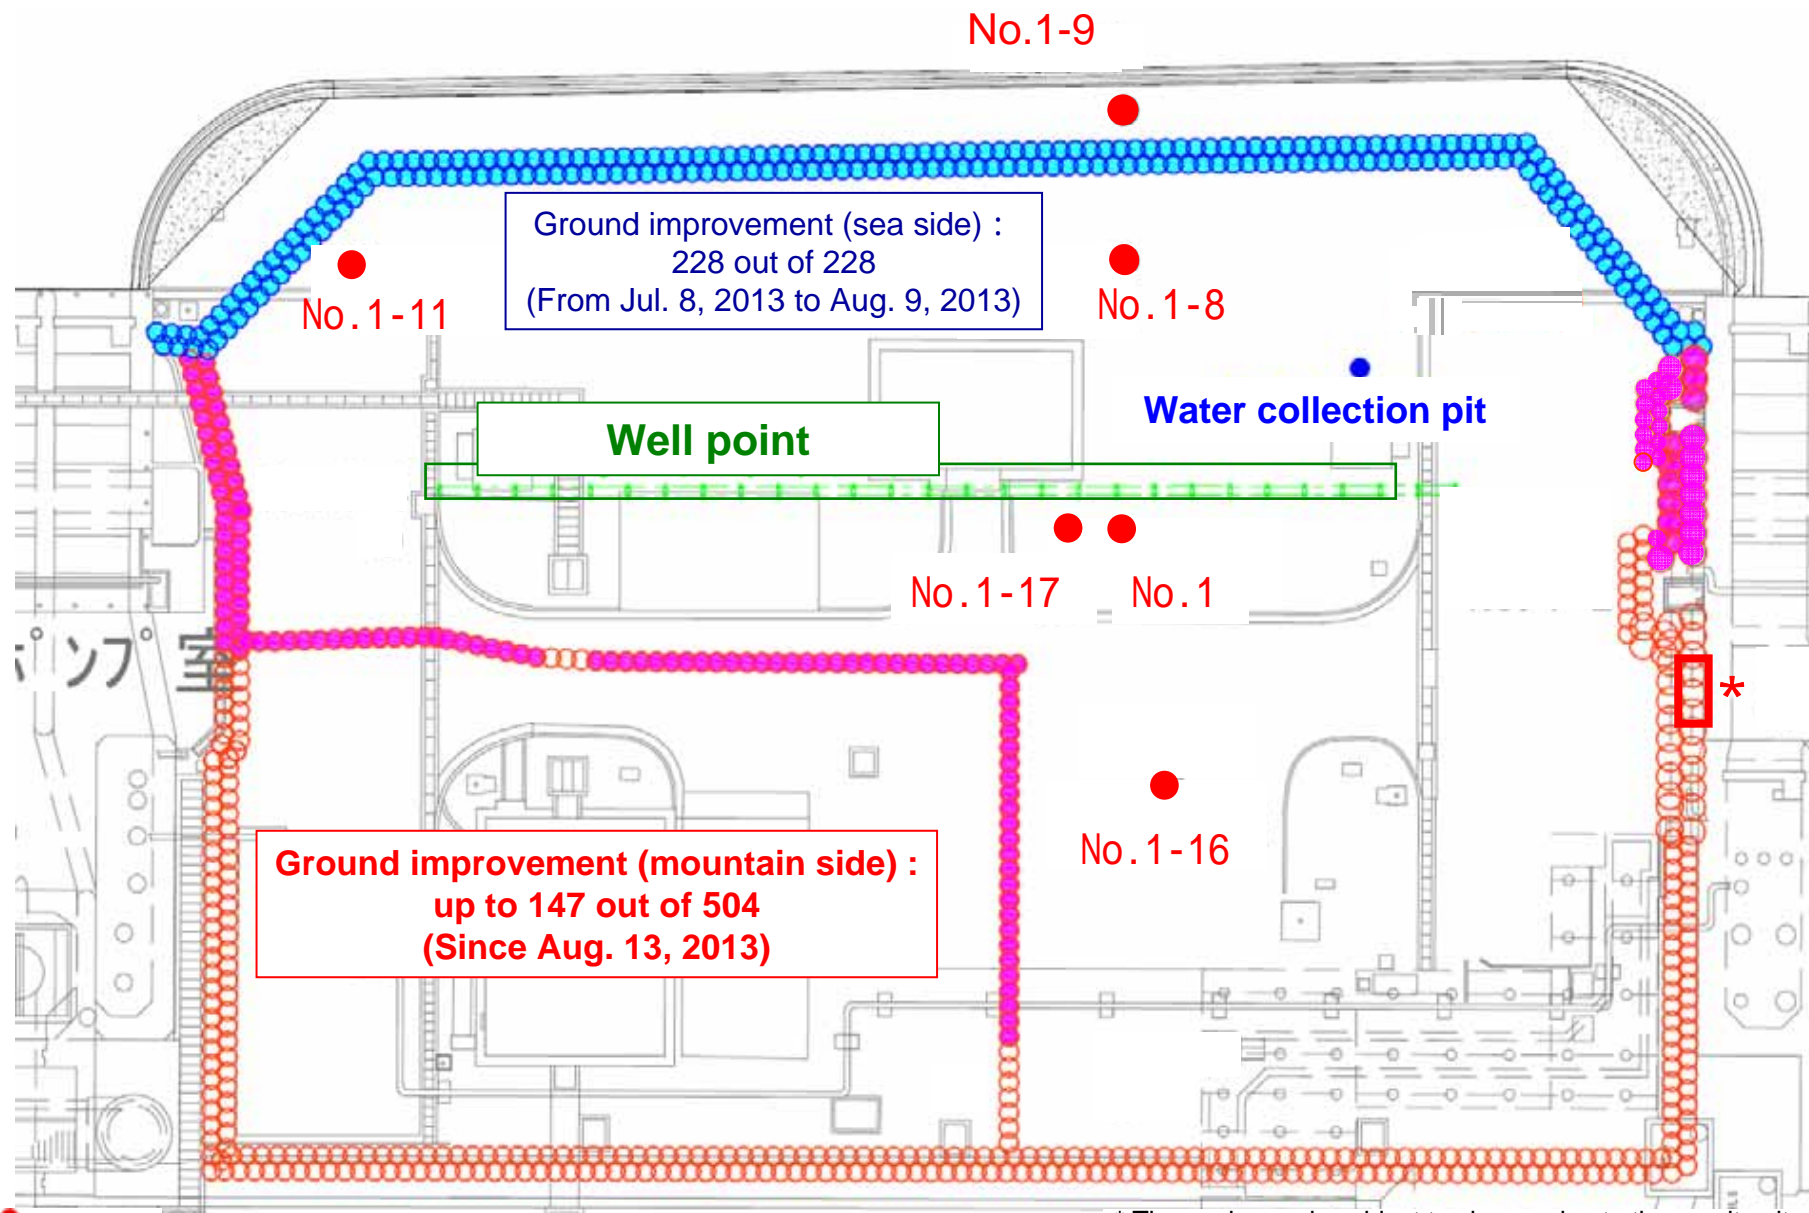
# Progress in the ground improvement work between Unit 1 and 2 (As of in the morning on Dec. 4)

\* The work area is subject to change due to the on-site situation.

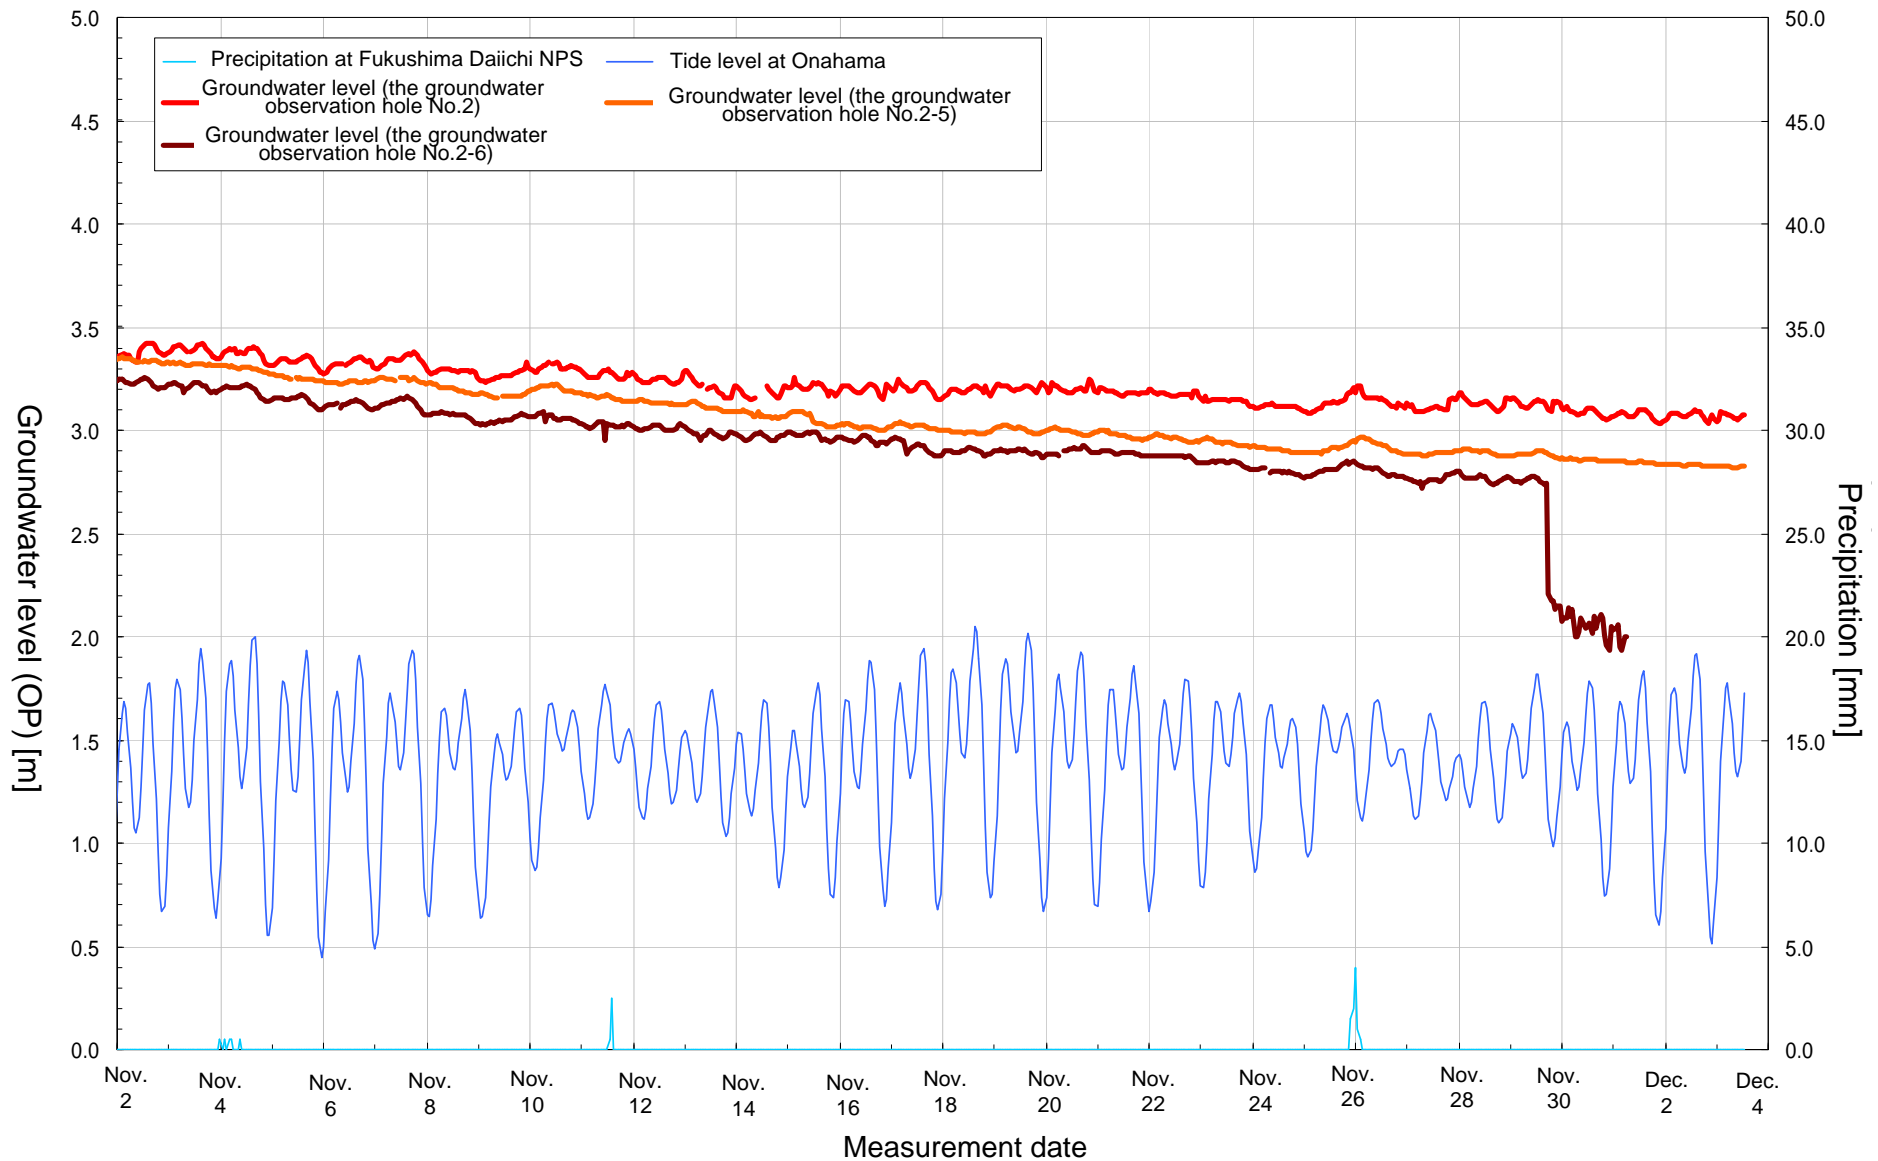
# Movement in groundwater (Between Unit 2 and 3: From Nov. 3 to Dec. 3)

\*As for the water level at the groundwater level observation hole No.2-6, the water gauge was replaced on December 3 because it was suspected out of order.

\*Automatic measurement through a water level indication

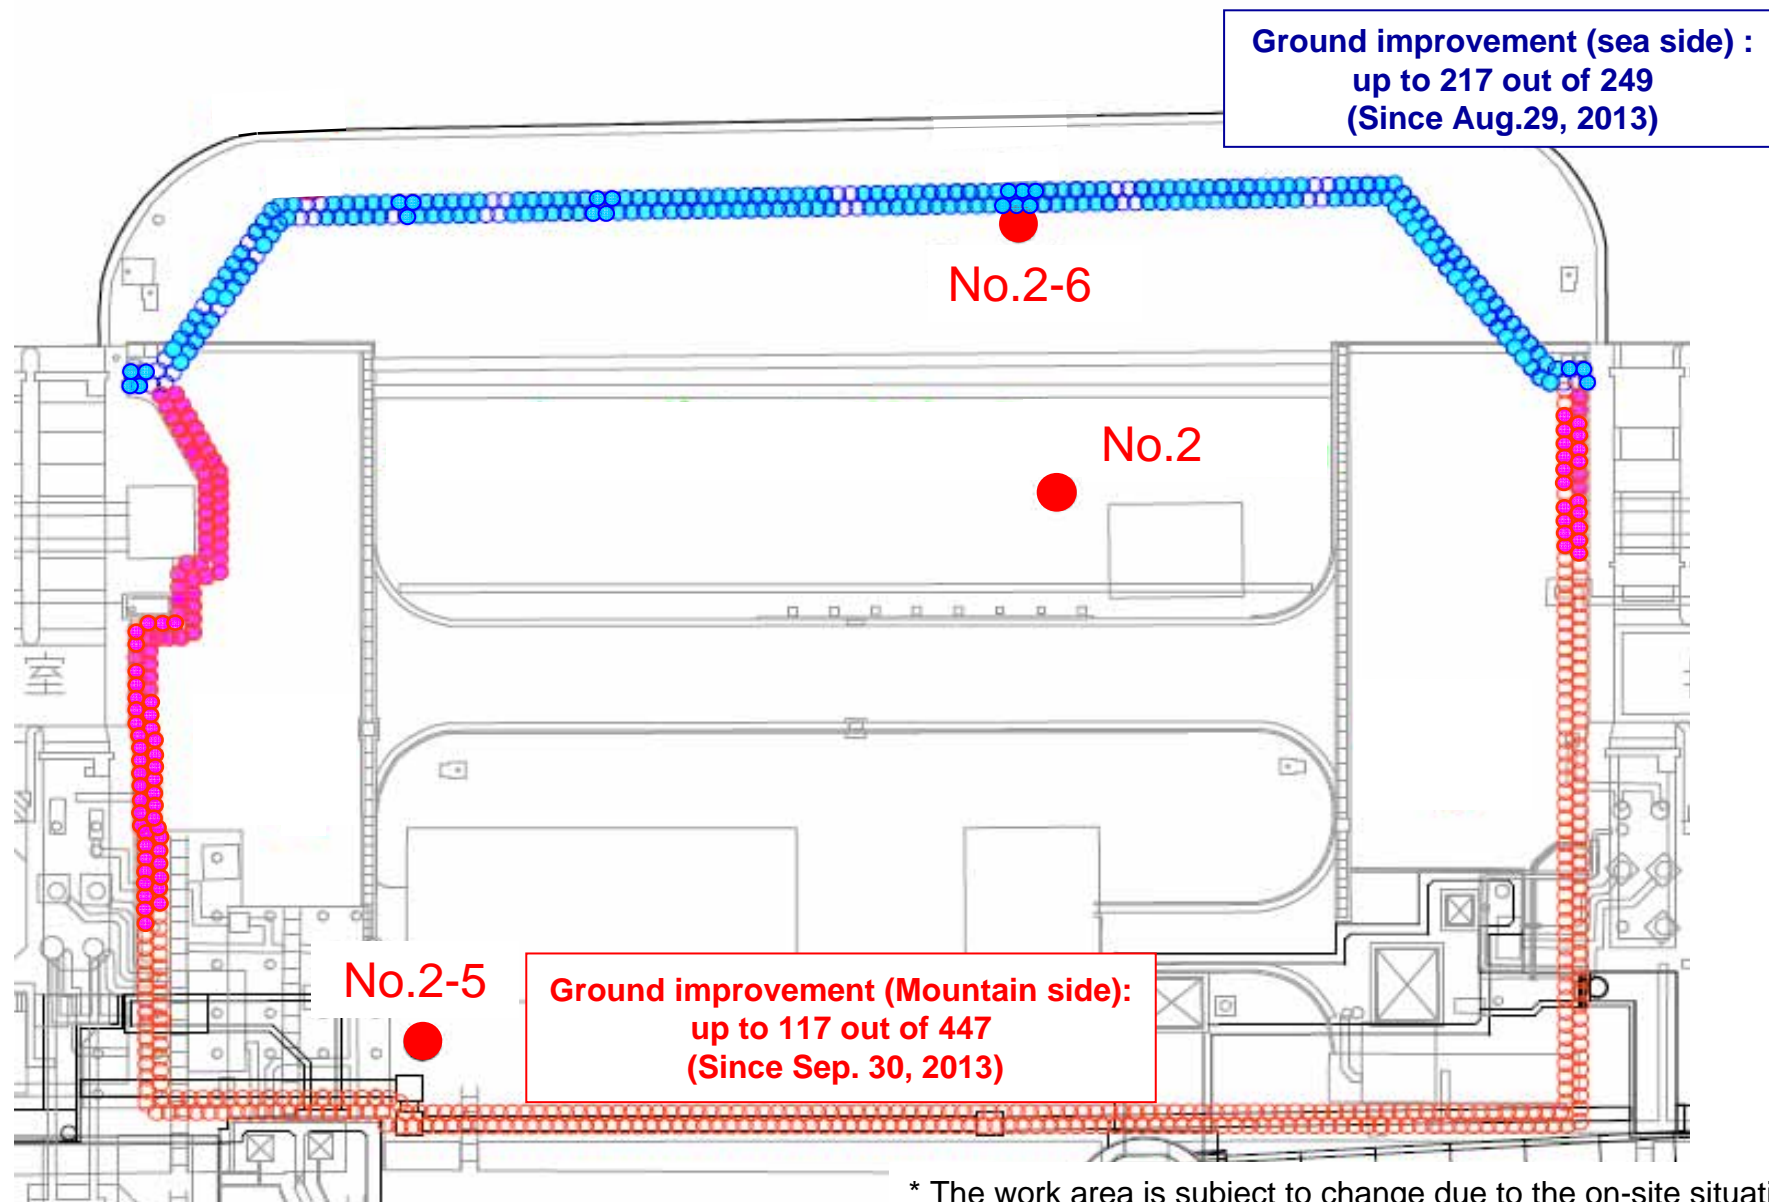
# Progress in the ground improvement work between Unit 2 and 3 (As of in the morning on Dec. 4)

\* The work area is subject to change due to the on-site situation.

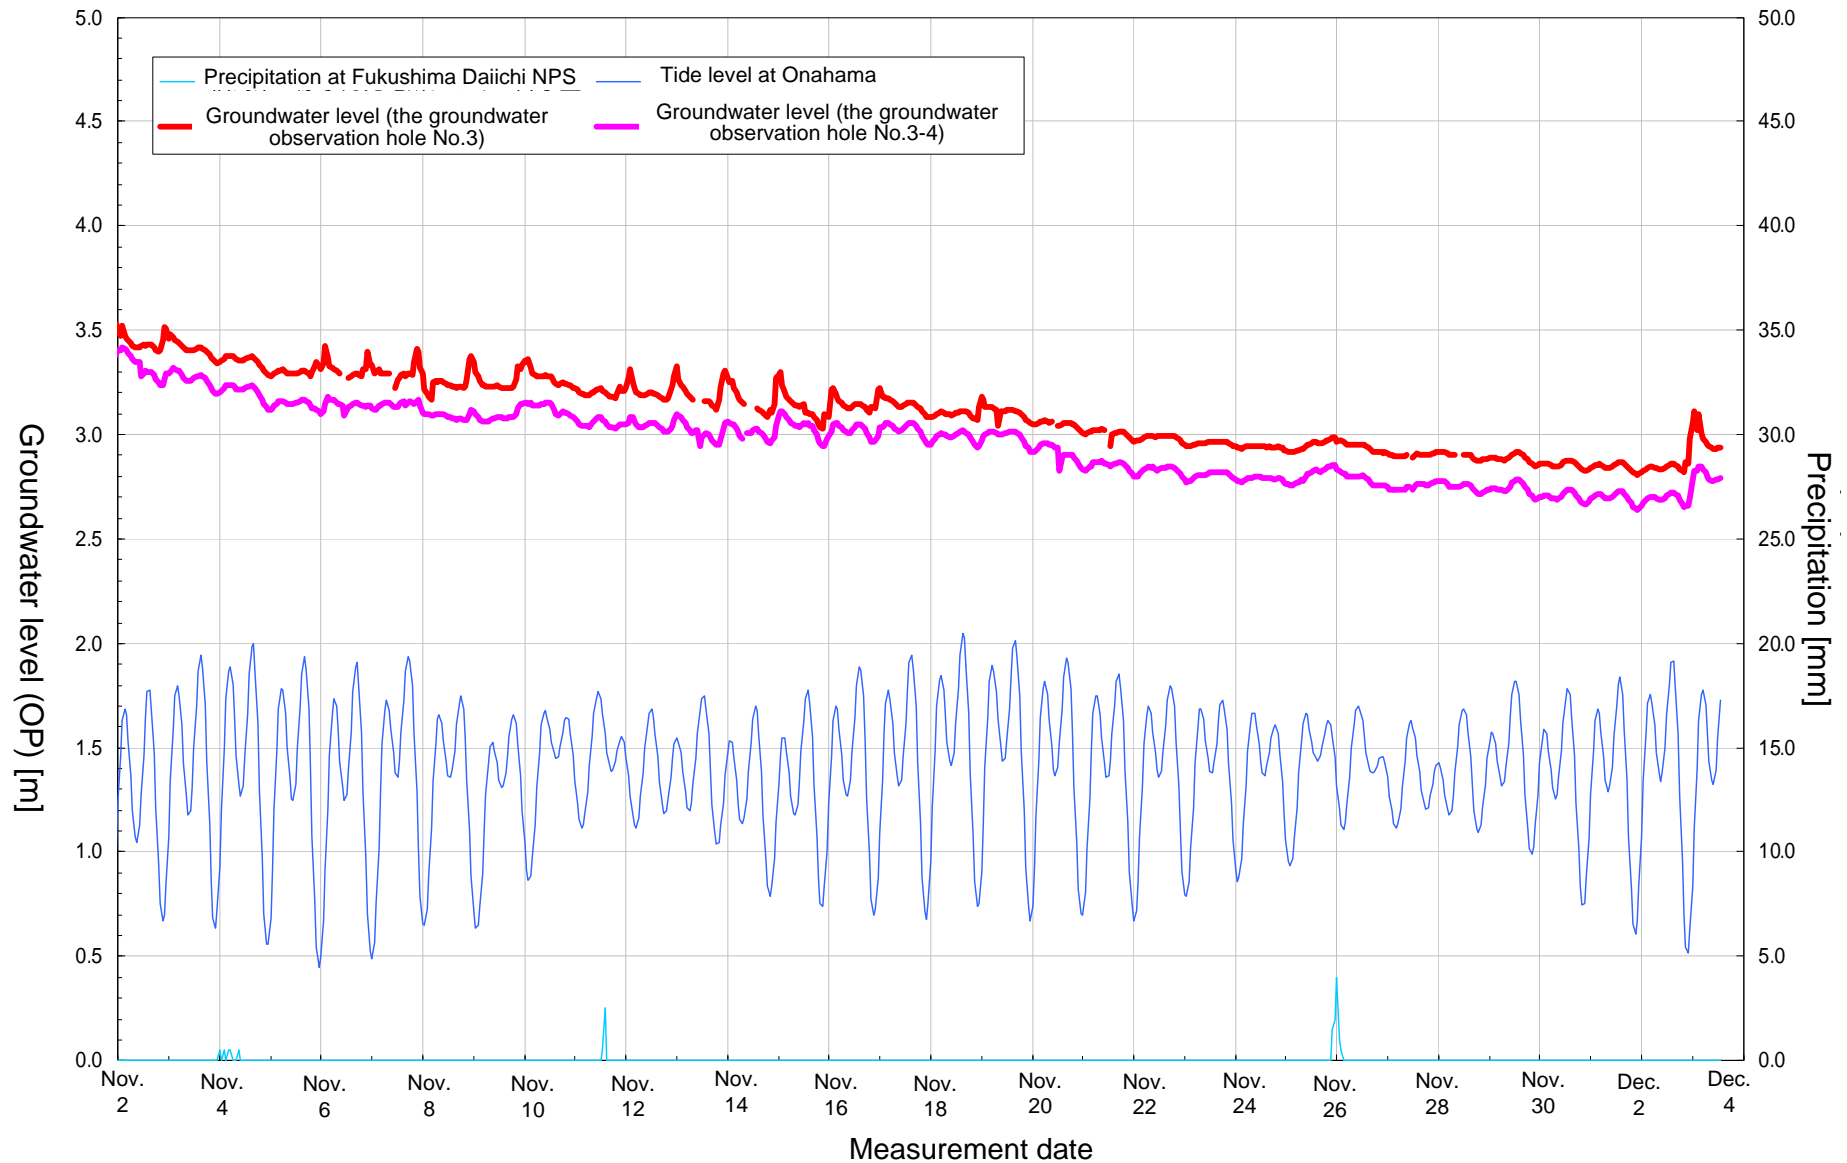
# Movement in groundwater (Between Unit 3 and 4: From Nov. 3 to Dec. 3)

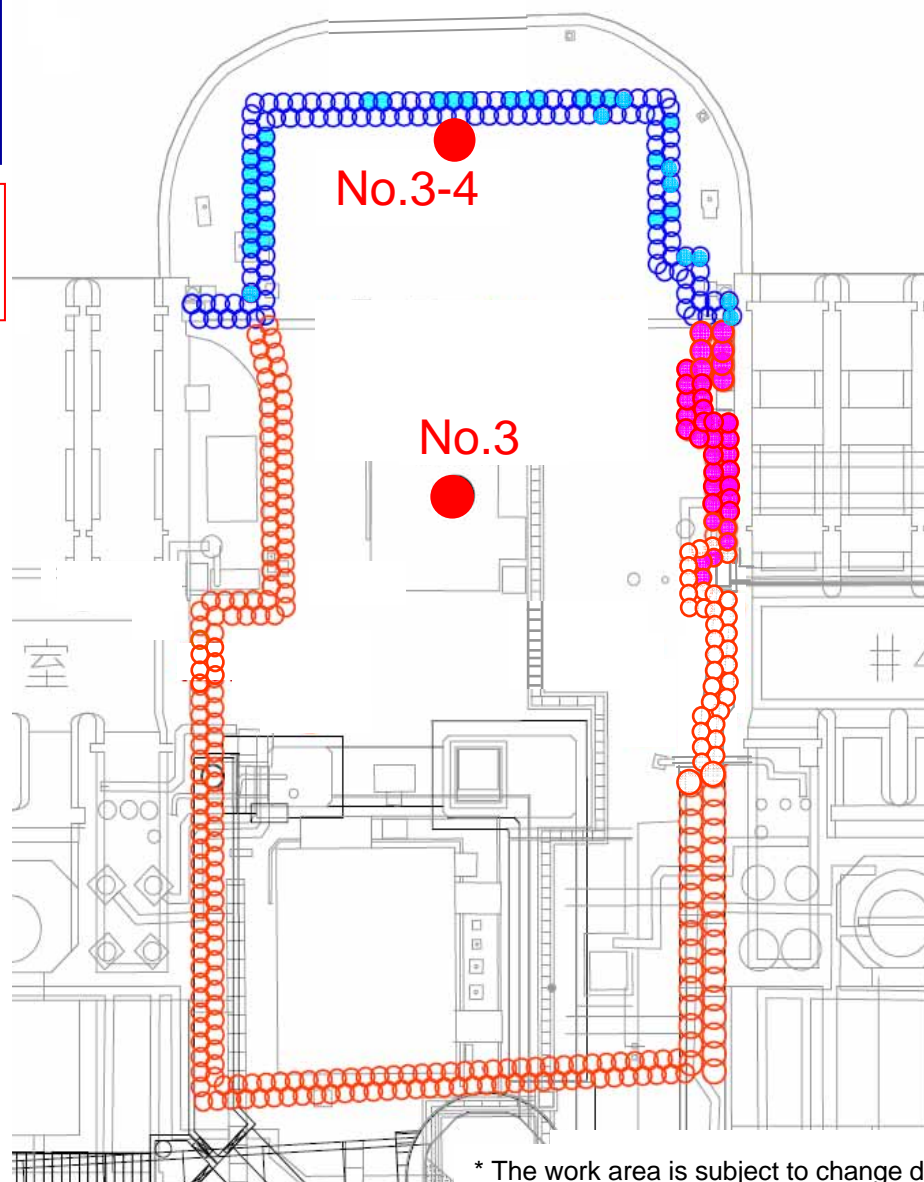
## Progress in the ground improvement work between Unit 3 and 4 (As of in the morning on Dec. 4)

Ground improvement (sea side):  
up to 38 out of 132  
(Since Aug. 23, 2013)

Ground improvement (mountain side):  
up to 36 out of 273  
(Since Oct. 19, 2013)

\* The work area is subject to change due to the on-site situation.
