National Project ‘Development of a Remote Controllable Decontamination Technique inside the Reactor Buildings’

Investigation into Contamination Status in the South on the First Floor of the Unit 1 Reactor Building

**December 18, 2013
Tokyo Electric Power Company**

Plan of an investigation into contamination status in the south on the first floor at Units 1, 2, and 3 reactor buildings

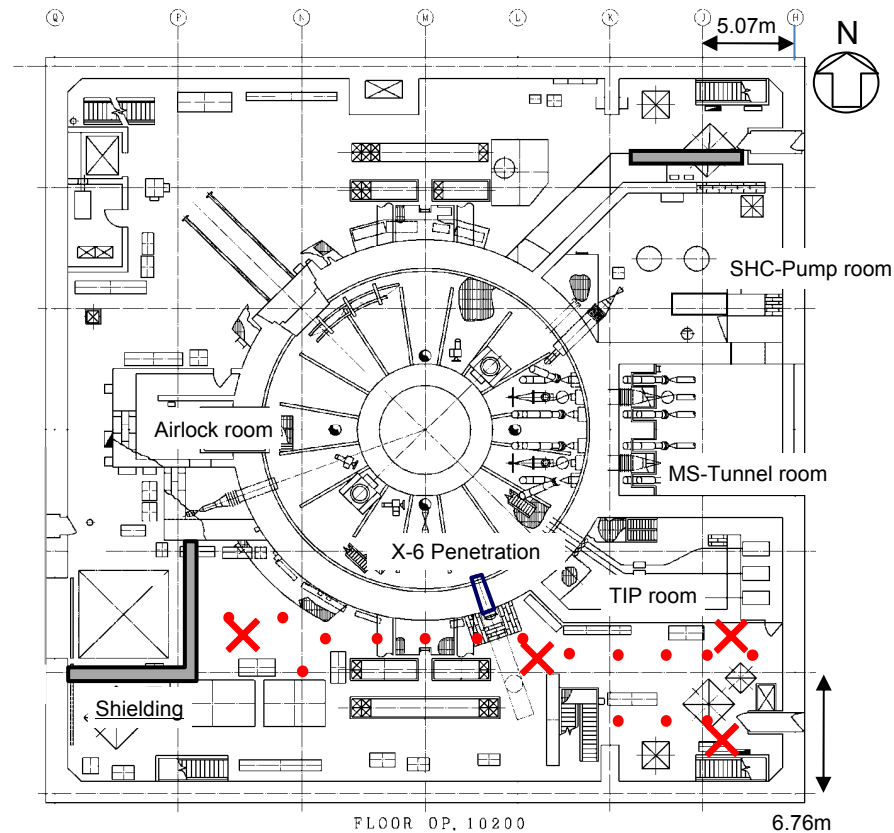
Figure 2. Investigation area (plan)

- Dose rate will be measured at every 3-meter point at the height of 5 and 150 cm (represented as • at Figure 2) in the south on the first floor. We will take photos with γ camera at the four points (represented as X at Figure 2)
- At each point, we will take photos from all directions with γ camera with various angles of elevation and rotation.

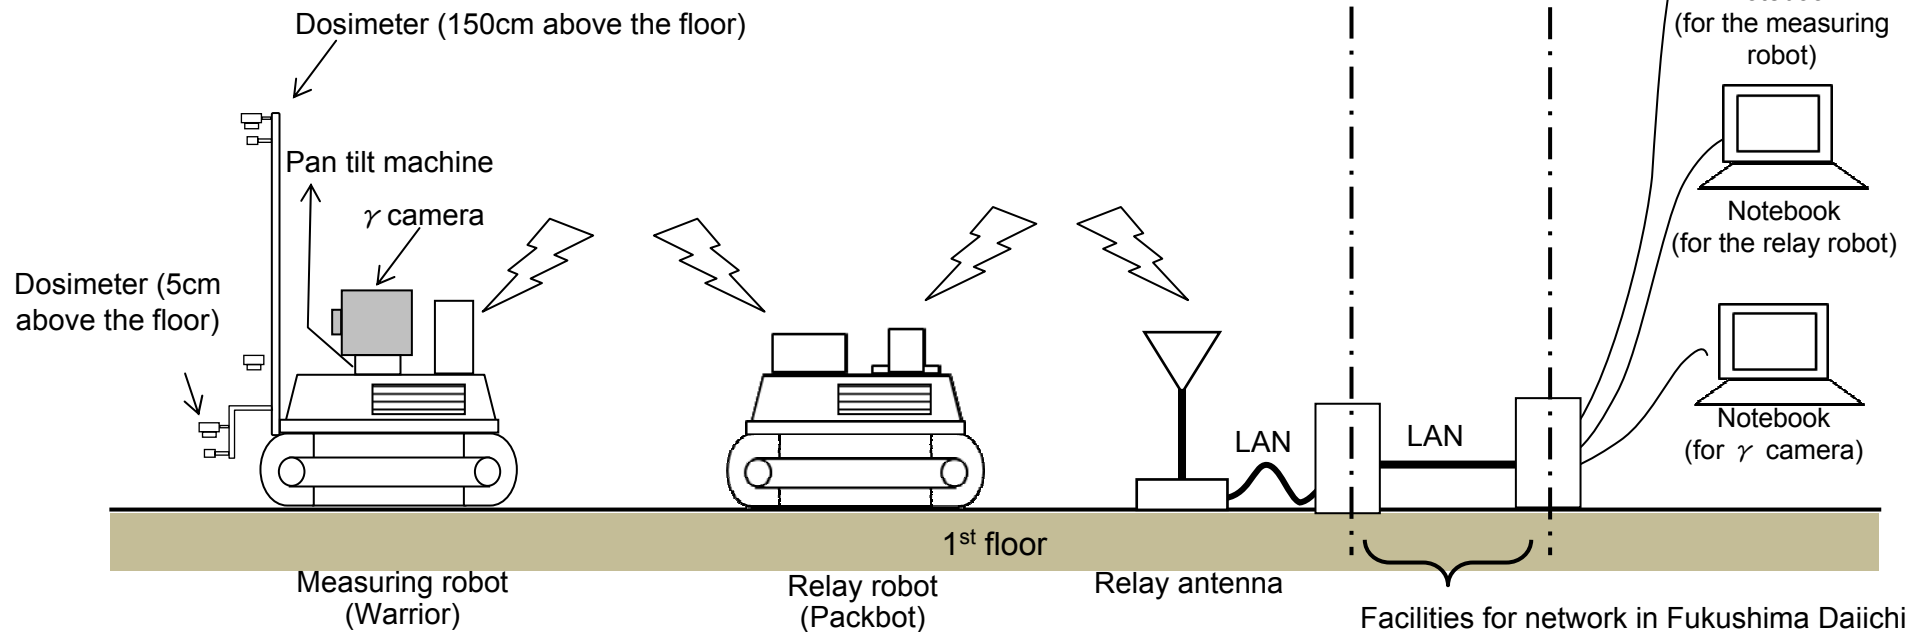
Figure 3. Structure of investigation apparatuses

- Robots and γ camera will be remote-controlled in the main anti-earthquake building via the network in Fukushima Daiichi NPS.
- The measuring robot (Warrior) will be equipped with dosimeters (at the height of 5 and 150cm above the floor) and γ camera. The relay robot will be used to support the travel and measure of the measuring robot (Packbot).
- Pan tilt machine will be installed under the γ camera in order to adjust the angle of elevation.

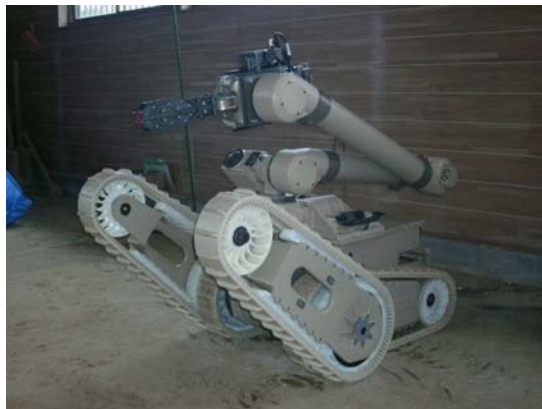
Figure 4. Warrior

Measuring robot: Warrior (made by i-Robot)

Weight: 222kg

Length: 889 mm Width: 768 mm Height: 438 mm

Operating time: 3 to 4 hours (with battery)

Traveling velocity: Max. 12.9km/h

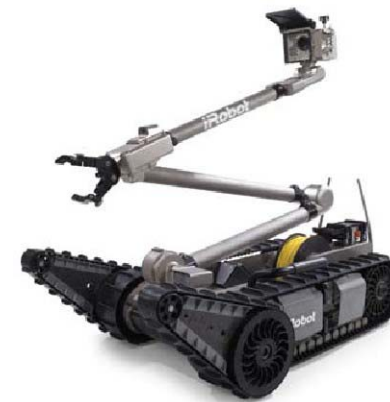
Figure 5. Packbot

Relay robot: Packbot (made by i-Robot)

Weight : Approx. 30kg

Length: 700 mm Width: 530 mm Height: 190 mm

Operating time: Approx. 8 hours (with battery)

Travelling velocity: Maxim 9.36km/h

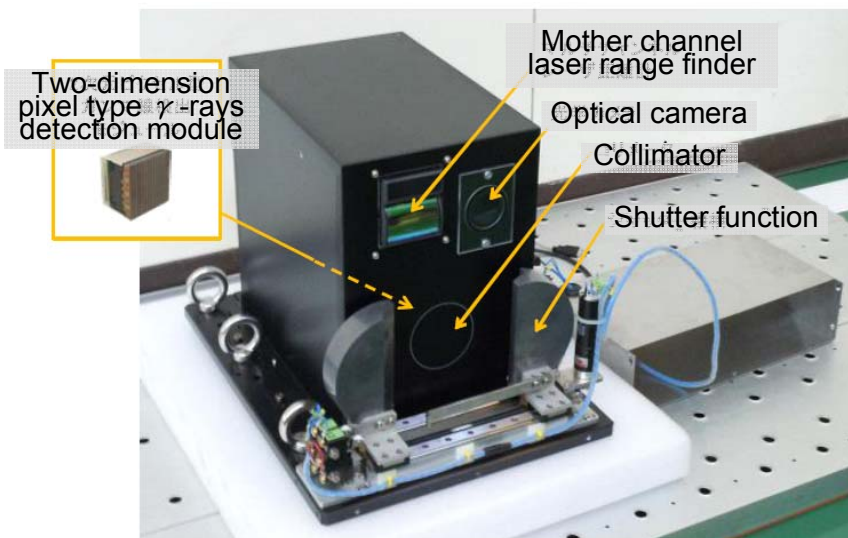
Figure 6. γ camera

- A γ camera was developed by Hitachi Ltd. in the 'research and development project of unmanned system for disaster handling' of New Energy and Industrial Technology Development Organization (NEDO).
- Specification of the camera

Size: 340mm×430mm×467mm

Weight: Approx. 80kg

Measurable background dose rate (design point): 300mSv/h

Detector: CdTe semiconductor detector (16 pixel×16 pixel)

Distance correction function: Distance correction per pixel

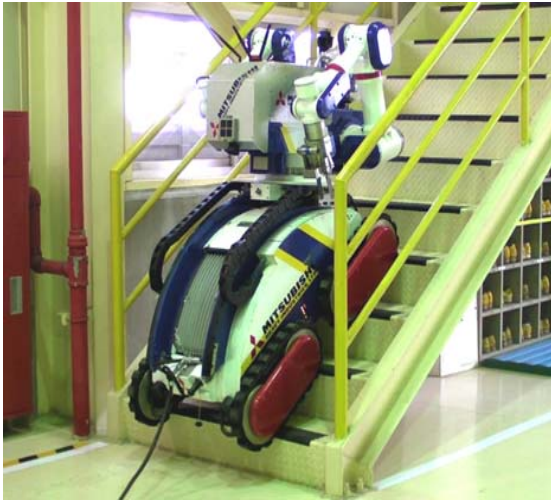
Figure 9. Traveling on stairs

The remote operated vehicle (ROV), 'MEISTeR' developed by Mitsubishi Heavy Industry has two arms: one arm equipped with core boring device and the other equipped with a chisel to cut core off. All the equipments run by electricity, therefore there is no danger of oil leak.

- Vehicle size: Length 1250mm, Width 700mm, Height 1300mm
- Weight : Approx. 550kg (Vehicle: 480kg, Core boring device: 70kg)
- Automatic following-tracking independent 4 crawlers (for travelling on ground) enable the vehicle to travel on stairs or rough/uneven ground with ease.
(However, the corridors inside the reactor building are too narrow for the vehicle to travel.)
- The vehicle automatically measures its center of gravity so that the upper equipments can be held at the right point. (Figure 9)
- The vehicle's two arms with seven axes enable the vehicle to do work such as core boring etc. (Figure 10)

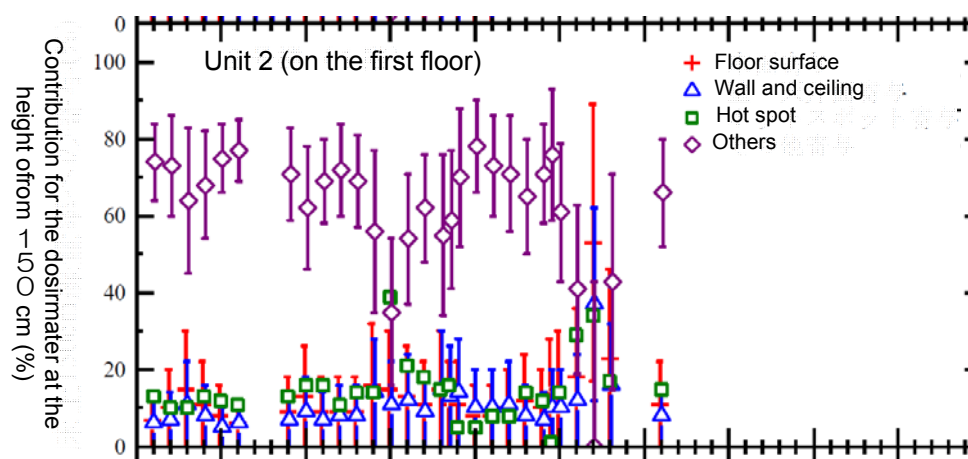
Figure 1. Contribution rate to the height of 150cm from the floor surface (on the first floor at Unit 2 reactor building)

- First floors at Units 1 to 3 reactor buildings (max. dose rate, up to 100Sv/h) were mainly investigated in a national project in FY2012. The result is as follows.
- Contribution rate for the dose rate at the height of 150cm from the floor ground from each contamination source (floor surface, wall, ceiling, hot spot, and others, mainly upper structure) was as follows:
 1. Contribution rate from the floor surface: 10 to 40%
 2. Contribution rate from the wall and ceiling: 5 to 15%
 3. Contribution rate from the hot spot: 10 to 40%
 4. Contribution rate from others mainly upper structure: 30 to 70%

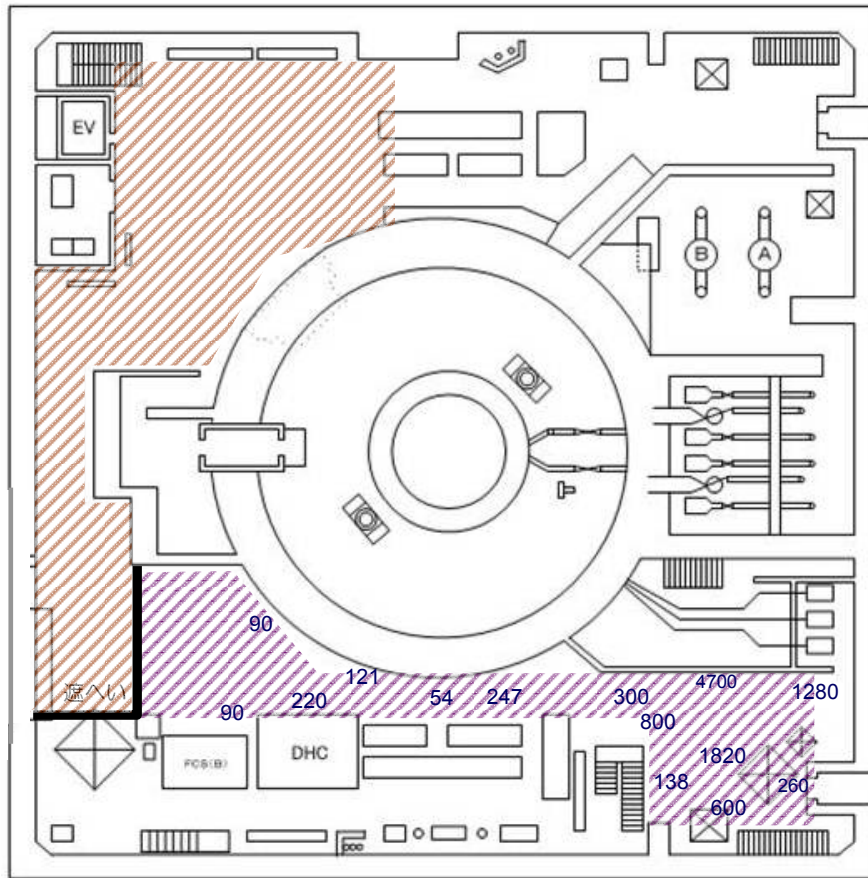
First floor at Unit 1

： Investigation area in FY 2012 (already completed)

： Investigation area in FY2013 (excluding the investigation area for the higher place*1)

*1: Investigation area for the higher places on the first floor at Unit 1 will be confirmed based on the measurement data by 3D laser obtained after December, 2013.

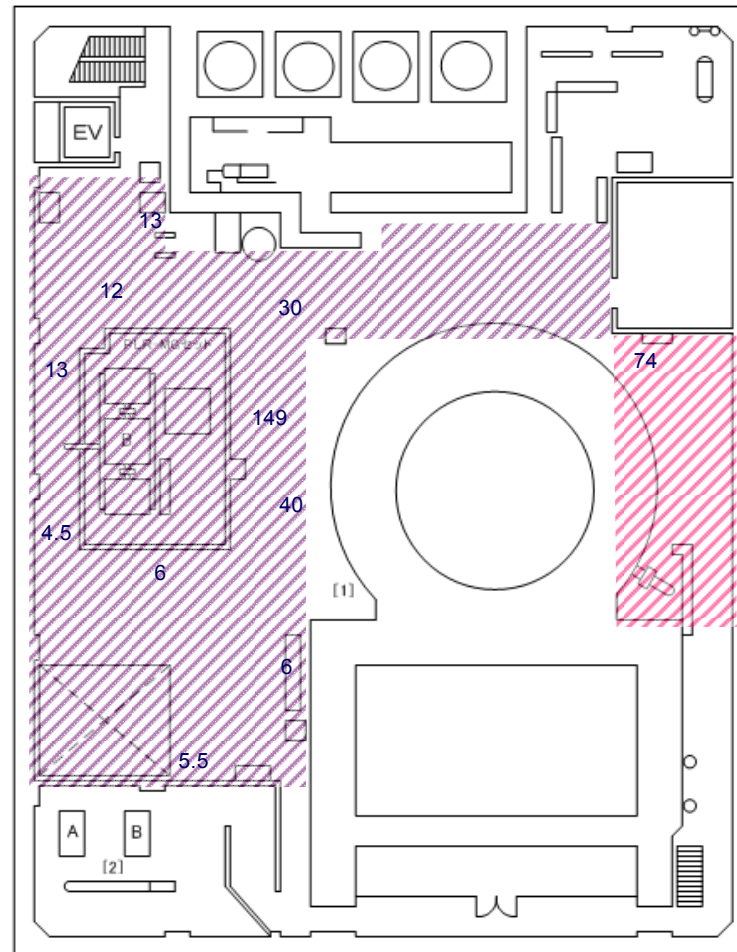
Third floor at Unit 1

: Investigation area in FY 2012 (already completed)

: Investigation area in FY2013

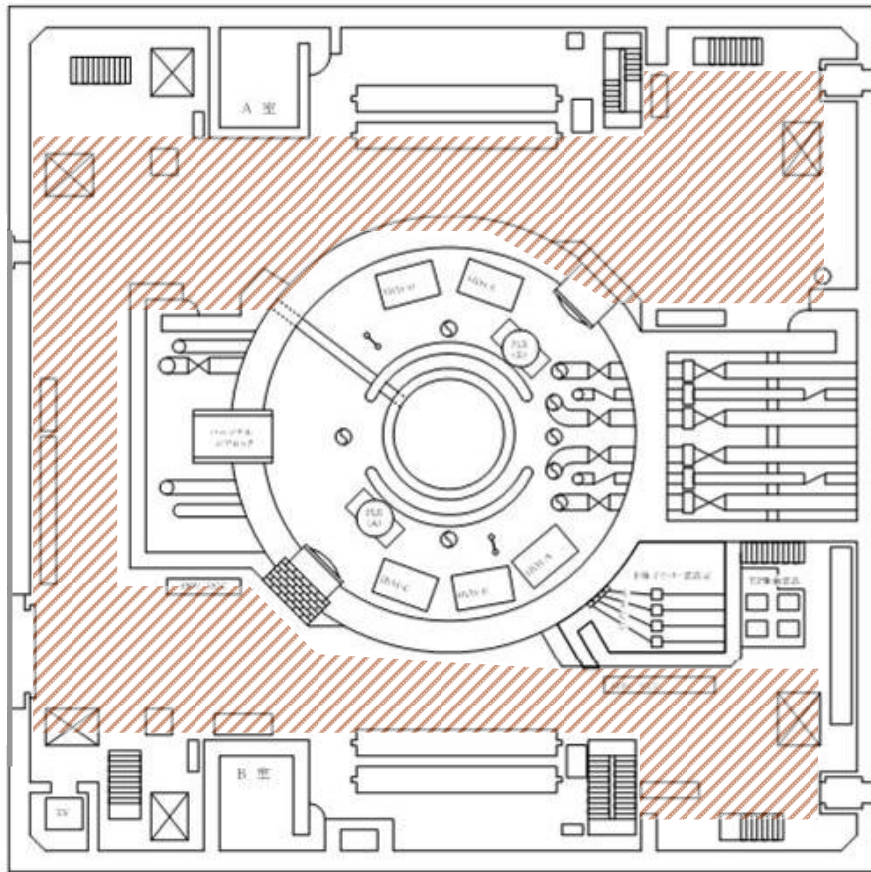
First floor at Unit 2

: Investigation area in FY 2012 (already completed)

: Investigation area in FY2013 (excluding the investigation area for the higher place*1)

*1: Investigation area for the higher places on the first floor at Unit 2 will be confirmed based on the measurement data by 3D laser obtained after December, 2013.

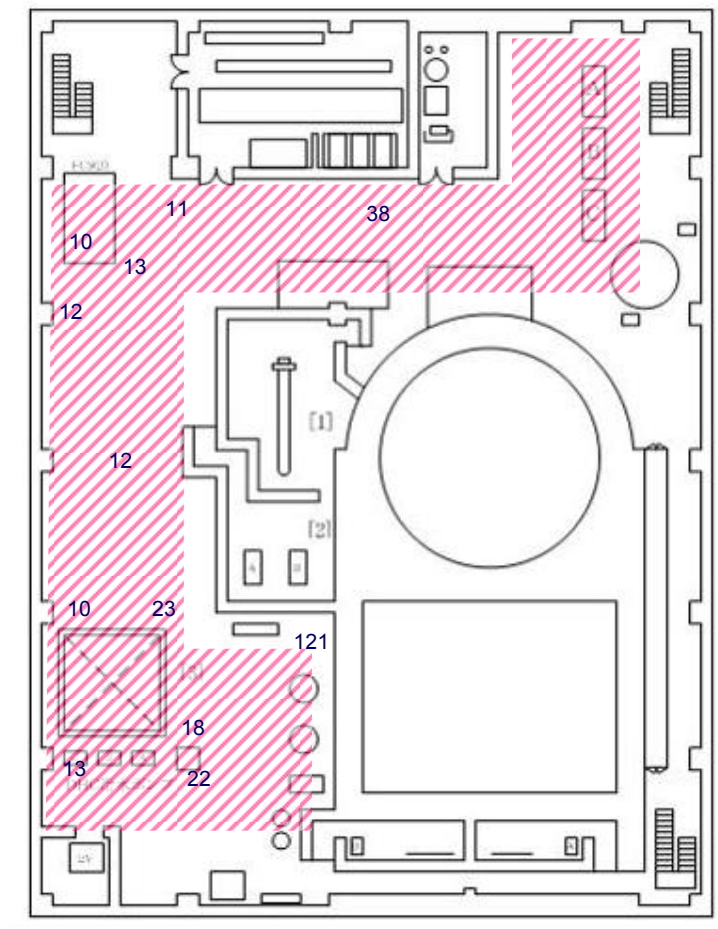
Third floor at Unit 2

: Investigation area in FY 2012 (already completed)

: Investigation area in FY2013

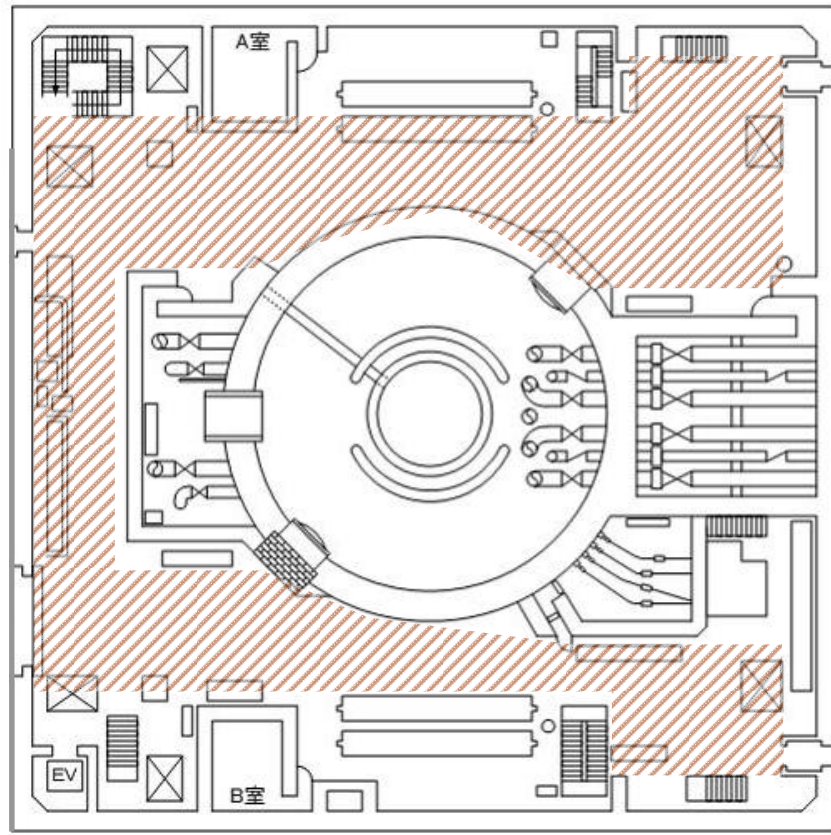
First floor at Unit 3

: Investigation area in FY2012 (already completed)

: Investigation area in FY2013 (excluding the investigation area for the higher place*1)

*1: Investigation area for the higher places at Unit 3 will be confirmed based on the measurement data by 3D laser obtained after February, 2014
