The seawall area at Fukushima Daiichi NPS

<Reference>
January 8, 2014
Tokyo Electric Power Company

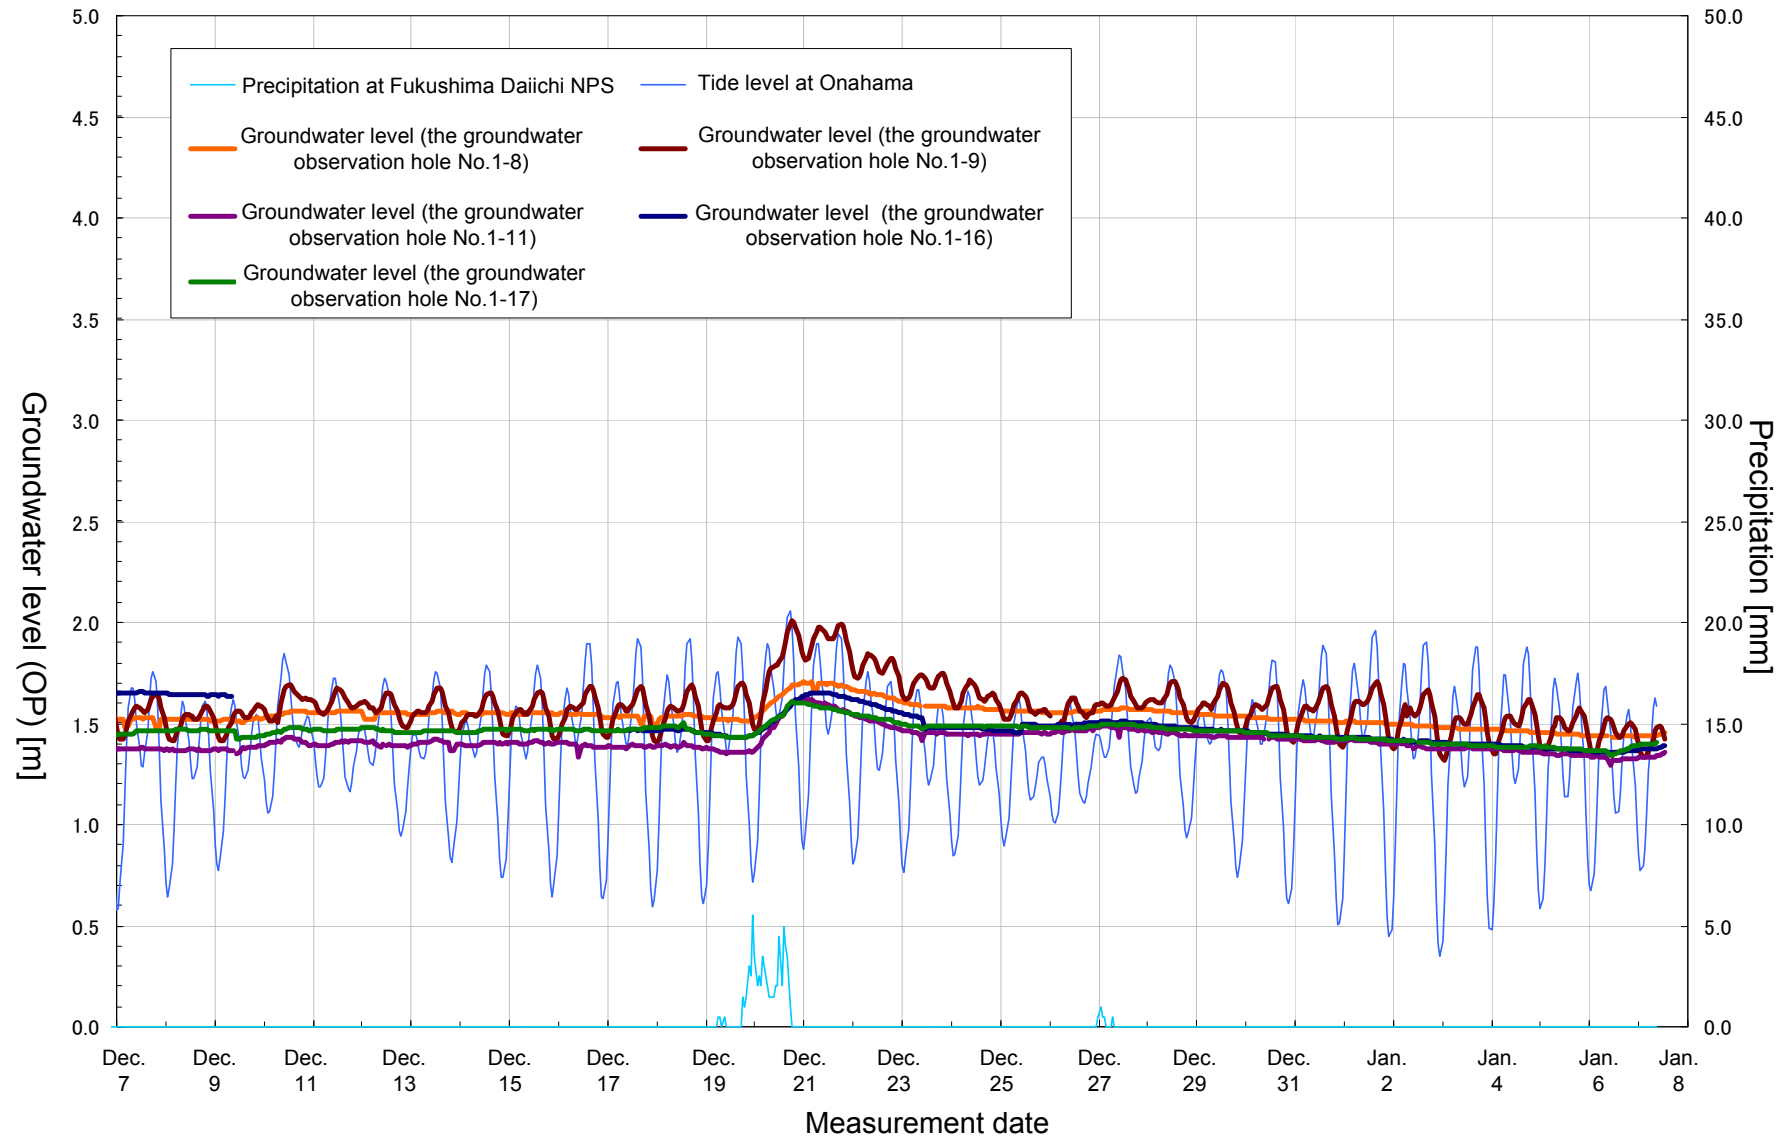
Movement in groundwater level (Between Unit 1 and 2: From Dec. 7 to Jan. 7)

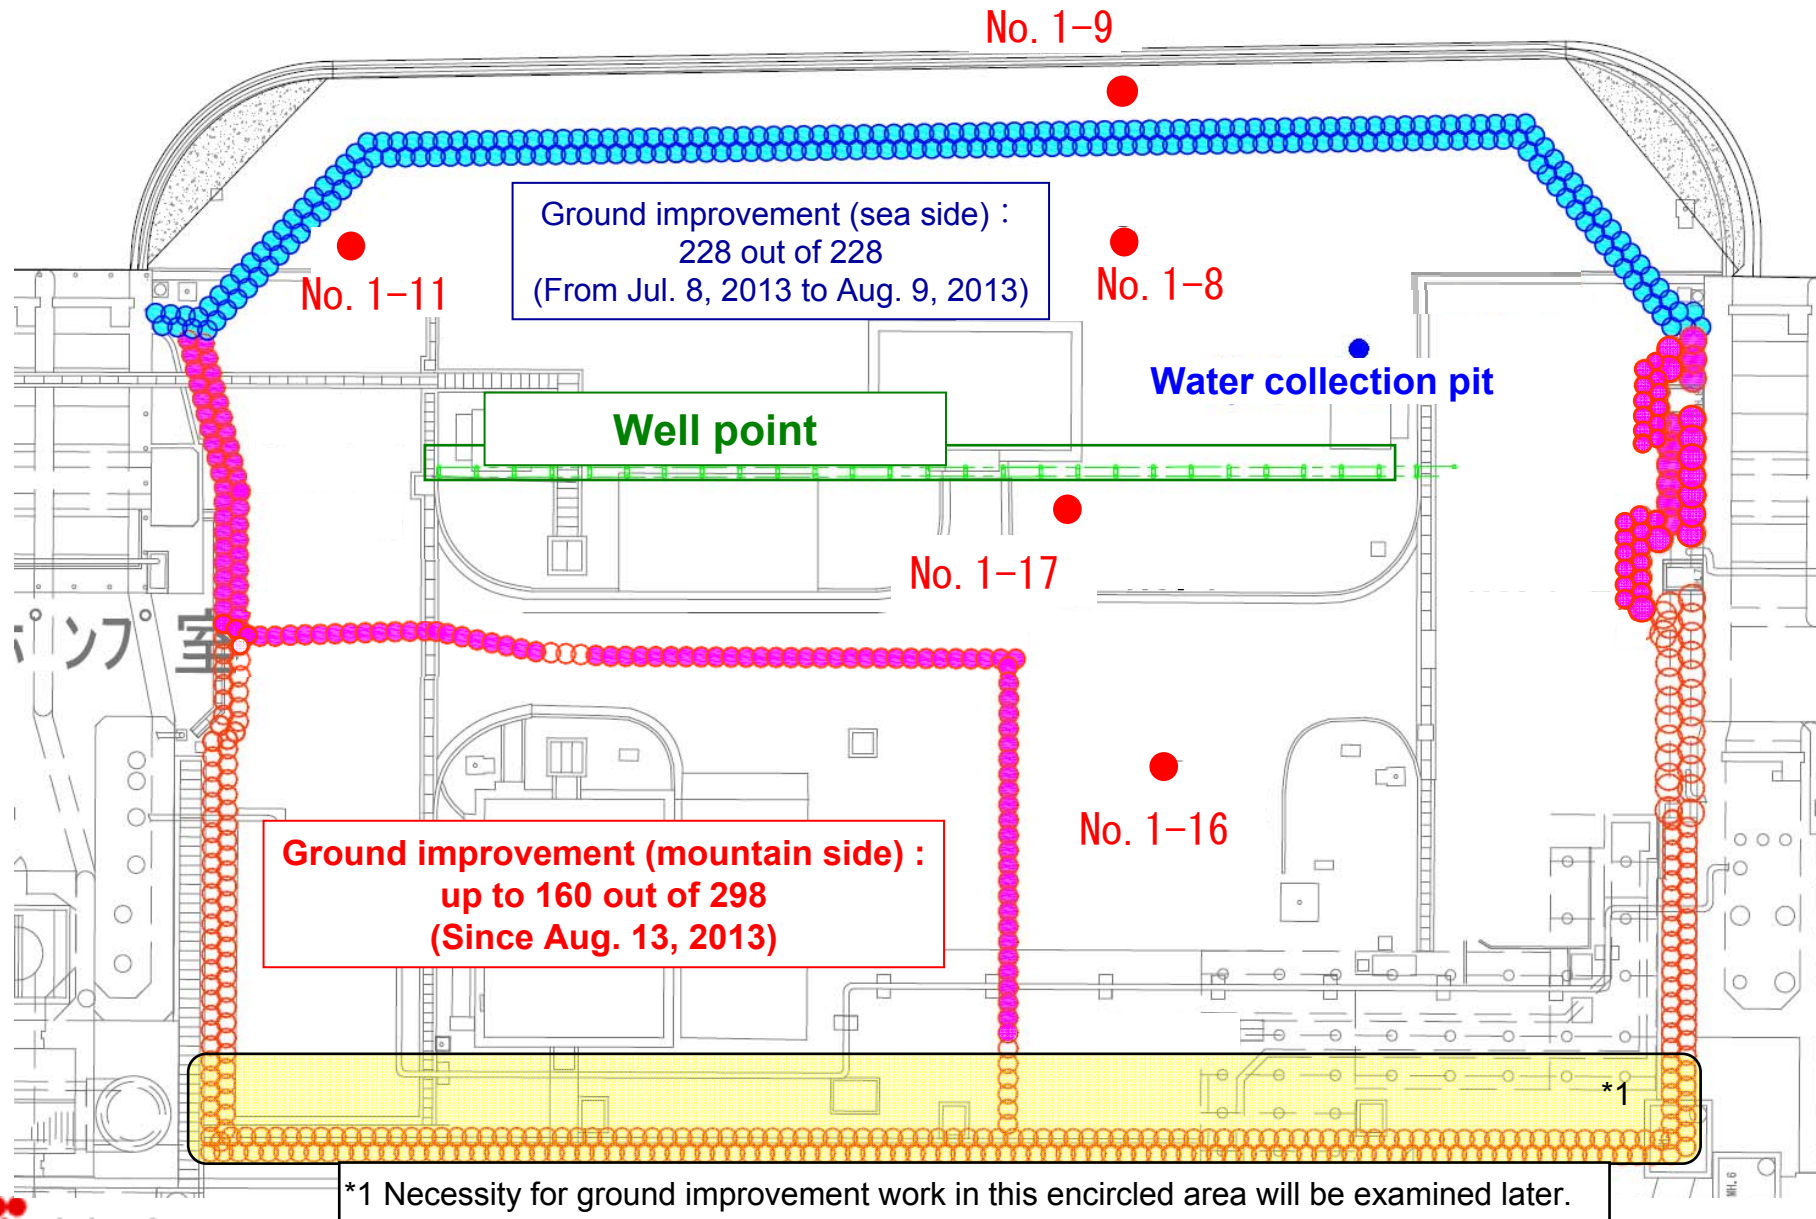
Progress in the ground improvement work between Unit 1 and 2 (As of in the morning on January 8)

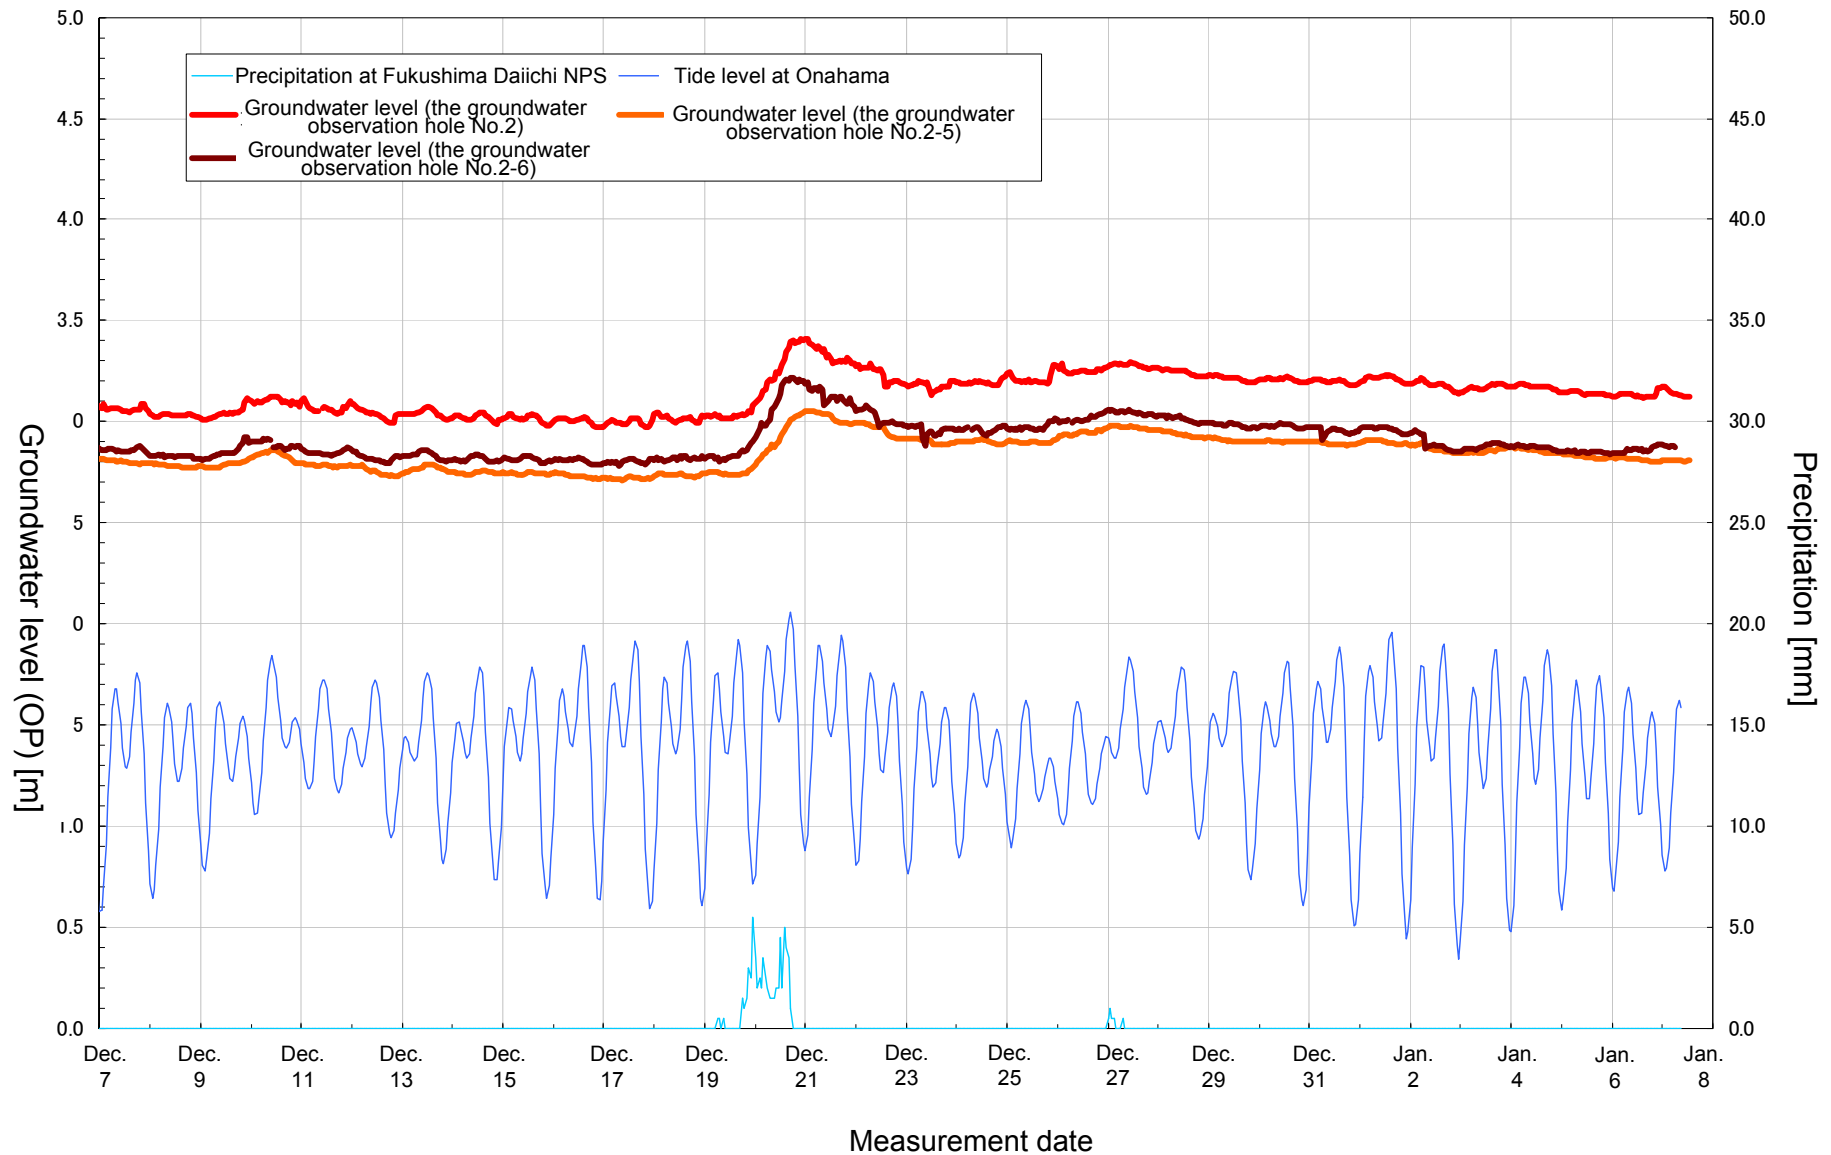
Movement in groundwater level (Between Unit 2 and 3: From Dec. 7 to Jan. 7)

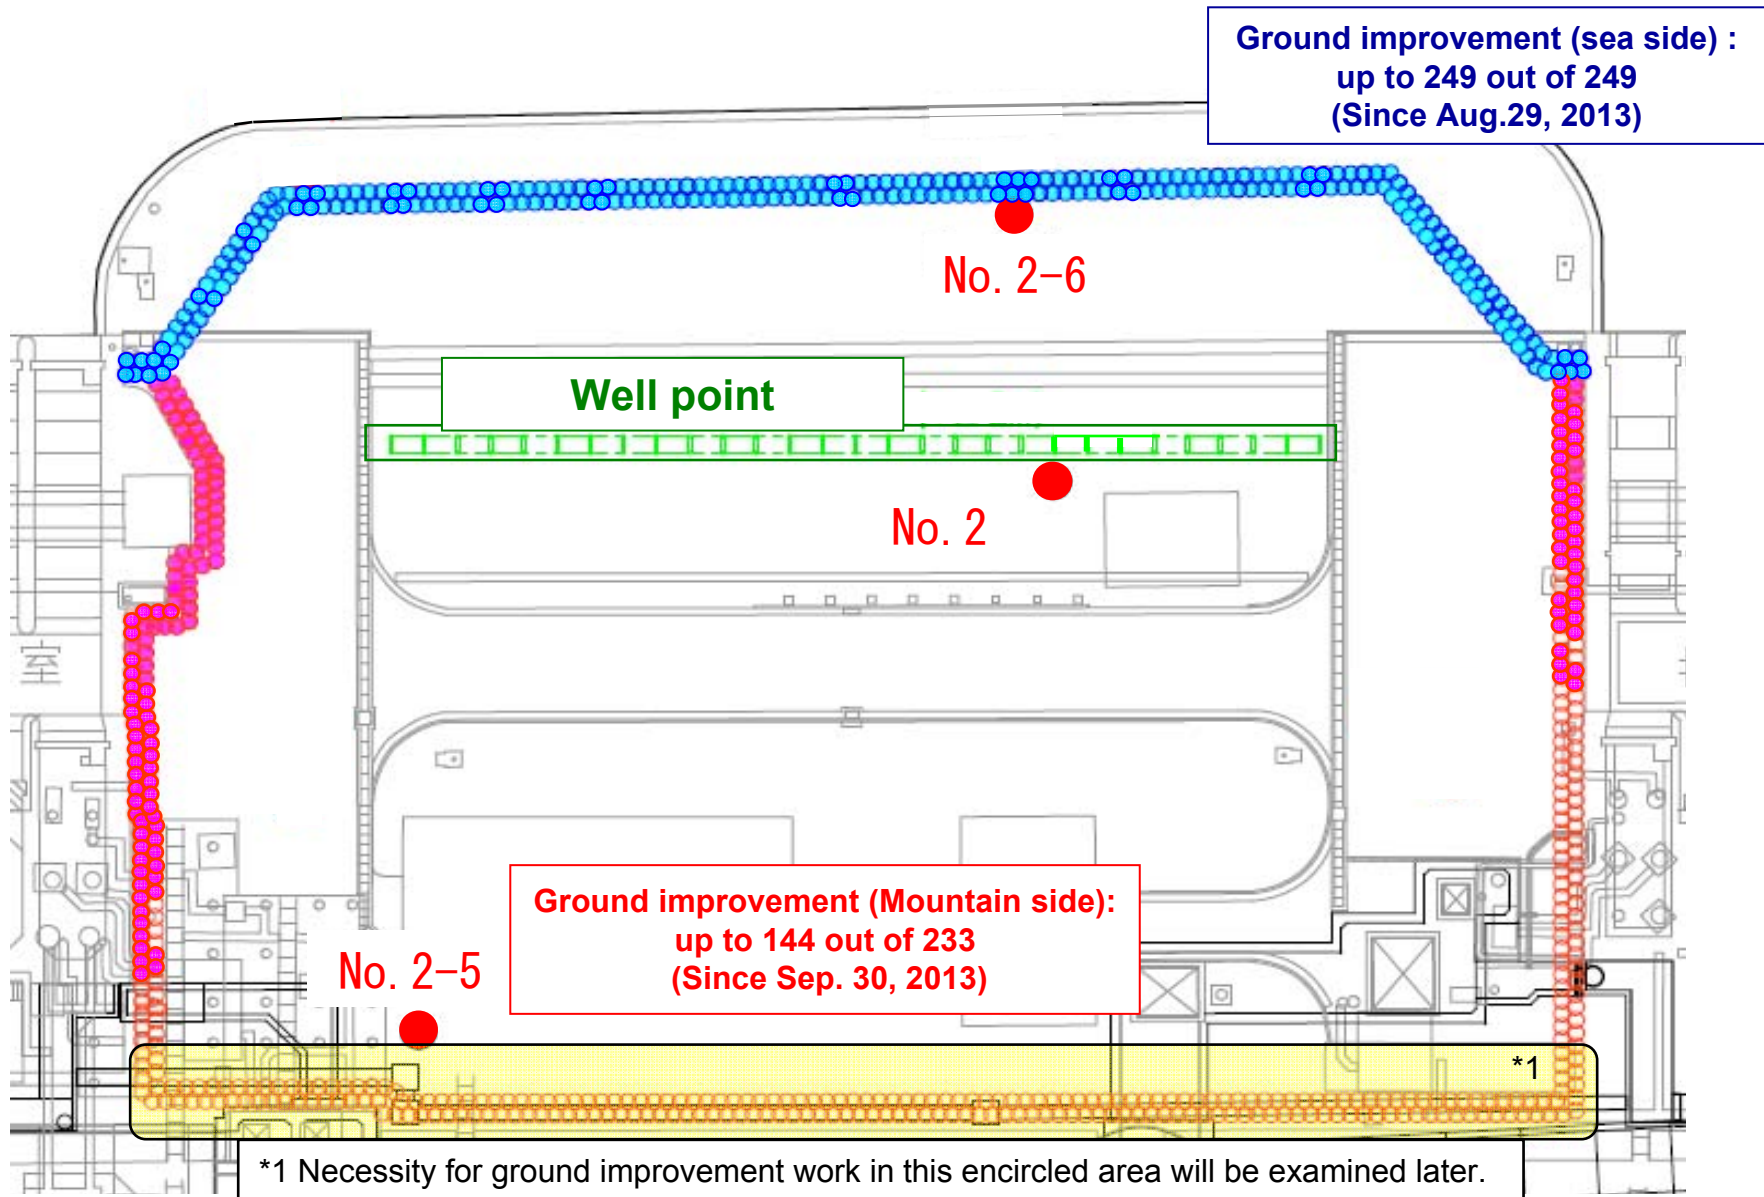
Progress in the ground improvement work between Unit 2 and 3 (As of in the morning on January 8)

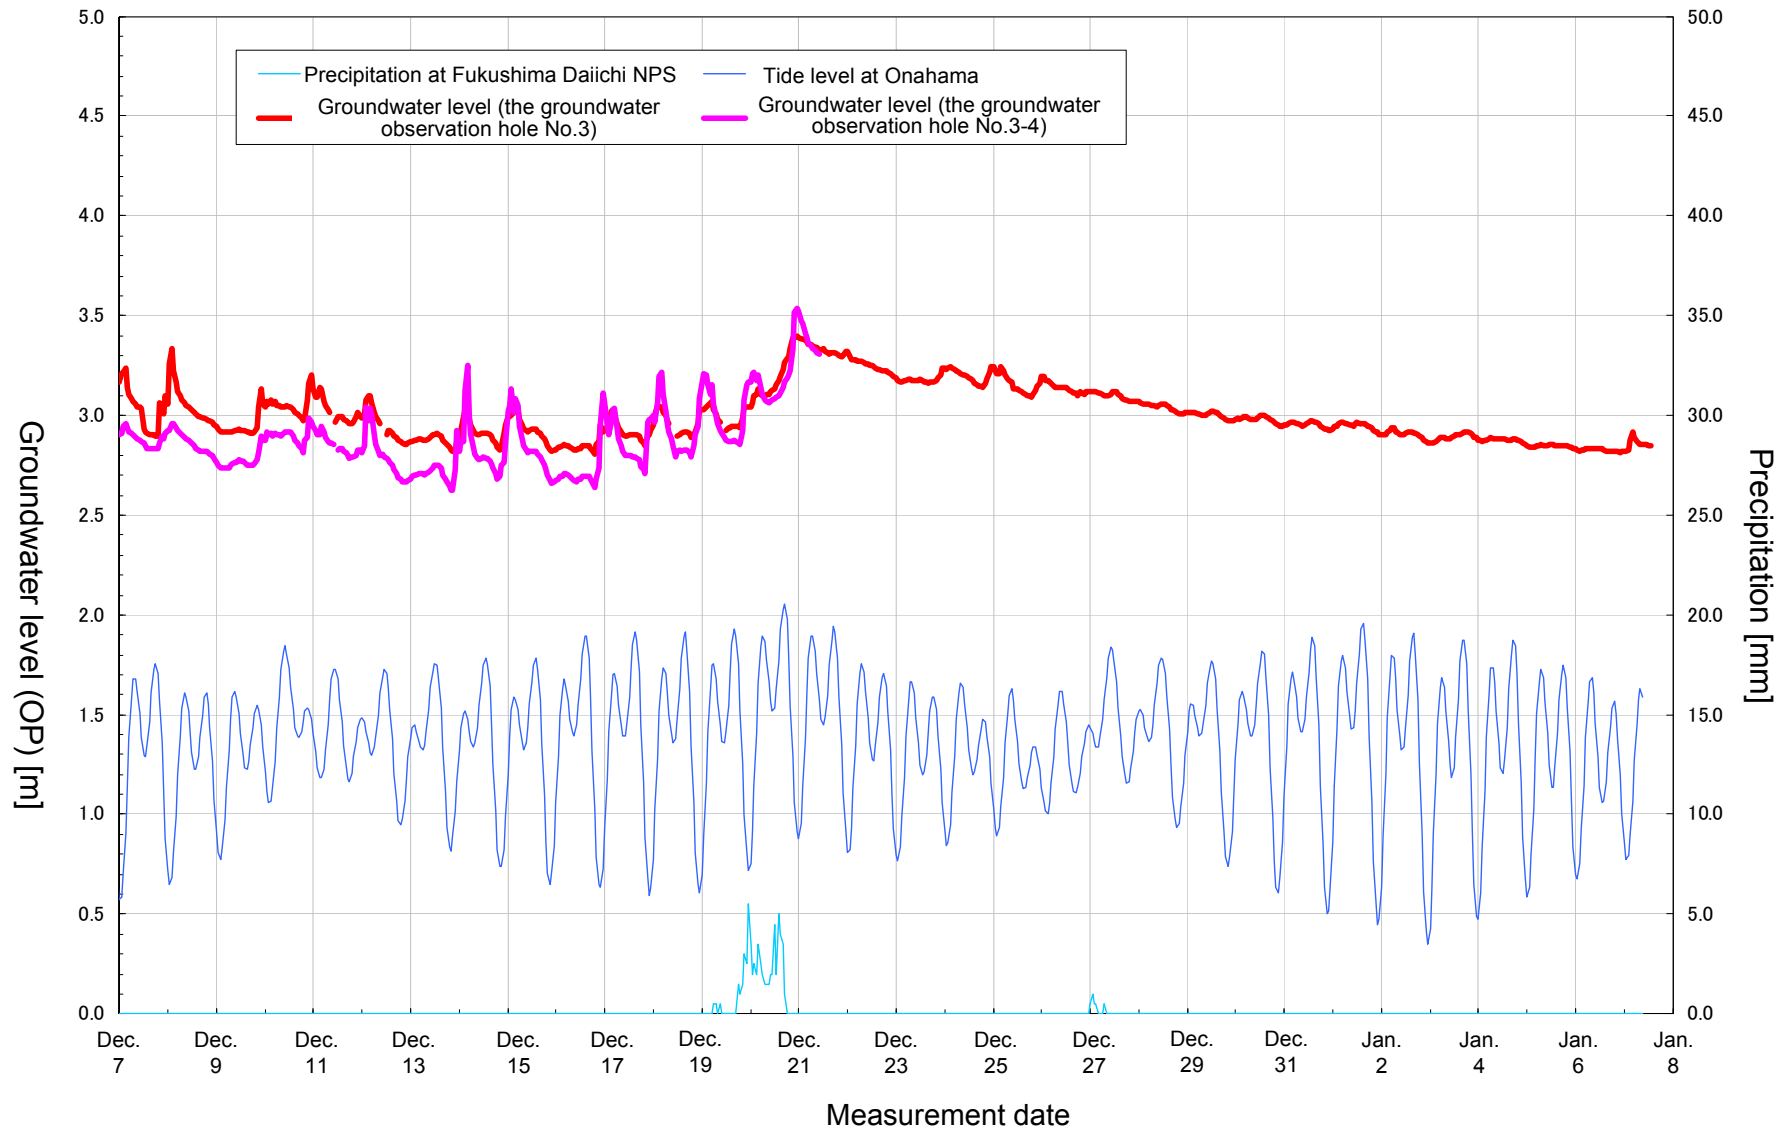
Movement in groundwater level (Between Unit 3 and 4: From Dec. 7 to Jan. 7)

* The water level gauge at the observation hole No.3-4 has been temporarily removed due to the ground improvement work.

Automatic measurement through a water level gauge

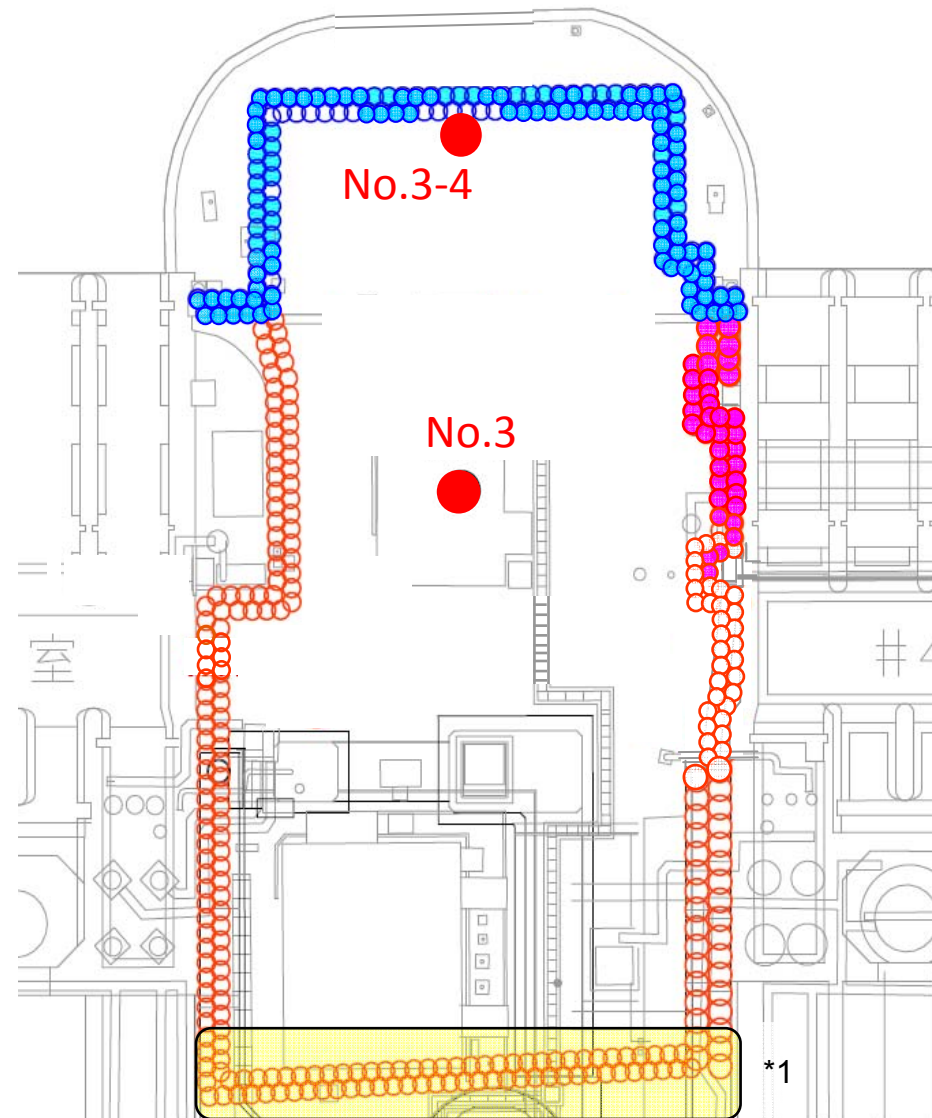
Progress in the ground improvement work between Unit 3 and 4 (As of in the morning on January 8)

Ground improvement (sea side):
up to 117 out of 132
(Since Aug. 23, 2013)

Ground improvement (mountain side):
up to 36 out of 273
(Since Oct. 19, 2013)

*1 Necessity for ground improvement work in this encircled area will be examined later.
