Water Flow Identified at First Floor of Unit 3 Reactor Building

-Water Flow from the Main Steam Isolation Valve Room to the Drainage Ditch on the Floor-

<Reference>
January 22, 2014
Tokyo Electric Power Company

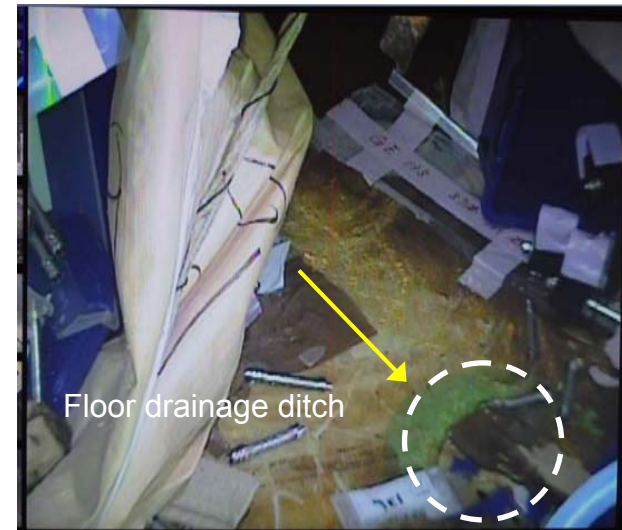
- At around 2:40 PM, a TEPCO employee found* a water flow from the door of the main steam isolation valve room in the northeast area on the first floor of Unit 3 Reactor Building to the nearby floor drainage ditch.

Flowing water (First detection on January 18)

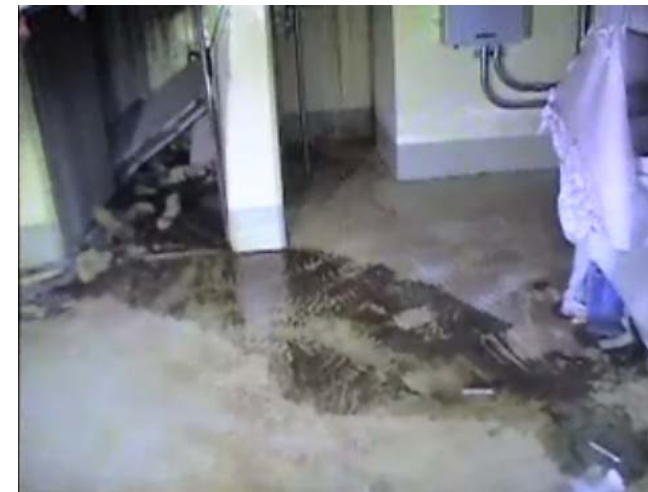
- We found that the volume of the flowing water greatly decreased when we were operating a robot to remove debris.
- No abnormality has been found in the related plant parameter since around 1:00 PM when we found the decrease of the amount of the flowing water.

Flowing water (After decrease on January 21)
