Leakage from Plastic Tank Installed on Side of H5 Tank Area of Fukushima Daiichi NPS

<Reference>
April 16, 2014
Tokyo Electric Power Company

Reproduction Test for Leakage from Plastic Tank

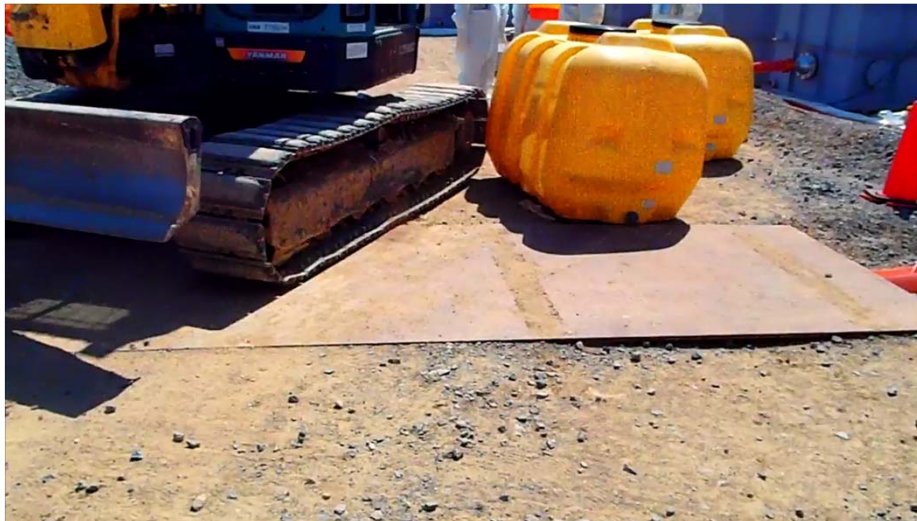
- In order to confirm whether to reproduce the damage of the plastic tank, the reproduction test with the backhoe has been carried out.
- As a result, when having the part of the caterpillar touched to the side of the plastic tank, the same hole is generated as the leakage is found.

Immediately above: Reproduction test status
Upper right: Damage of the leaked tank in the H5 area
Lower right: Damage of the tank in the reproduction test
