Fire on the bank of the road on the west side of Unit 5 and 6 within the premises of Fukushima-Daiichi Nuclear Power Station

<Reference>
April 1, 2015
Tokyo Electric Power Company

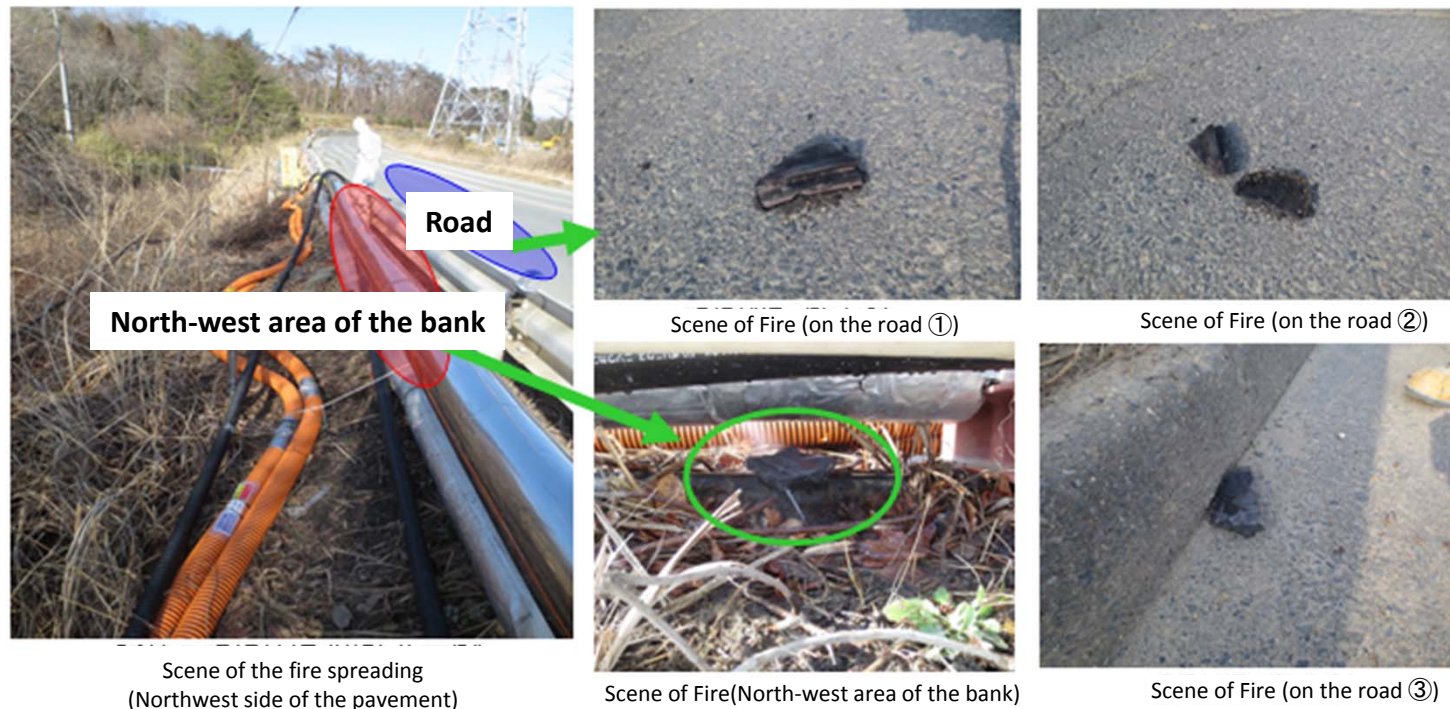
- Date and time : March 21, 2015 (Sat) , around 11:48 AM
- Scene: At the bank of the road on the west side of Unit 5 and 6, Fukushima Daiichi Nuclear Power Station.
- Discoverer : Cooperative company workers
- Area burned: 2 locations [approx. 2m X 15m, and approx. 2 m X 10 m]

On the day the fire occurred, some pieces of a vehicle were found on the road and in the area burned as a result of the on-site investigation. Since these were deemed as the cause of the fire, subsequently on a later day, an investigation was conducted on vehicles which might have run around the area.

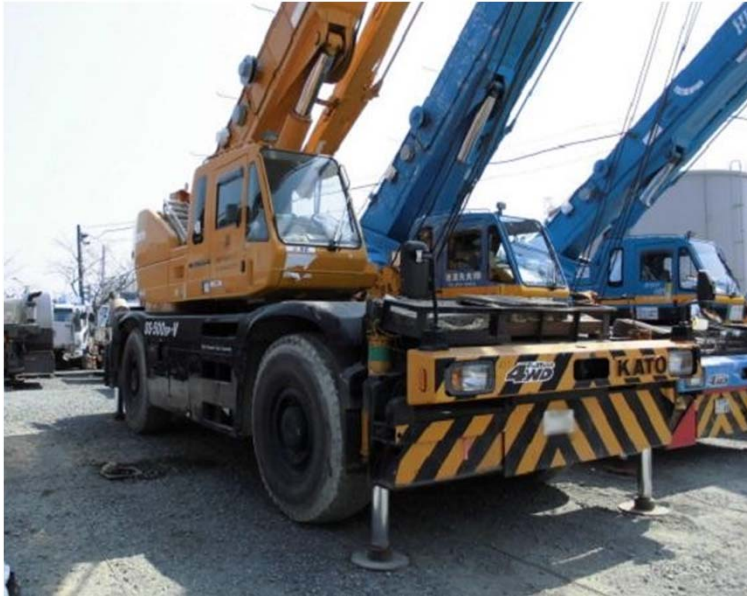
In the investigation, a 50t class wheel crane was found with its parking brake partially damaged. Since the shape of the pieces left on the scene were closely matched with that of the damaged part, the crane was identified as the car concerned.

50t class wheel crane identified [photo taken on Mar 30, 2015]

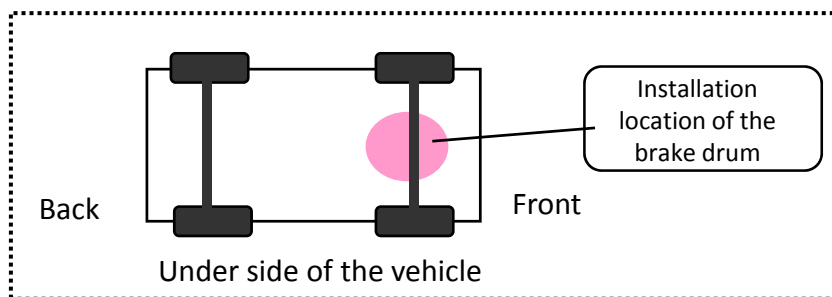
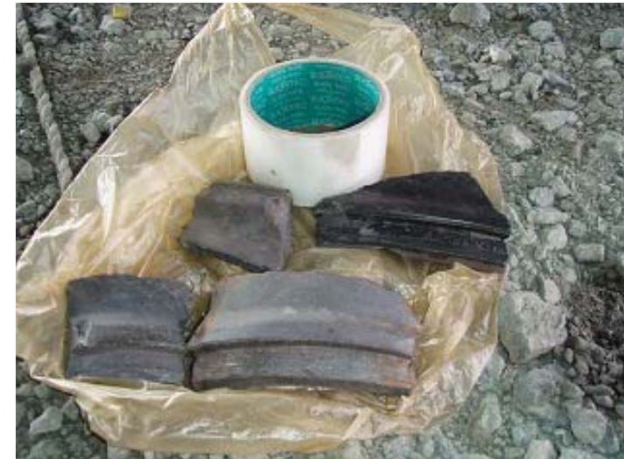
Pieces left on the scene [Photo taken on Mar 30, 2015]

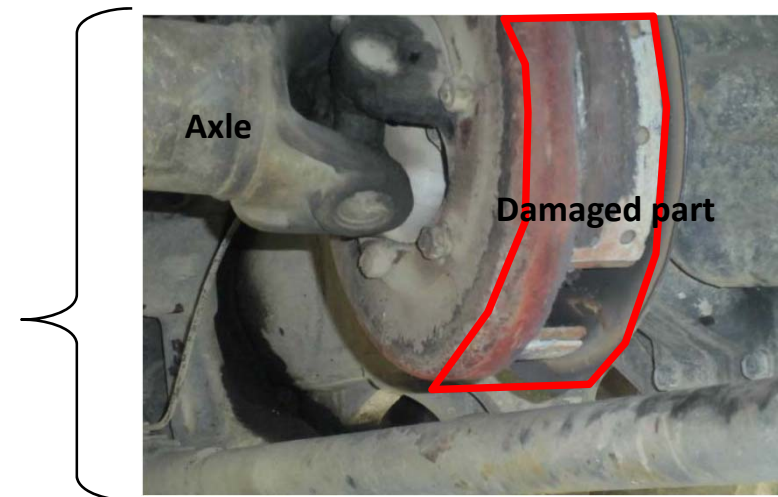
The damaged part of the brake drum
(Photo taken on Mar 30, 2015)
