- On August 2nd, after removing the FHM (Fuel Handling Machine,) substantial progress in rubble removal for Unit 3 was made, a major milestone for fuel removals and decommissioning to follow.
- On August 4th, we conducted an investigation of the piles of rubble with an underwater camera in the Unit 3 Spent Fuel Pool at Fukushima Daiichi Nuclear Power Station.

<Investigation results>

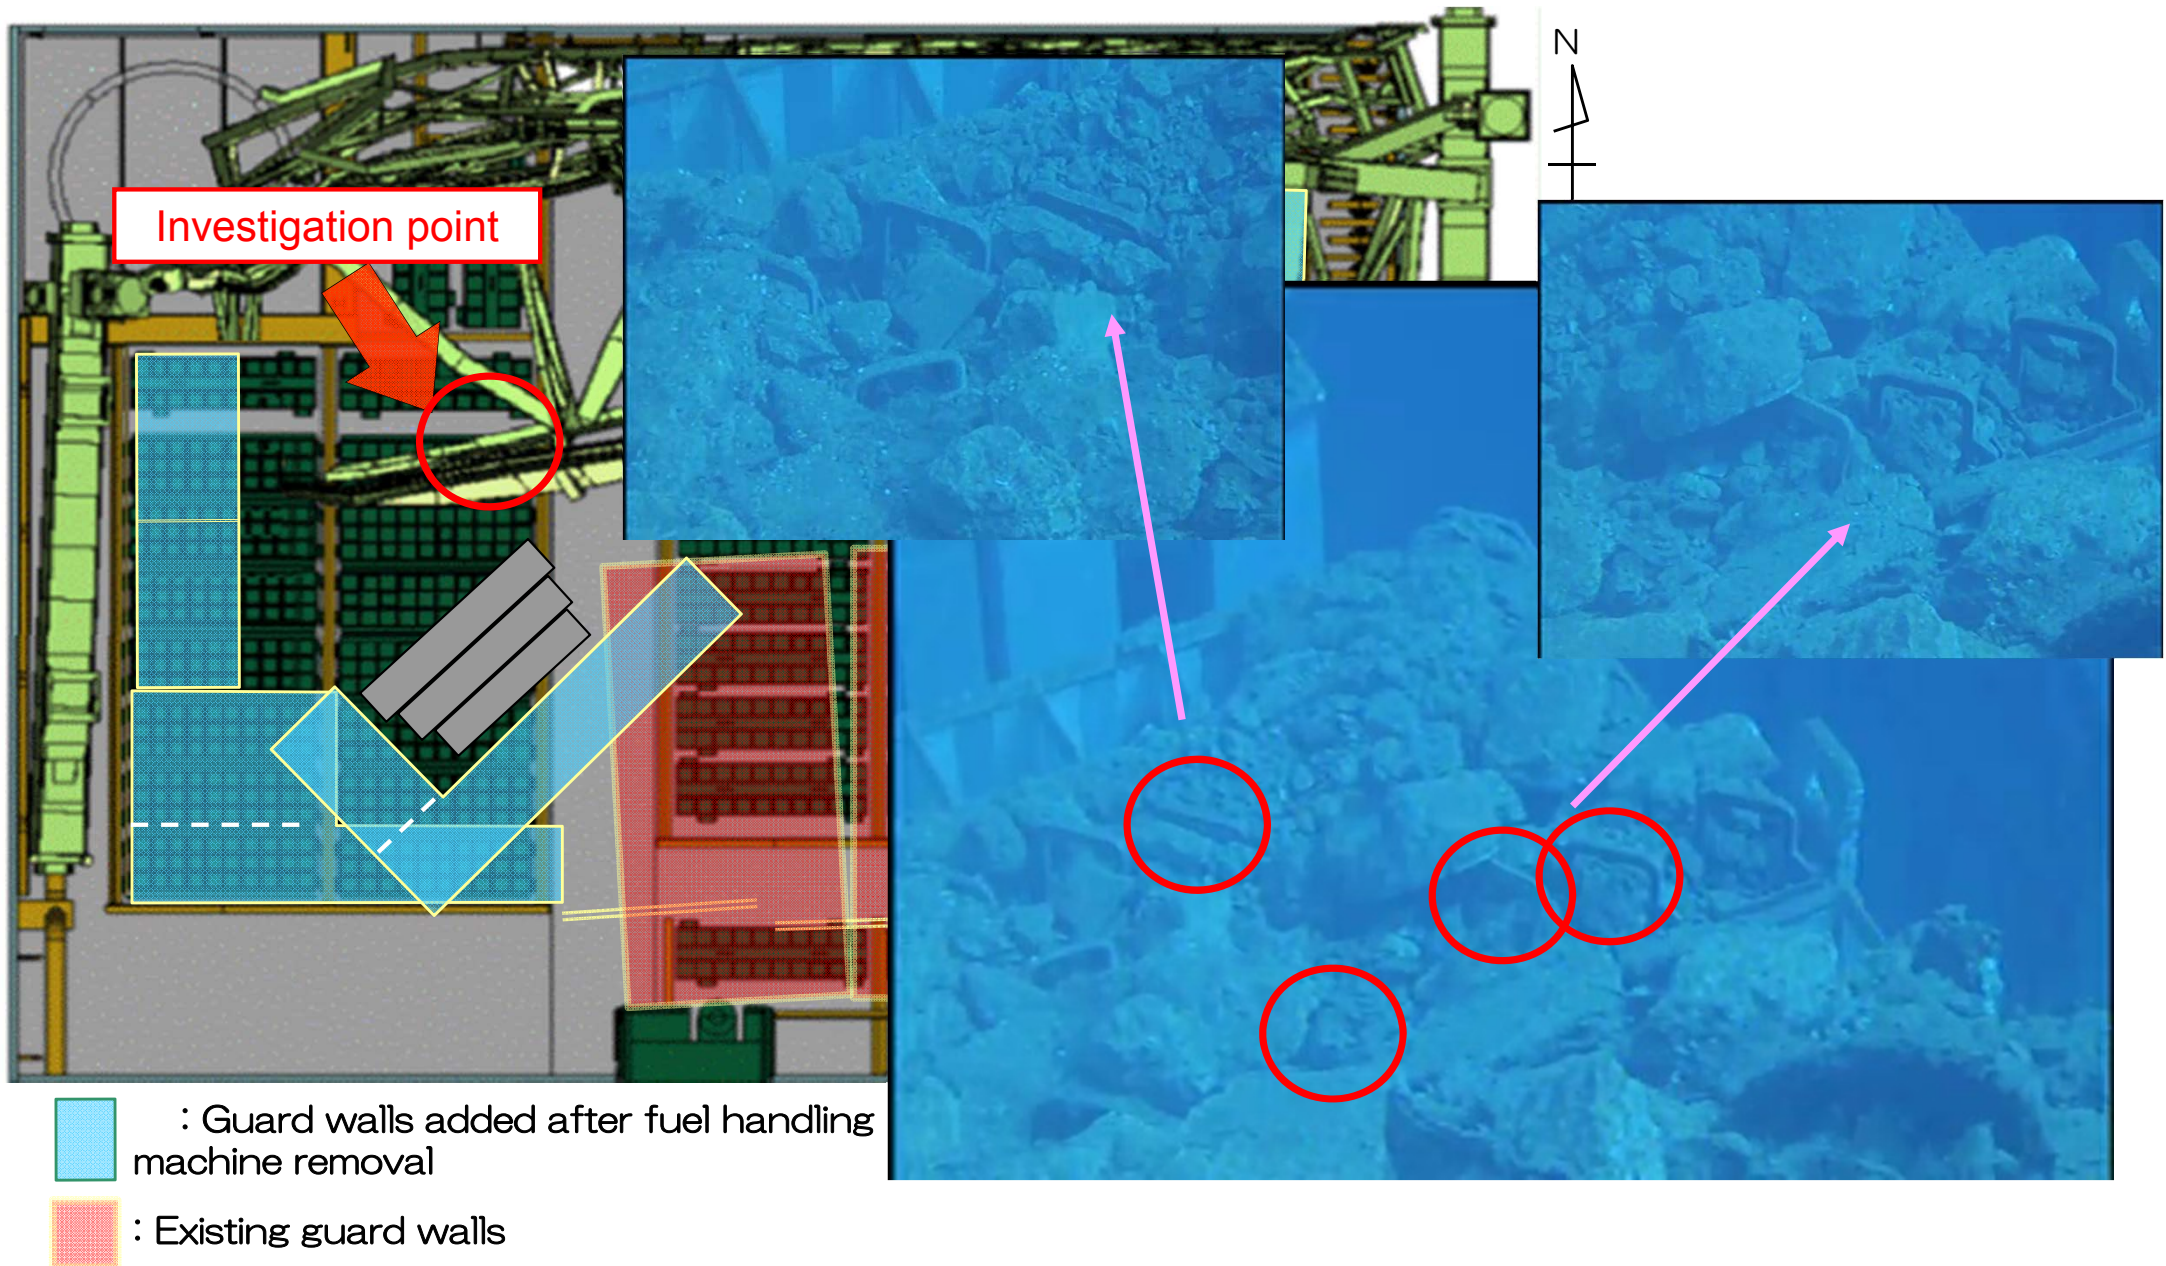
Investigation point / Footage from underwater camera

- At around 9:05 A.M., we found bent handles of 4 nuclear fuel assemblies located under the Fuel Handling Machine which was removed on August 2nd, during the underwater camera investigation in the Spent Fuel Pool.
- There was no significant change in radioactive material concentration in the water of the Spent Fuel Pool which we collected on August 3rd. We found no significant change in the monitoring post data before and after the removal of the FHM which means there is no indication of new fuel failure by the removal and no impact to the surrounding environment.
- In the future, when discussing fuel removal, we will consider how to deal with the bent handles of nuclear fuel assemblies.
