Tokyo Electric Power Company Holdings, Inc.

Unit 1 Primary Containment Vessel (PCV) Investigation
at Fukushima Daiichi Nuclear Power Station

1. Work steps for Unit 1 PCV investigation

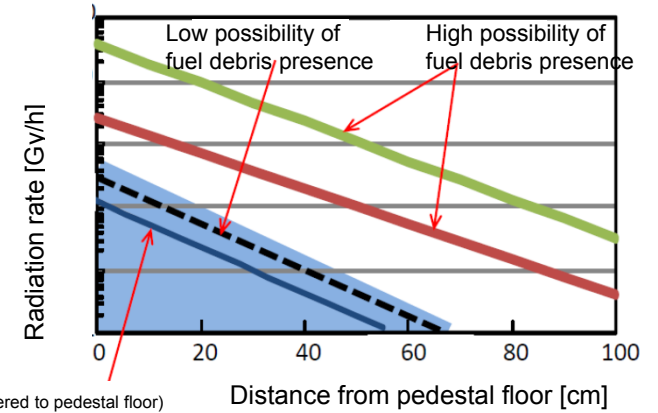
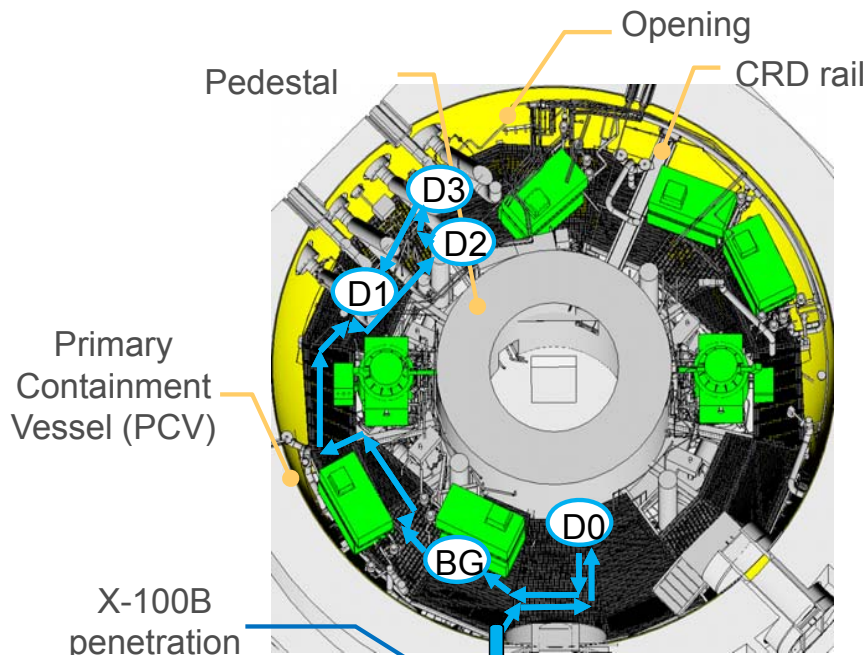
Access route on 1st floor metal grating for a self-propelled investigation device

- Presence of fuel debris will be estimated from the comparison of radiation doses and distances subtracted from the background data.
- It is necessary to compare and evaluate digital images and radiation data because radiation levels can increase locally around the pipes connected to the reactor. Evaluation results will be provided later after organizing the data.

Measurement points	Estimation
D0	Spreading of fuel debris from drain sump
BG	Background levels against D0-D3 measurements
D1, D2	Spreading of fuel debris from opening
D3	Possibility of fuel debris reaching to PCV shell

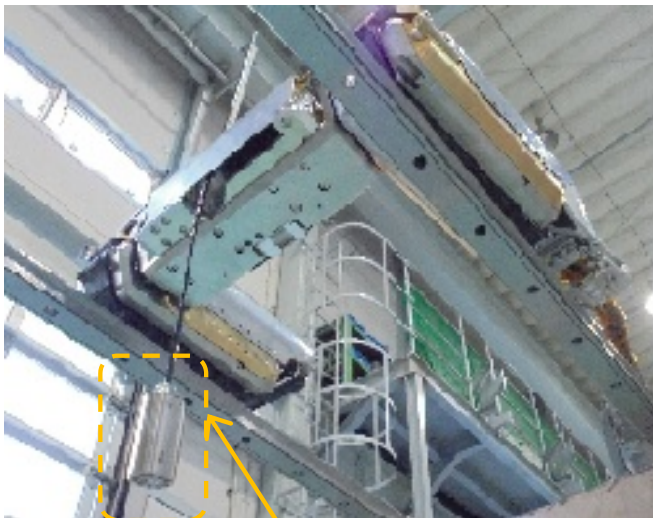
When capturing digital images and measuring radiation doses

Sensor unit integrating a camera and dosimeter

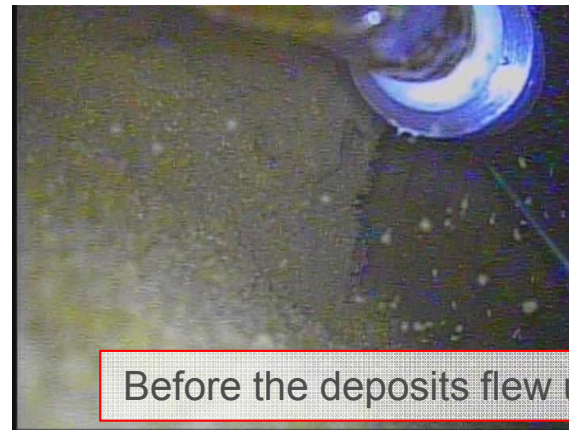
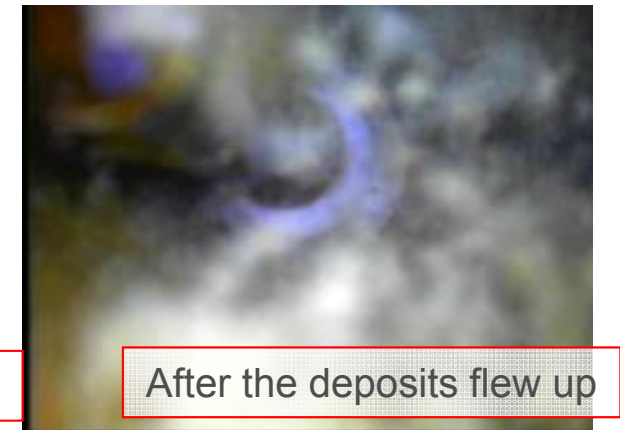
Conditions of deposits when reinstalling a permanent monitoring instrument (announced in January 2016)

- It was observed that floating deposits flew up within the PCV retained water when a permanent monitoring instrument was reinstalled after the previous investigation (April 2015).
- Sampling of the deposits at the bottom of PCV will be conducted to identify them and determine how to remove and treat them because they can pose obstacles to the future investigation and fuel debris removal.
- The sampled deposits will be analyzed with the simple X-ray fluorescence in a glove box to find the component.
