Internal Exploration of the Unit 2 Primary Containment Vessel (PCV) ~Reevaluation of Dose Rate Estimate~

July 27, 2017

Tokyo Electric Power Company Holdings,
Inc.

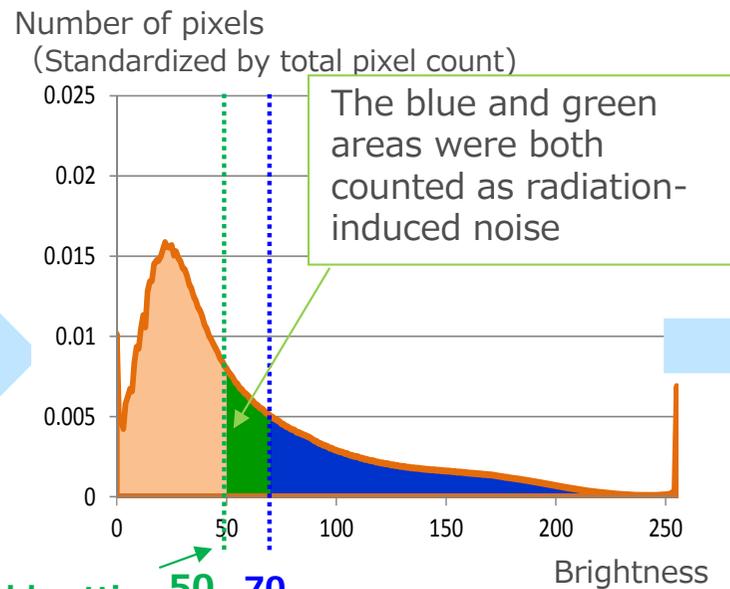
Brightness distribution

■ During calibration using irradiation tests it was assumed that radiation levels inside the PCV are quite high, so pixels brighter than the threshold level of 70 were counted as being noise caused by radiation. However, when making preparations to conduct the internal exploration of the PCV in a low radiation level environment, the threshold values were lowered to 50 in order to check operation of the equipment, but were never returned to 70 before conducting the PCV internal exploration.

■ Therefore, pixels that should NOT have been counted because they fell below the brightness threshold value were counted as being radiation noise thereby inflating the pixel count and resulting in an overestimated dose rate.

Threshold setting 50 during PCV internal survey

70 Threshold used for calibration curve creation

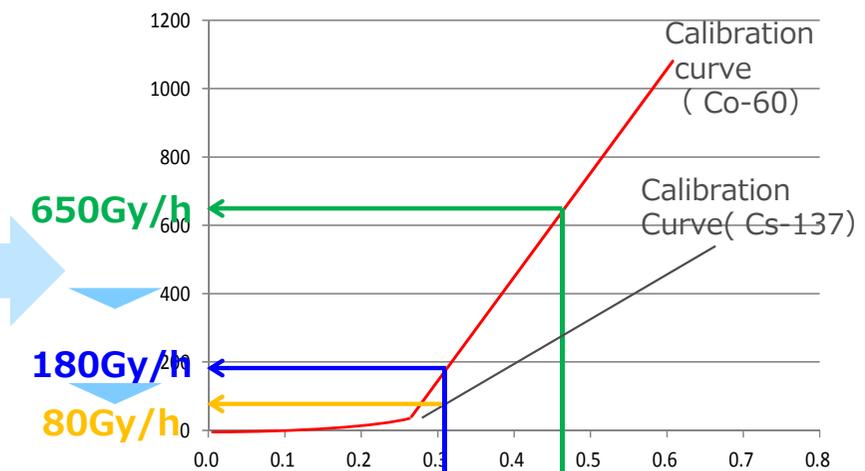
■ Furthermore, whereas dose rates were estimated using a calibration curve based upon camera irradiation test results using Co-60 radiation sources, the dominant source of gamma radiation inside of the Unit 2 PCV is assumed to be Cs-137, so irradiation tests and analysis were conducted to examine the amount of noise produced by Cs-137.

■ It was confirmed that Cs-137 causes more noise than Co-60, thereby resulting in overestimates of dose rates.

Dose rate [Gy/h]

Number of pixels for radiation noise at threshold 50

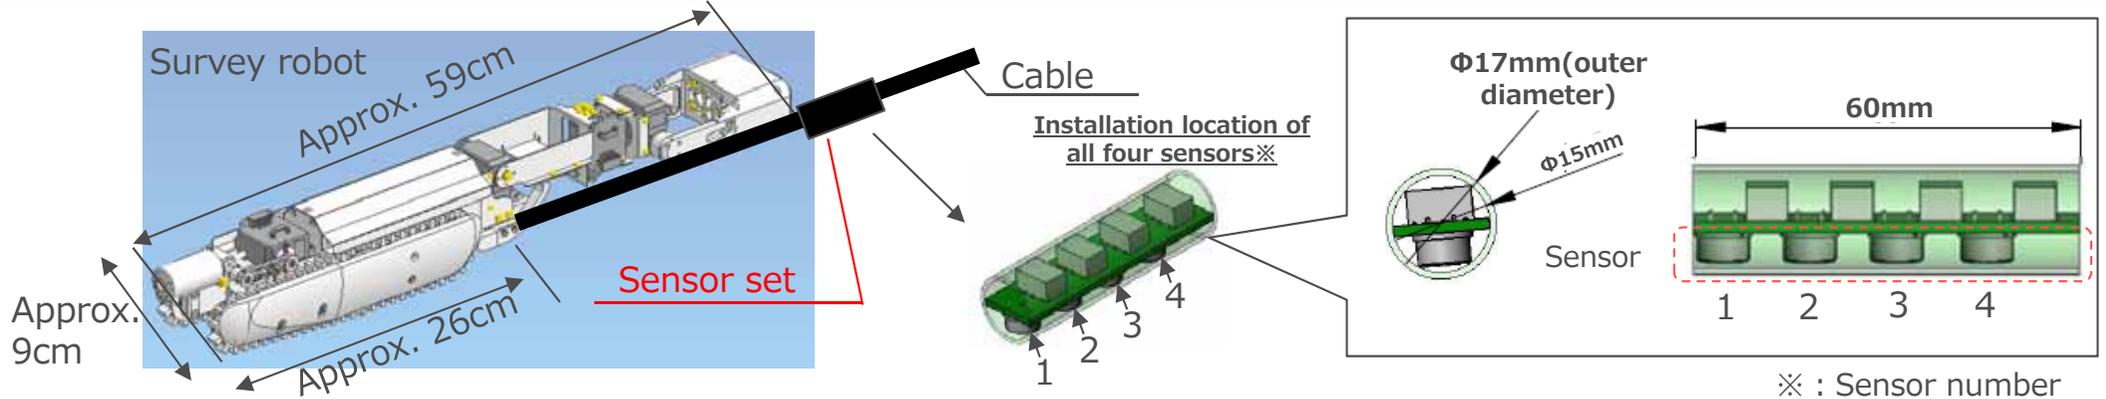
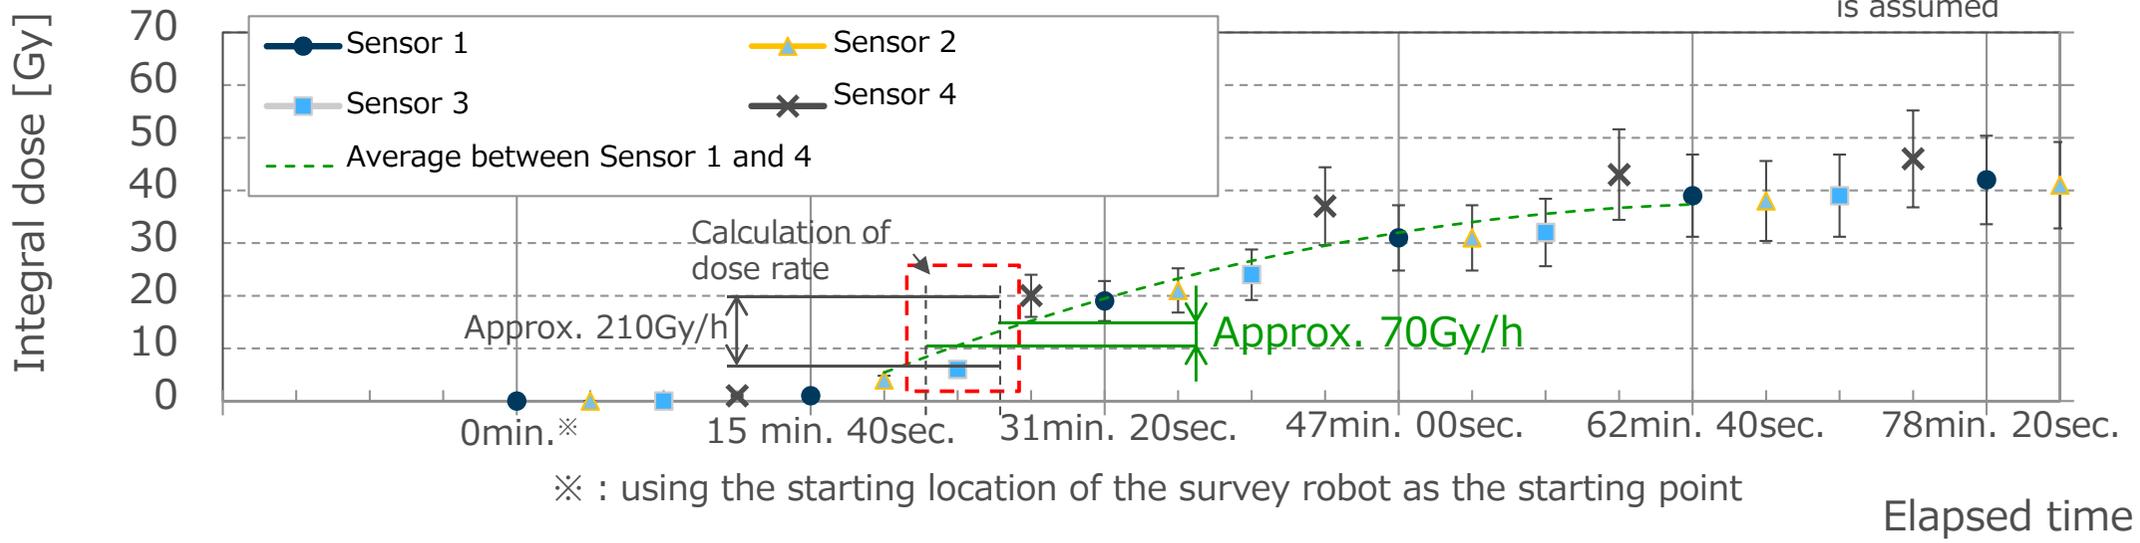
- When using the difference in readings from two integral dosimeters out of four installed dosimeters (sensors) to calculate dose rate in order to shorten measurement time, the dose obtained was approximately 210Gy/h
- Upon conclusion of the exploration, it was found when checking the readings from each of the four sensors, that the No. 4 sensor, which produced the approximate 210 Gy/h reading from the aforementioned location, was generating higher readings than the other three sensors. When dose rate was calculated from the average readings from each sensor in consideration of the discrepancies between the No. 1 through No. 4 sensors, the resulting dose rate for the aforementioned location was approximately 70 Gy/h.

※ : using the starting location of the survey robot as the starting point

Elapsed time

- Dose rate was calculated from the difference in measurement of two out of four integrating dosimeters, but when the measurement of each dosimeter were checked, it was found that the measurements from one of the dosimeters had a tendency to consistently record much higher measurement results than the other three dosimeters (and needs appropriation).

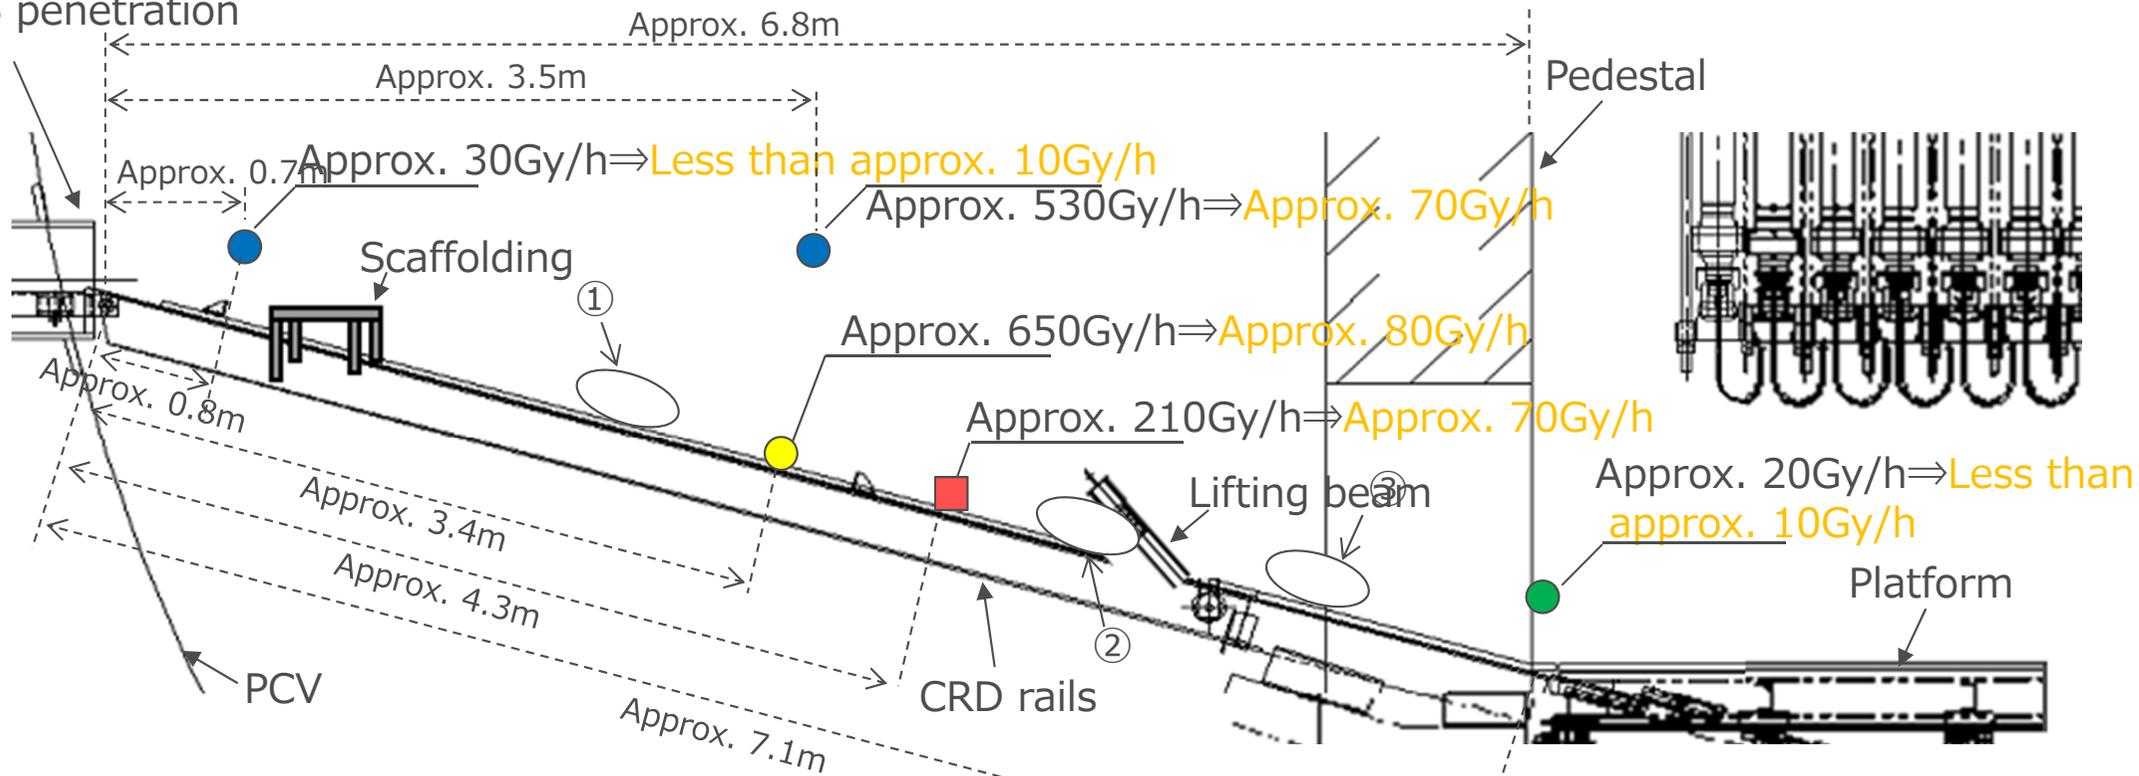
(Reference) Dose rate-related survey results

Key
[Prior to check] ⇒ [After check]

Dose rate estimated from camera video noise

Dose rate calculated using integral dosimeters

- Inside the X-6 penetration, advance survey of CRD rails: 1/26
- Advance survey of inside of pedestal: 1/30
- Front camera on deposit removal robot: 2/9
- Self-propelled survey robot: 2/16

X-6 penetration

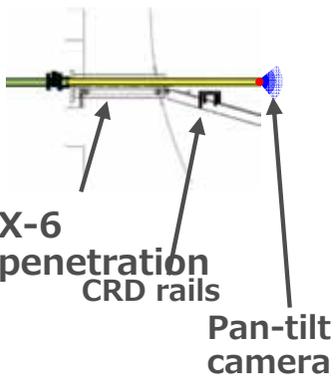
Advance survey of CRD rails conducted inside the X-6 penetration seal through a guide pipe inserted for prior examination

Conducted on 1/26

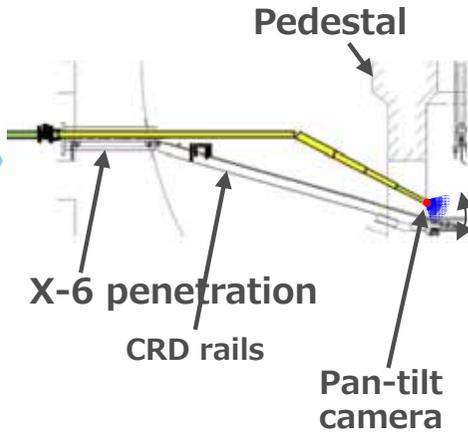
Advance survey of inside of pedestal through guide pipe

Conducted on 1/30

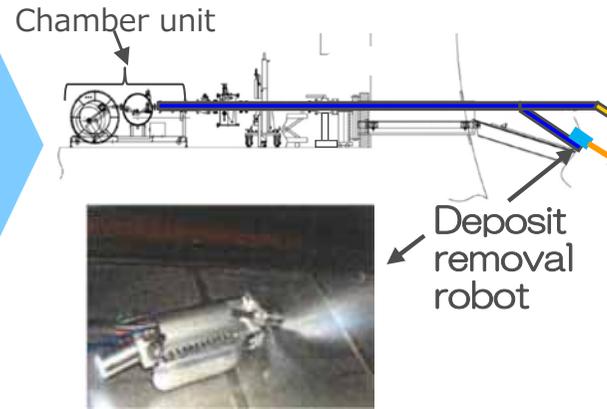
Insertion of deposit removal robot

Conducted on 2/9

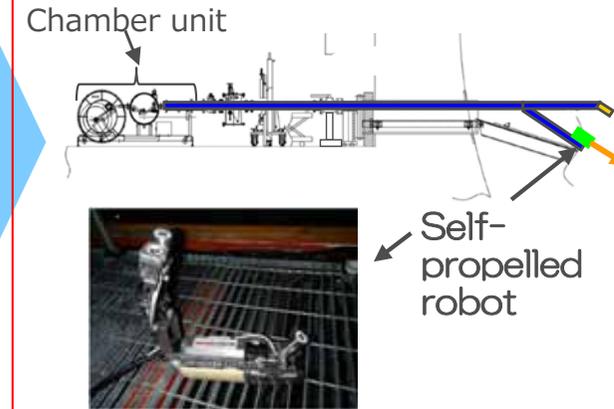
Internal exploration conducted using self-propelled robot

Conducted on 2/16
