November 5, 2011

Tokyo Electric Power Company

**Obstacle Removal by Robot
and Radiation Dose Measurement
after the Removal on the First Floor
of Unit 3 Reactor Building
at Fukushima Daiichi Nuclear Power Station**

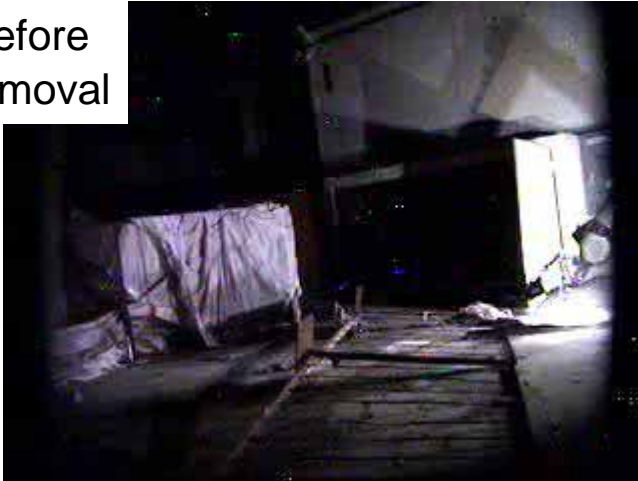
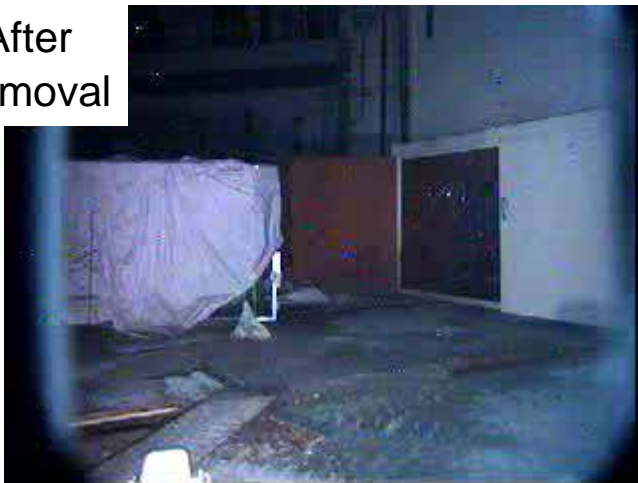
< In Front of the Equipment
Hatch at North-East Area >

Before
Removal

Photo taken on November 2, 2011

After
Removal

Photo taken on November 3, 2011

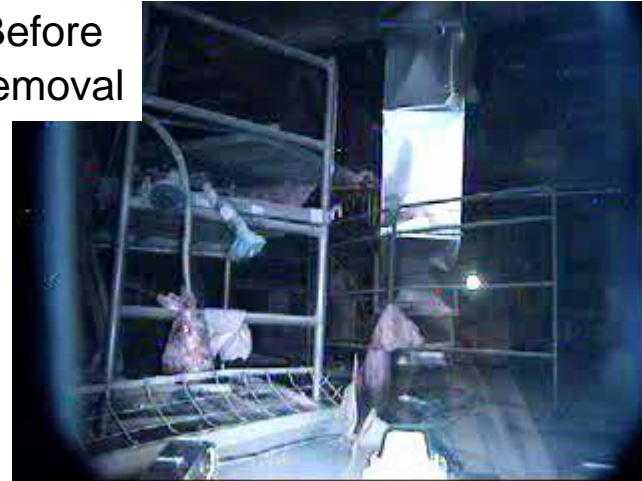
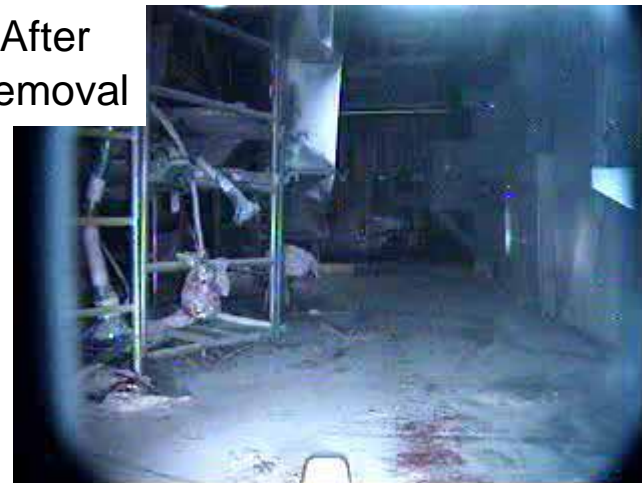
< North Corridor >

Before
Removal

Photo taken on November 2, 2011

After
Removal

Photo taken on November 3, 2011

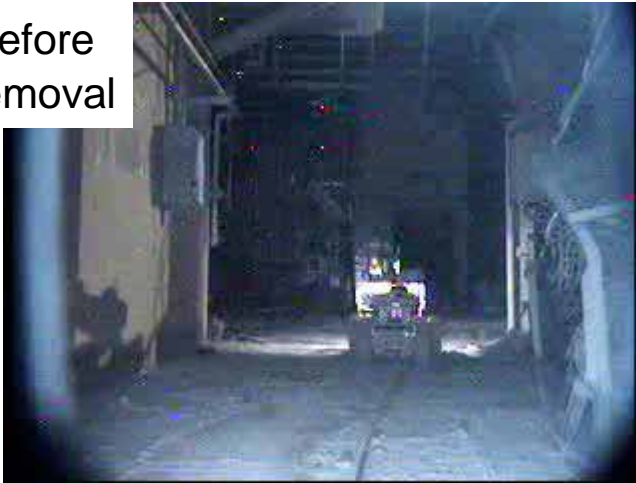
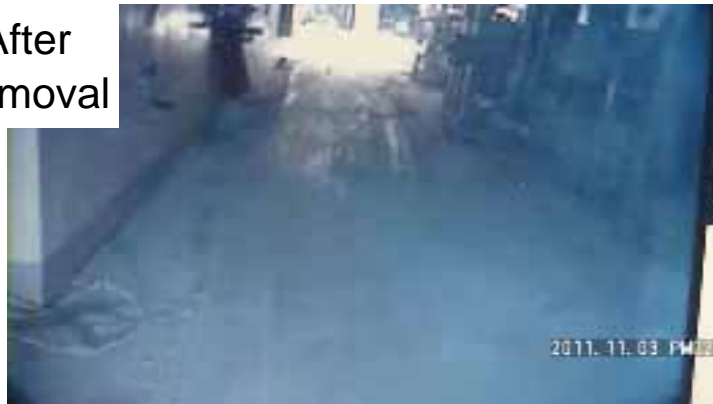
< **West Corridor** >

Before
Removal

Photo taken on November 3, 2011

After
Removal

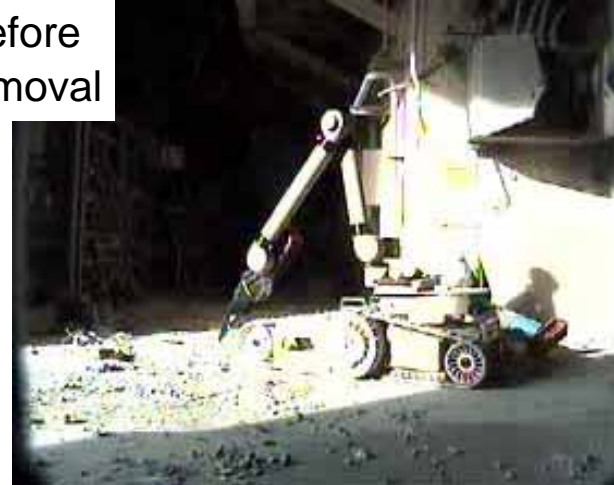
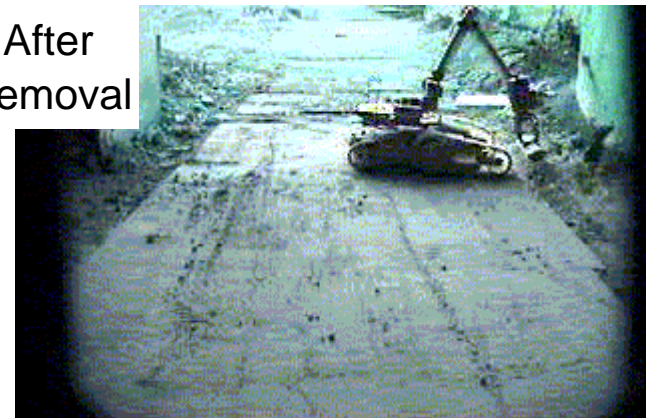
< **Under the Equipment
Hatch at South-West Area** >

Before
Removal

Photo taken on November 3, 2011

After
Removal
