## Water leakage from the concentrated water tank of the water desalinations (reverse osmosis membrane)

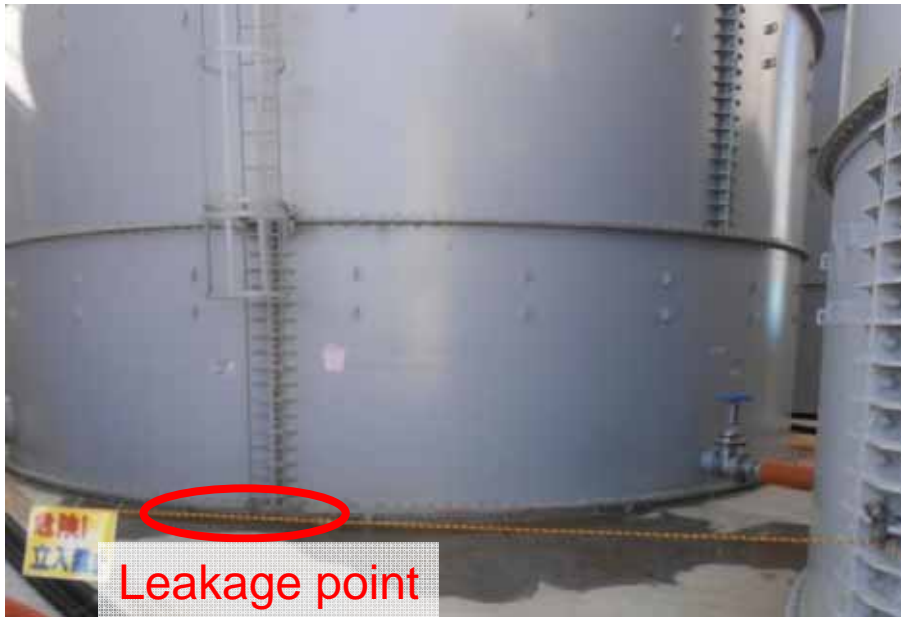
Leakage point

<Leaked tank>

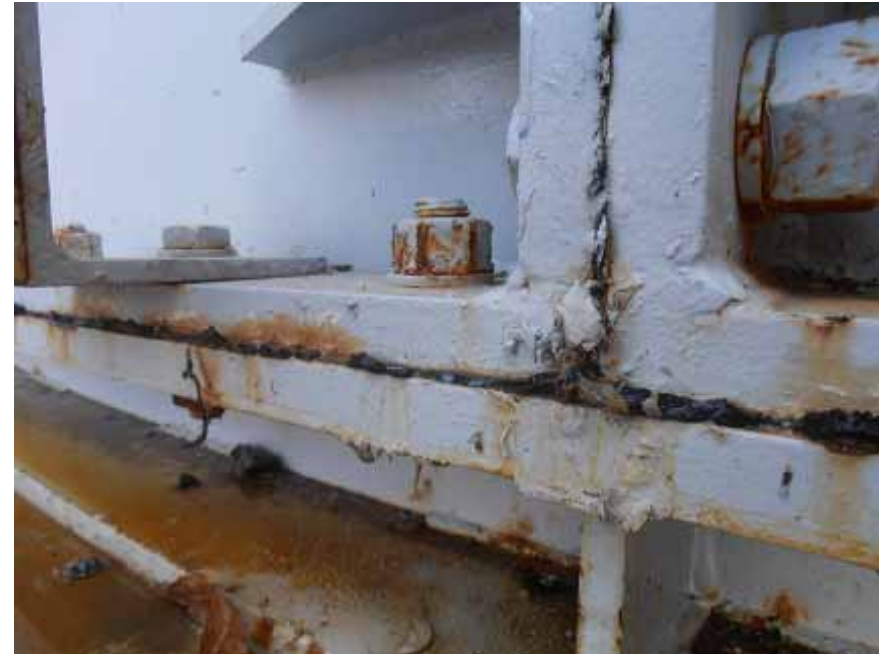
<Close-up photo of the leaked point>
