March 22, 2012

Tokyo Electric Power Company

**Survey Results of TIP Room in
Ground-floor at Reactor Building,
Unit 2 at Fukushima Daiichi Nuclear
Power Station
(Conducted on March 21, 2012)**

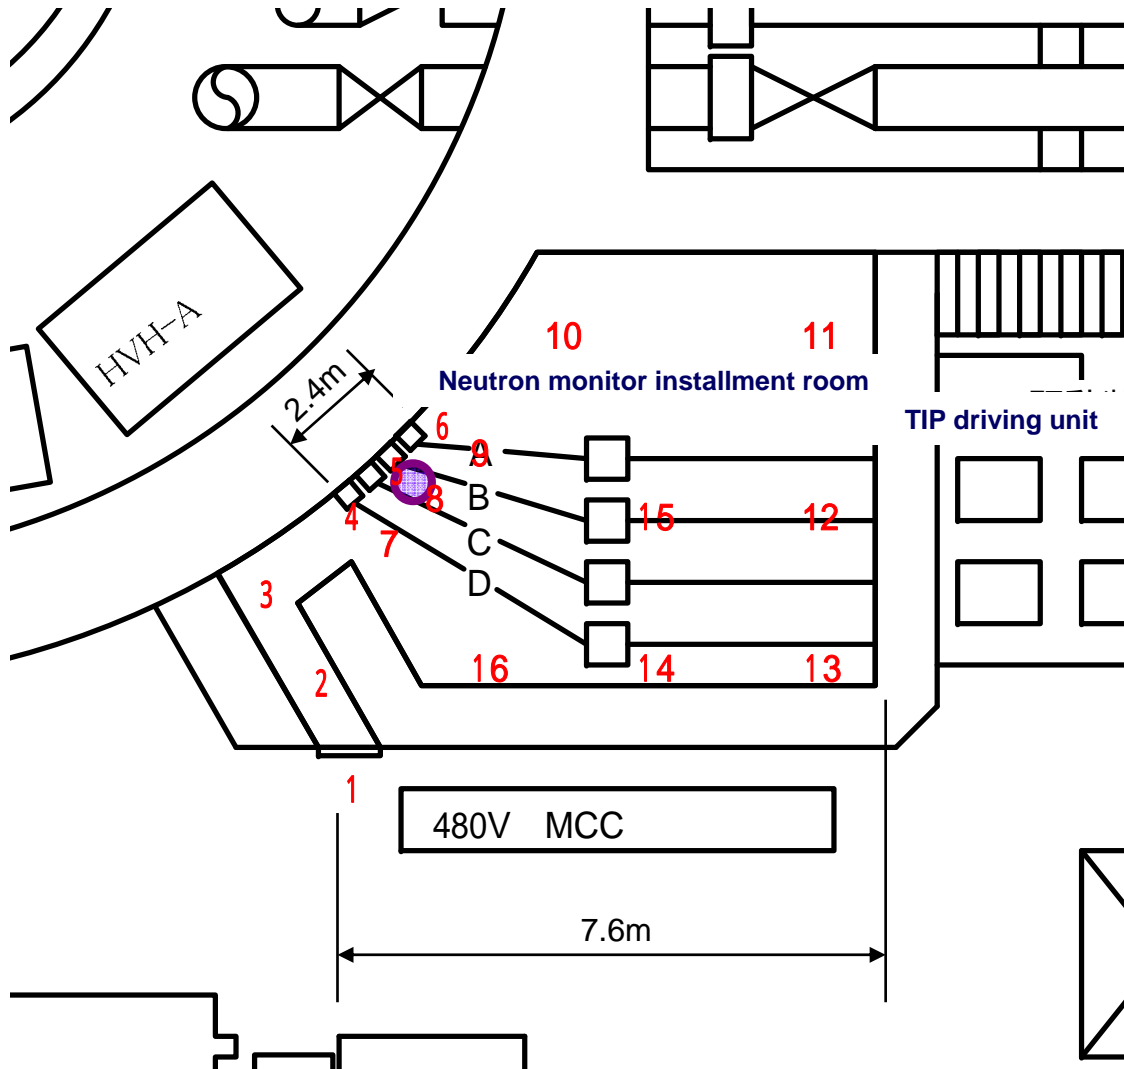
Survey results (Radiation dose rate, etc)

Location	Dose rate [mSv/h]
1	1.1
2	3
3	1.5
4	1.0
5	2.2
6	1.8
7	2.0
8	1.8
9	1.8
10	1.7
11	1.8
12	1.8
13	1.8
14	1.8
15	1.8
16	2.0

Temperature	Humidity
18.7	26.2%

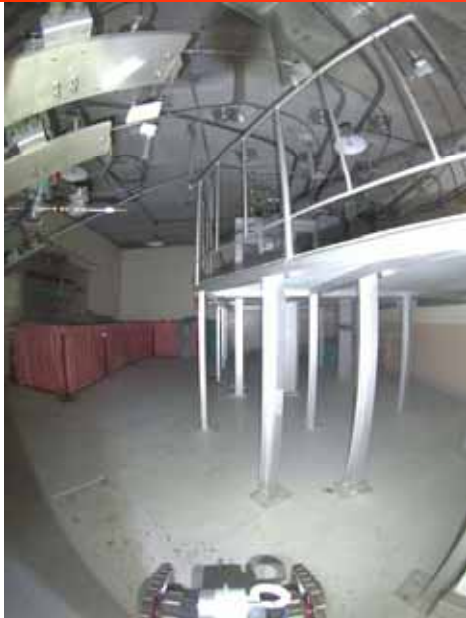
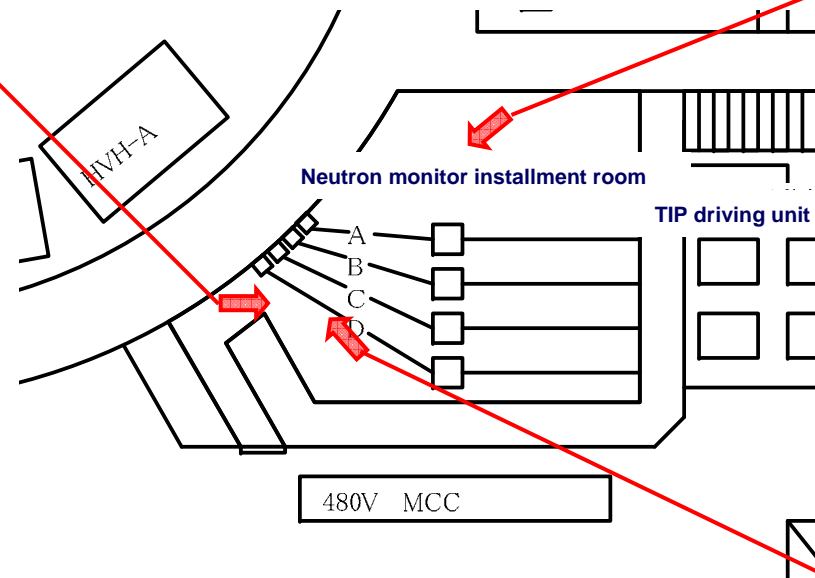
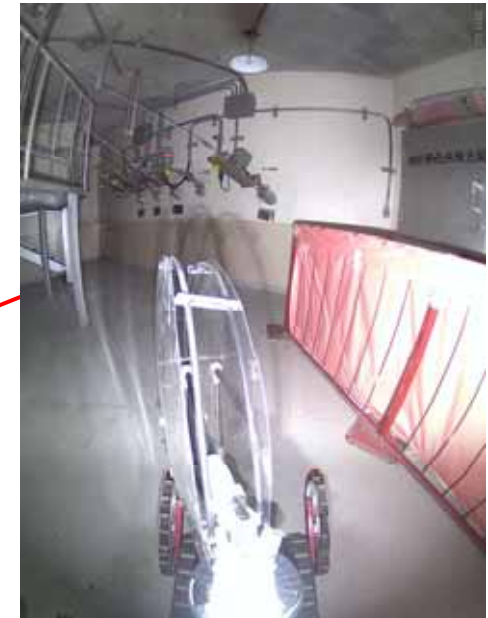
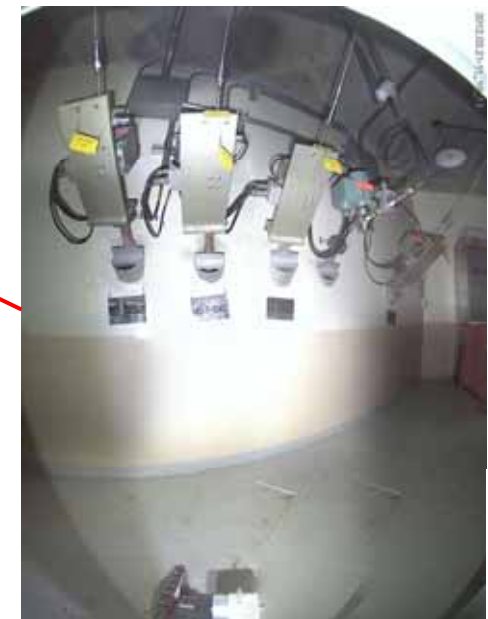
Survey results (Pictures)

Notable damage is not confirmed in TIP system unit

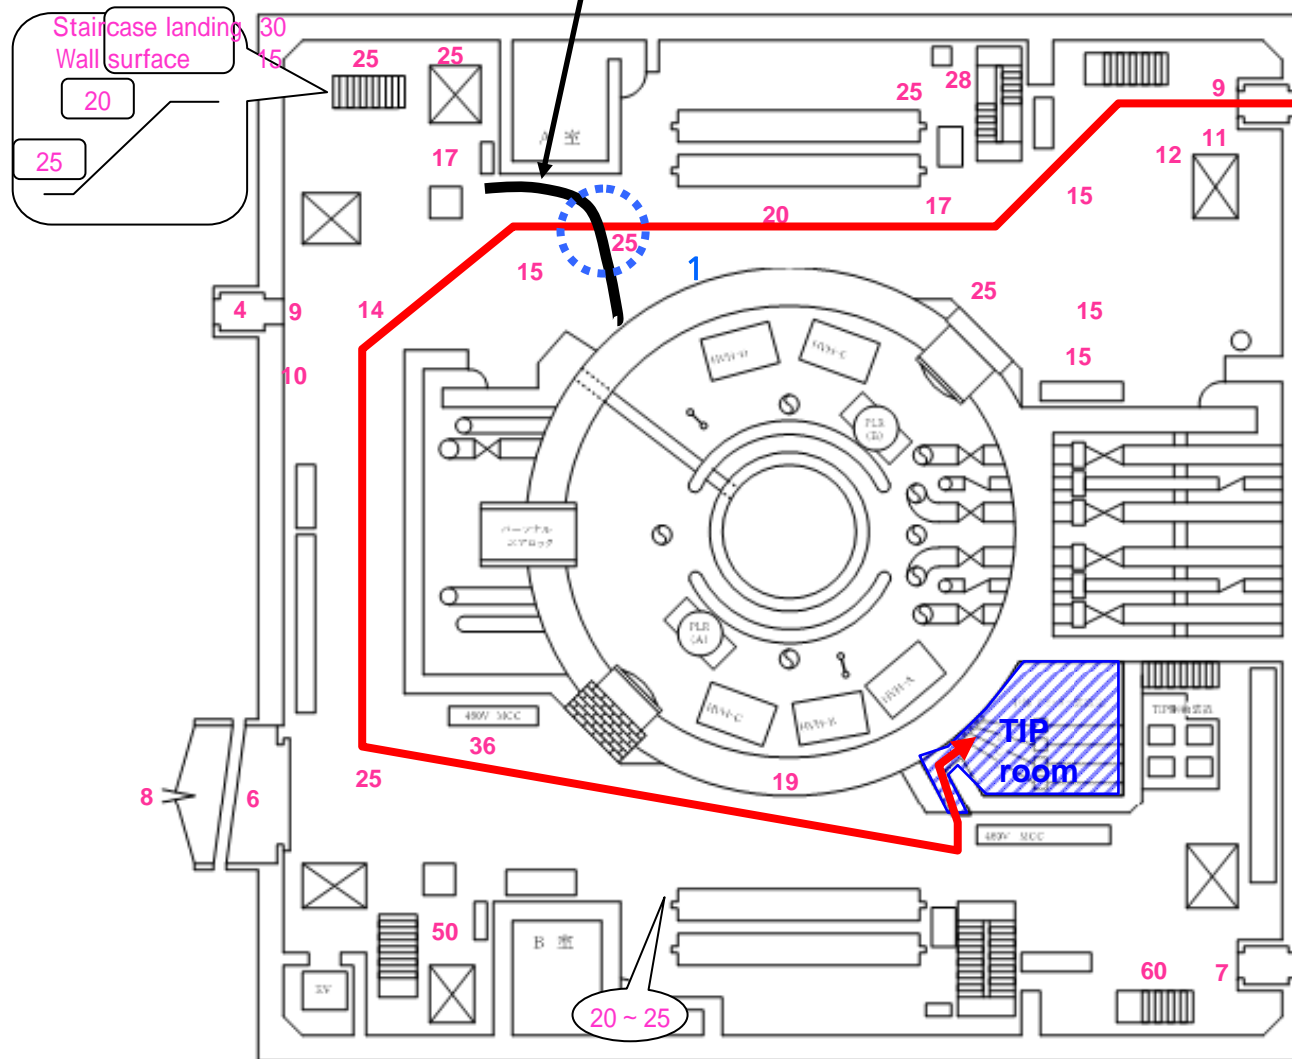
(Reference) Robot access route

Ground-floor at reactor building, Unit 2

— Robot route

1 The robot was hauled by man to step over equipments such as hose.
