## Site Investigation Result of the Accumulated Water Found at Unit 3 Radiation Waste Underground Storage Facility Building At Fukushima Daiichi Nuclear Power Station (May 28-29)

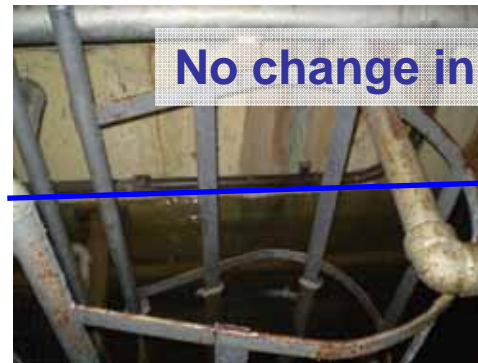
Water Level (May 24)

- Water level: No change (See the photo on the right)
  - Inflow water amount: No change (See the photo on the next slide)
  - Found water accumulated in the reactor coolant filtering system resin storage tank. (See the photo on the next slide)
  - The location where pipes penetrate through the wall between the radiation waste underground storage facility building and the radiation waste treatment building was under the water. (See the photo on the next slide)
  - Sampling result (Total nuclides, Unit: Bq/cm<sup>3</sup>)
- Water flow into the spent sludge tank room:  $4.5 \times 10^{-1}$   
 Water accumulated in the spent sludge tank room (near tank A):  $9.7 \times 10^0$   
 Water accumulated in the reactor coolant filtering system spent resin storage room:  $8.0 \times 10^0$

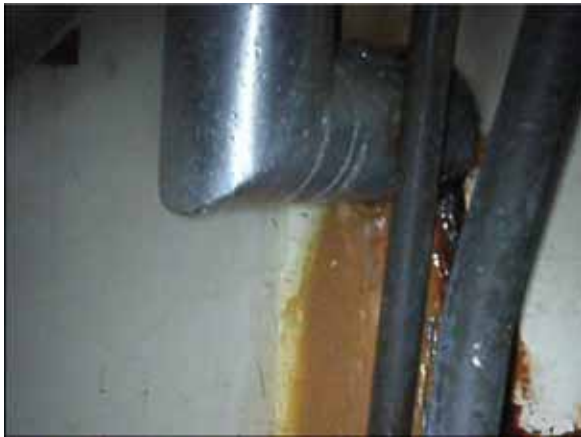
Location where water flow was confirmed on the Centralized Environment Facility Radiation Waste Common Duct (Water amount: Width of 3 fingers, No change)

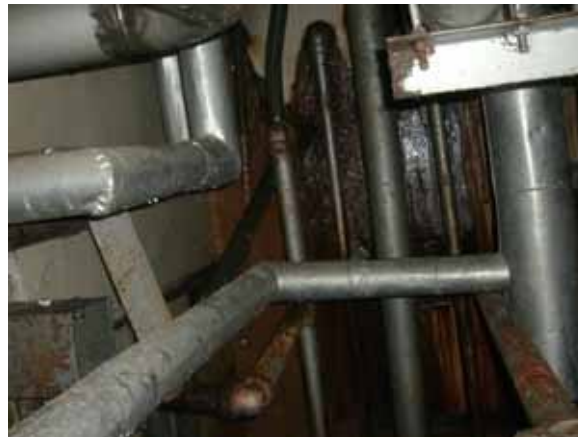
The location near where the water flow was confirmed

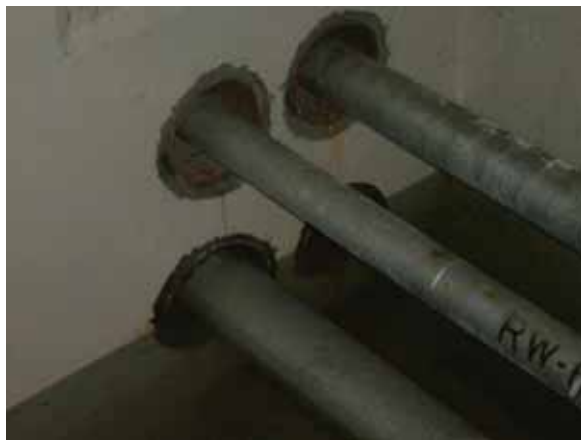
Location where the pipes penetrate through the wall between the reactor coolant filtering system spent resin storage tank room and the spent sludge storage tank room (under the water)

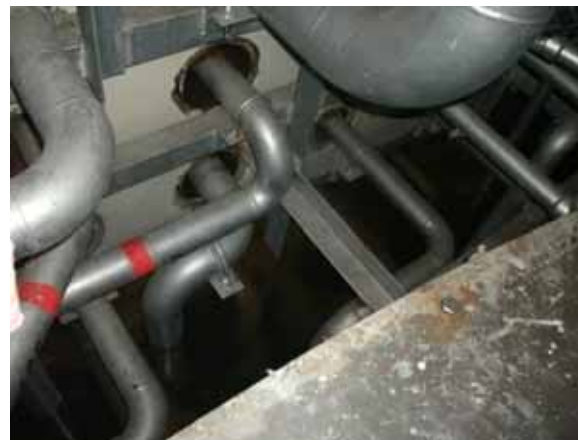
Location where the pipes penetrate through the wall between the radiation waste underground storage facility building and the radiation waste treatment building (under the water)

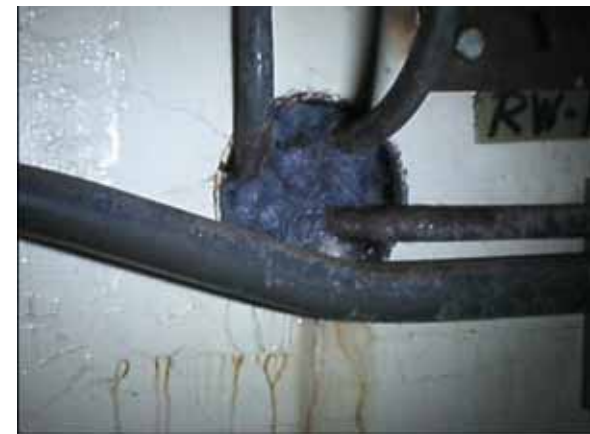
Water exuded on the location where the pipe penetrates through the south wall of the spent sludge tank A
