Reliability Improvement of the Second Cesium Absorption Apparatus

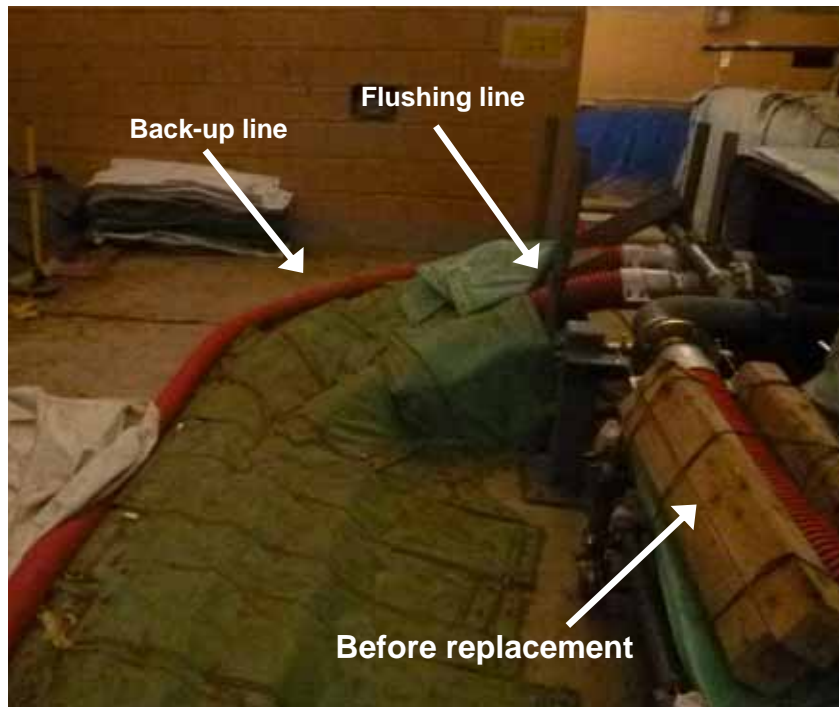
Before replacement

The part of SARRY accumulated water treatment pipeline where pressure hose was used has been replaced with steel pipe* (Work carried out from August 8 to 10, 2012).

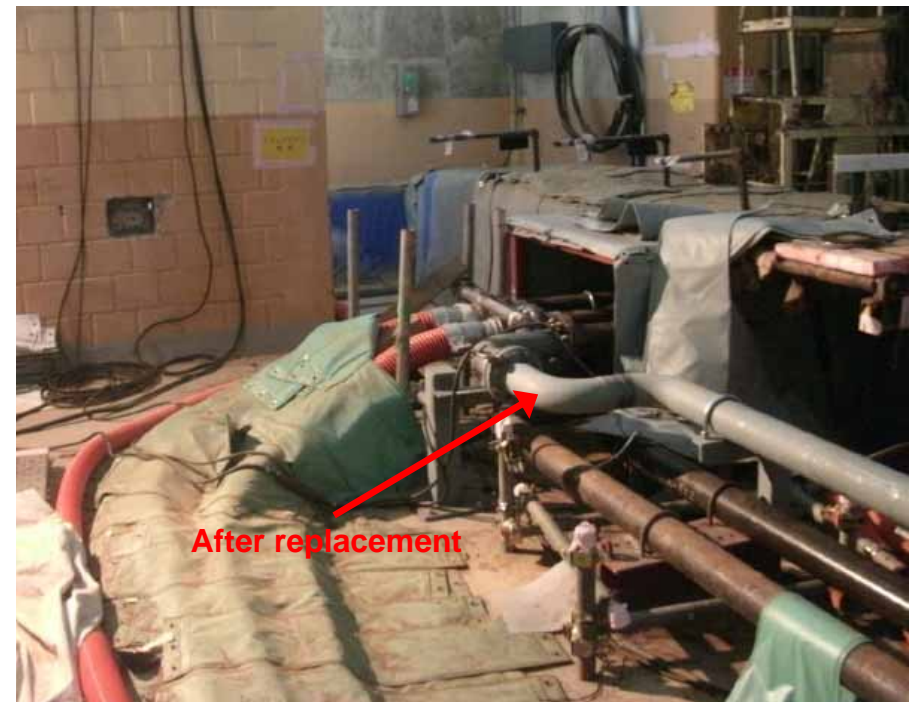
After replacement

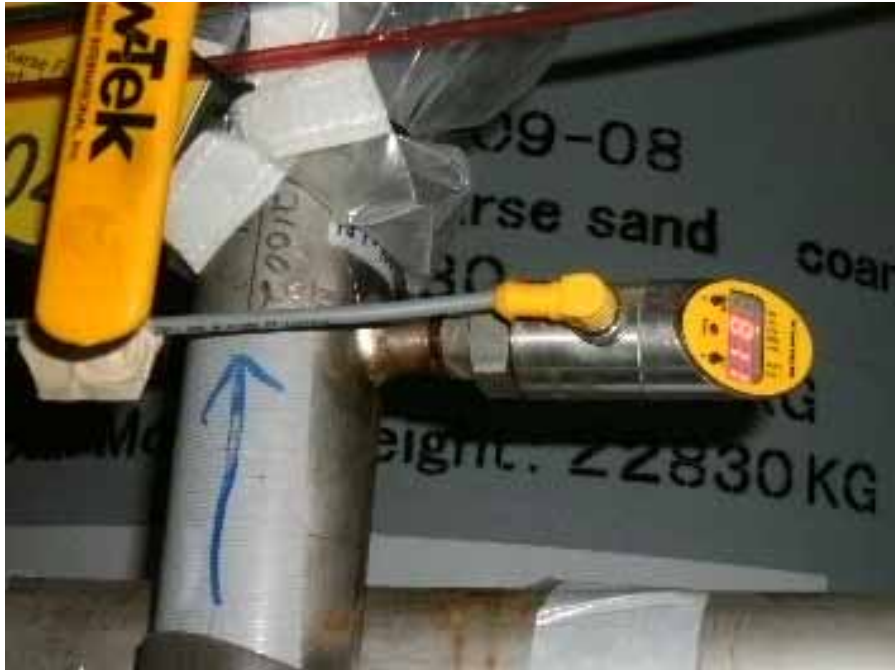
Before replacement (PIT100B)

All the pressure indicator transmitters (PIT) (22 units) have been replaced (August 8-10, 2012).

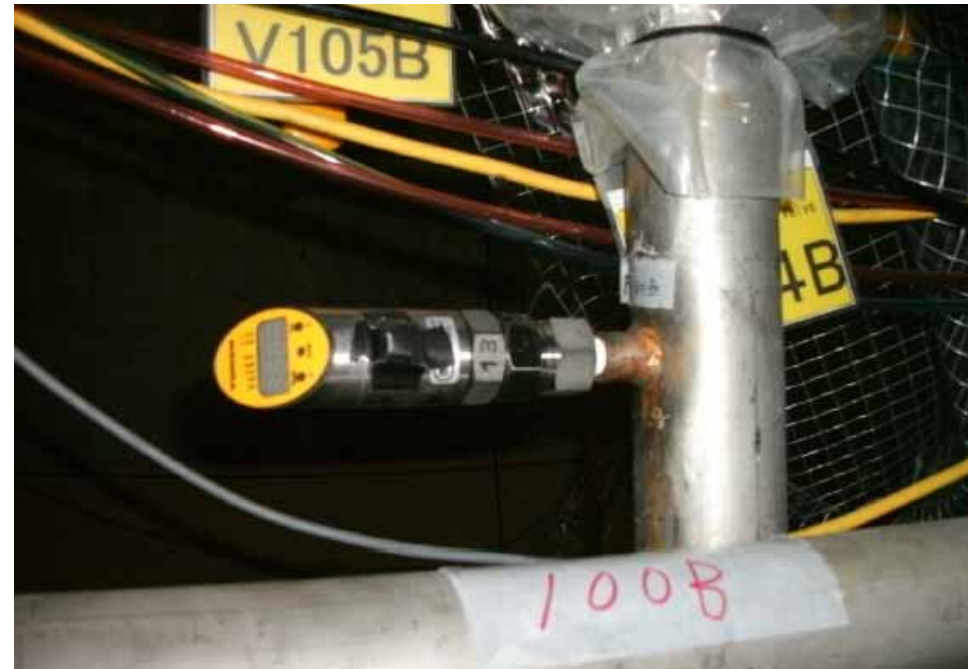
After replacement (PIT100B)

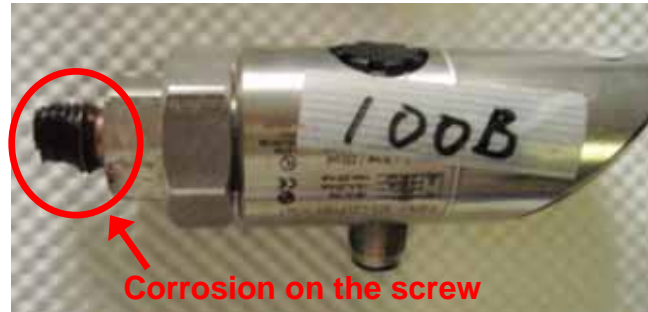
PIT100B (Before replacement)

- Though the screw of PIT (SUS303) was corroded, the screw on the pipe side (SUS316L) was not. The corrosion was found with other PITs as well.
- The corrosion of PIT screw is considered to be due to the high chloride ion concentration.
- All the PITs (SUS303) have been replaced with PITs (SUS316L) with improved corrosion resistance.

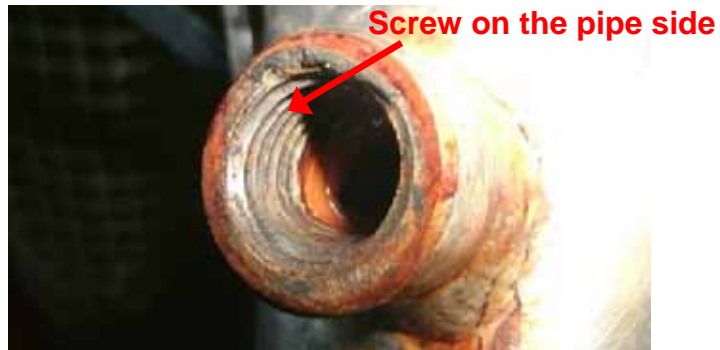
PIT100B installation area
