October 3, 2012

Tokyo Electric Power Company

# Unit 2 RPV Alternative Thermometer Installation at Fukushima Daiichi Nuclear Power Station

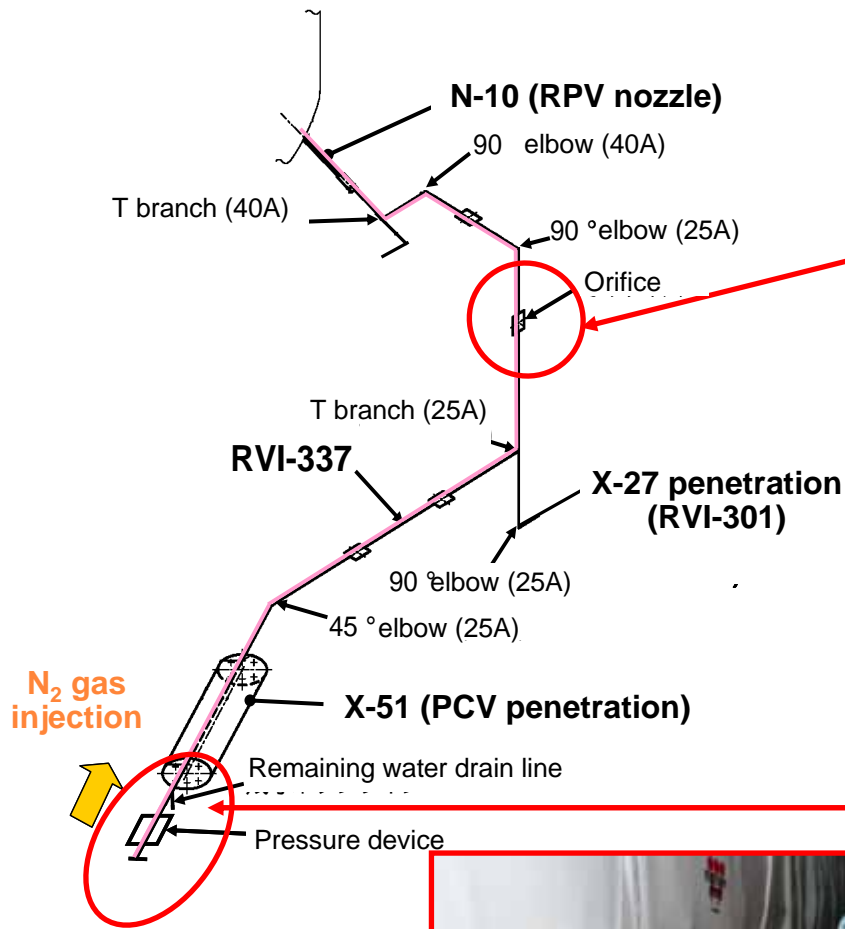
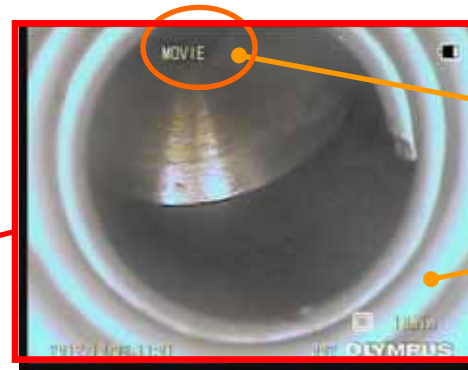
Investigation of the inside of the pipe by an endoscope (October 2)

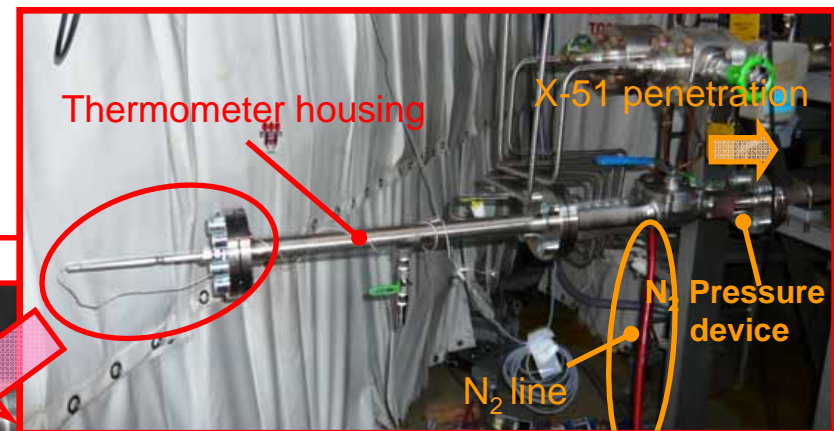
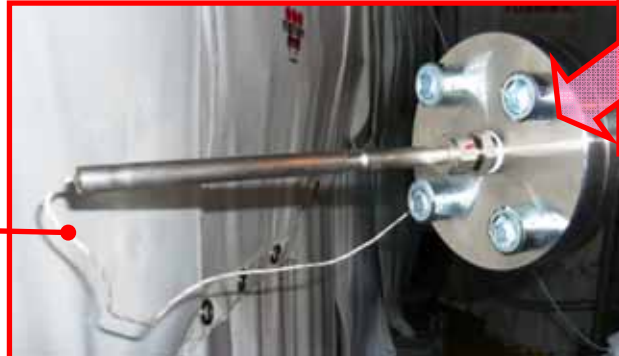
Thermometer installation condition (October 3)

Thermometer compensation lead wire

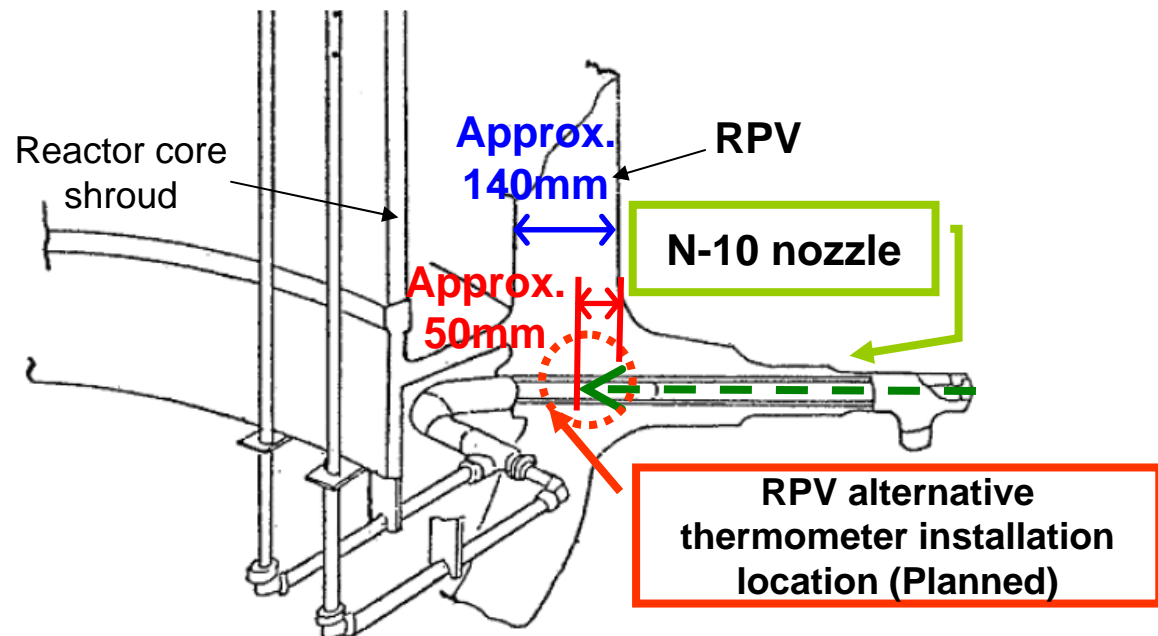
## 2. RPV Alternative Thermometer Installation Location

- The RPV alternative thermometer has been installed in N-10 nozzle at approx. 5cm inward from the RPV external wall surface. The thermometer measures the temperature of the RPV wall surface material similarly to the existing RPV bottom thermometer. The thermometer was inserted to the location determined based on dimensional control. The target installation location is set at 5cm inward from the RPV external wall surface considering the error ( $\pm 5\text{cm}$  max.).
- It has been confirmed at the mockup test that the thermometer is capable of accurately measuring the temperature as long as the thermometer reaches the RPV wall even if it does not touch the metal part.

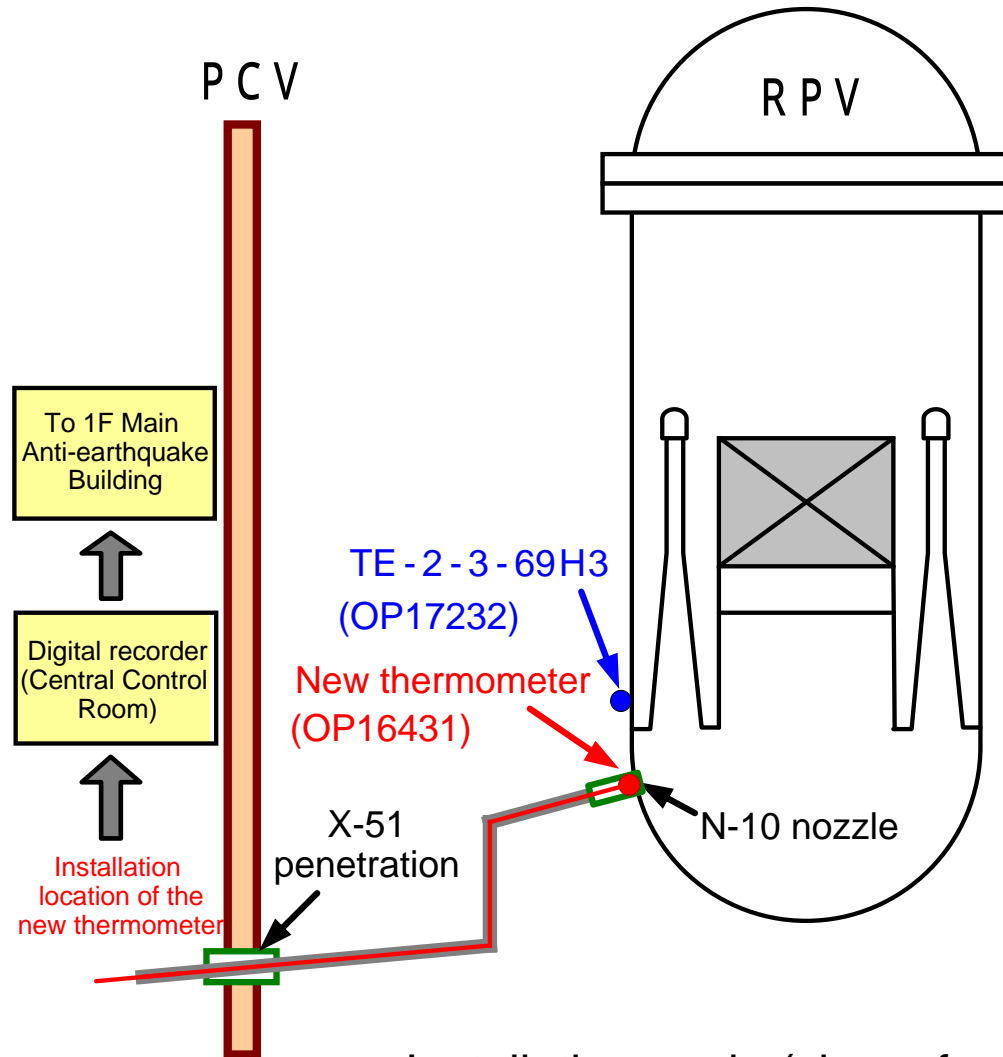
# 3. Comparison between the Alternative Thermometer and the Existing Thermometer

## Installation location

Installation angle (circumferential direction): 270 ° / 180 °

Table 1. Readings of the existing thermometer and the new thermometer

TE-2-3-69H3 (RPV bottom head upper thermometer)	New thermometer
46.1	42.6
